# ULTRA PREMIUM HOME INSPECTION REPORT

**GRUHA  
INSPECTION  
SERVICES**

| Project / Apartment | Rajapushpa Imperia |
| Location | Tellapur |

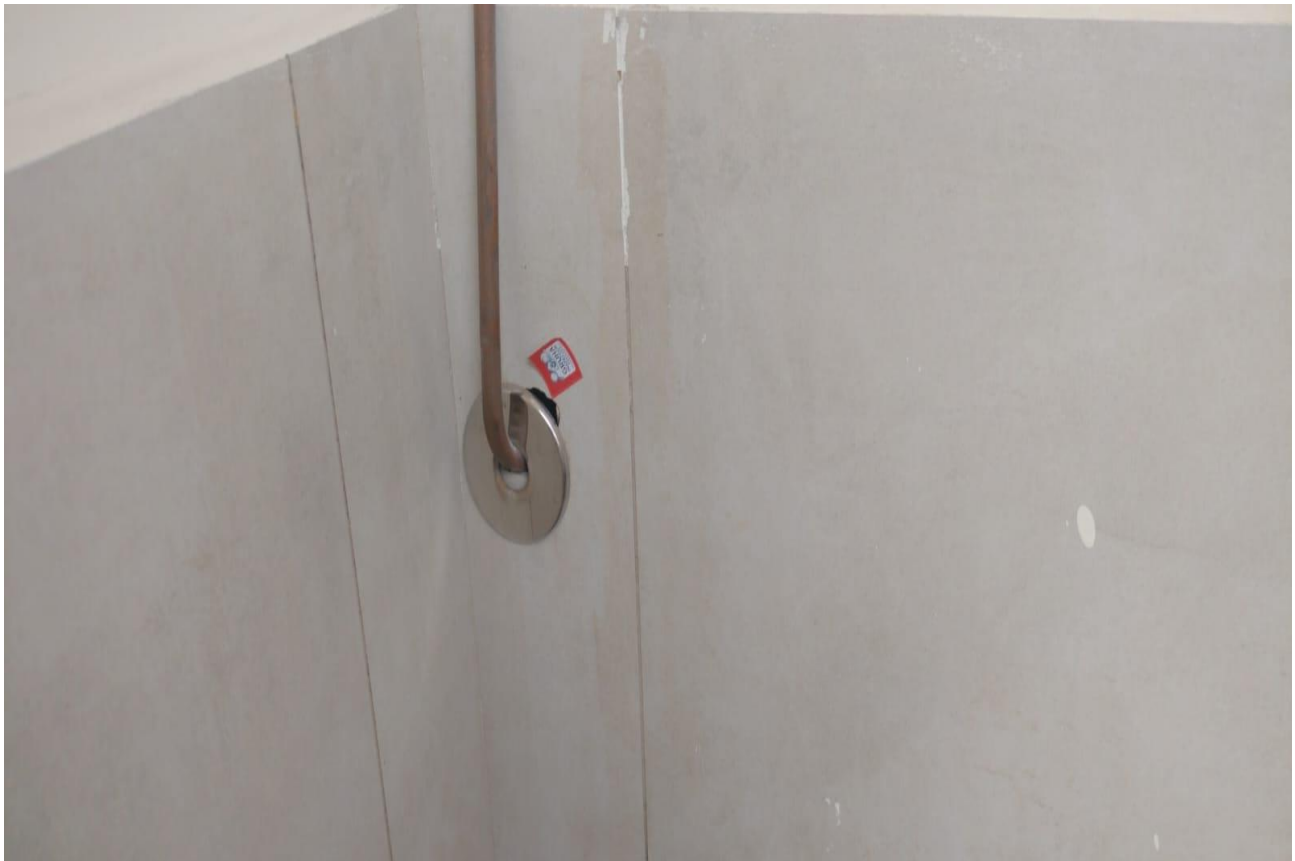
| Observation No | 01 |

| Observation Description | Void/gap not packed around the gas pipeline hole in the wall behind the cover plate. |

| Recommendation | Pack the void around the gas pipe with non-shrink mortar or suitable packing material, and properly seal and fix the cover plate flush against the tile surface. |

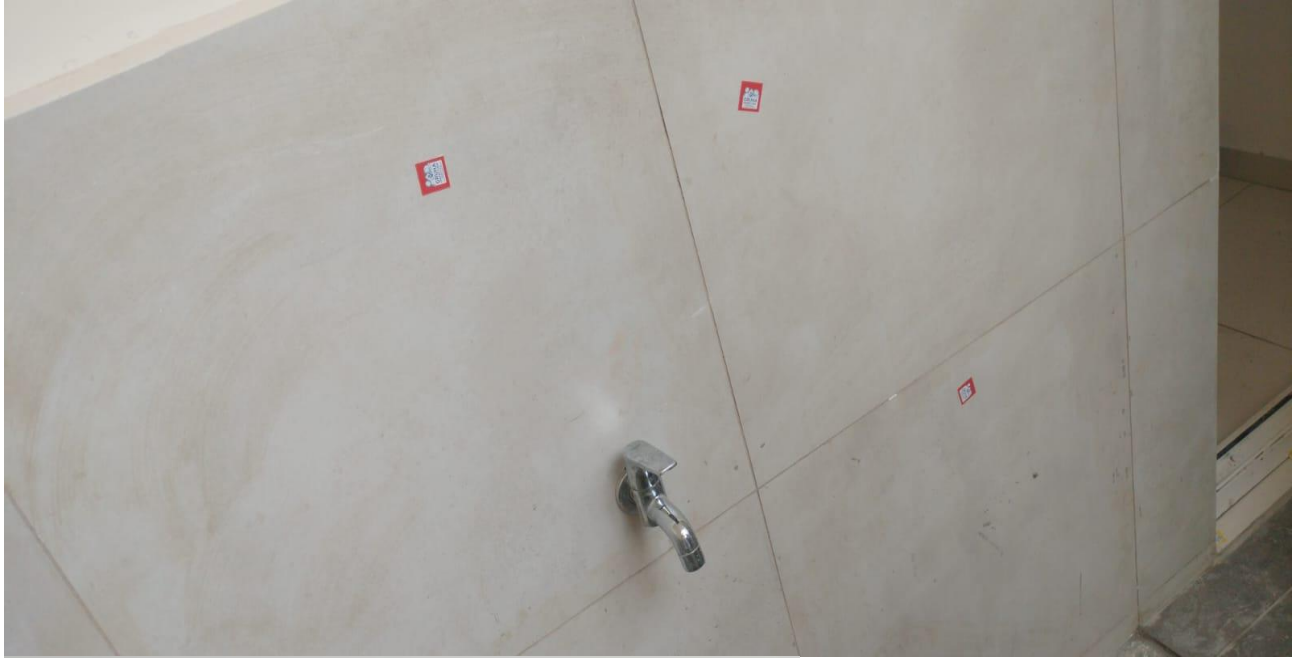
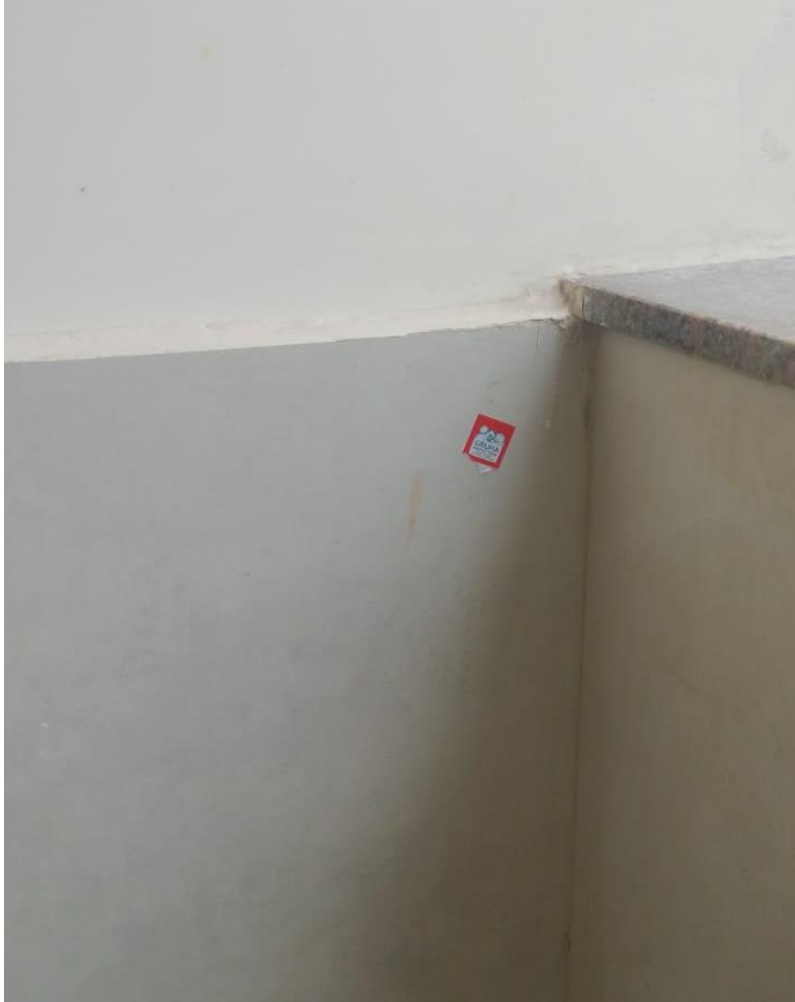
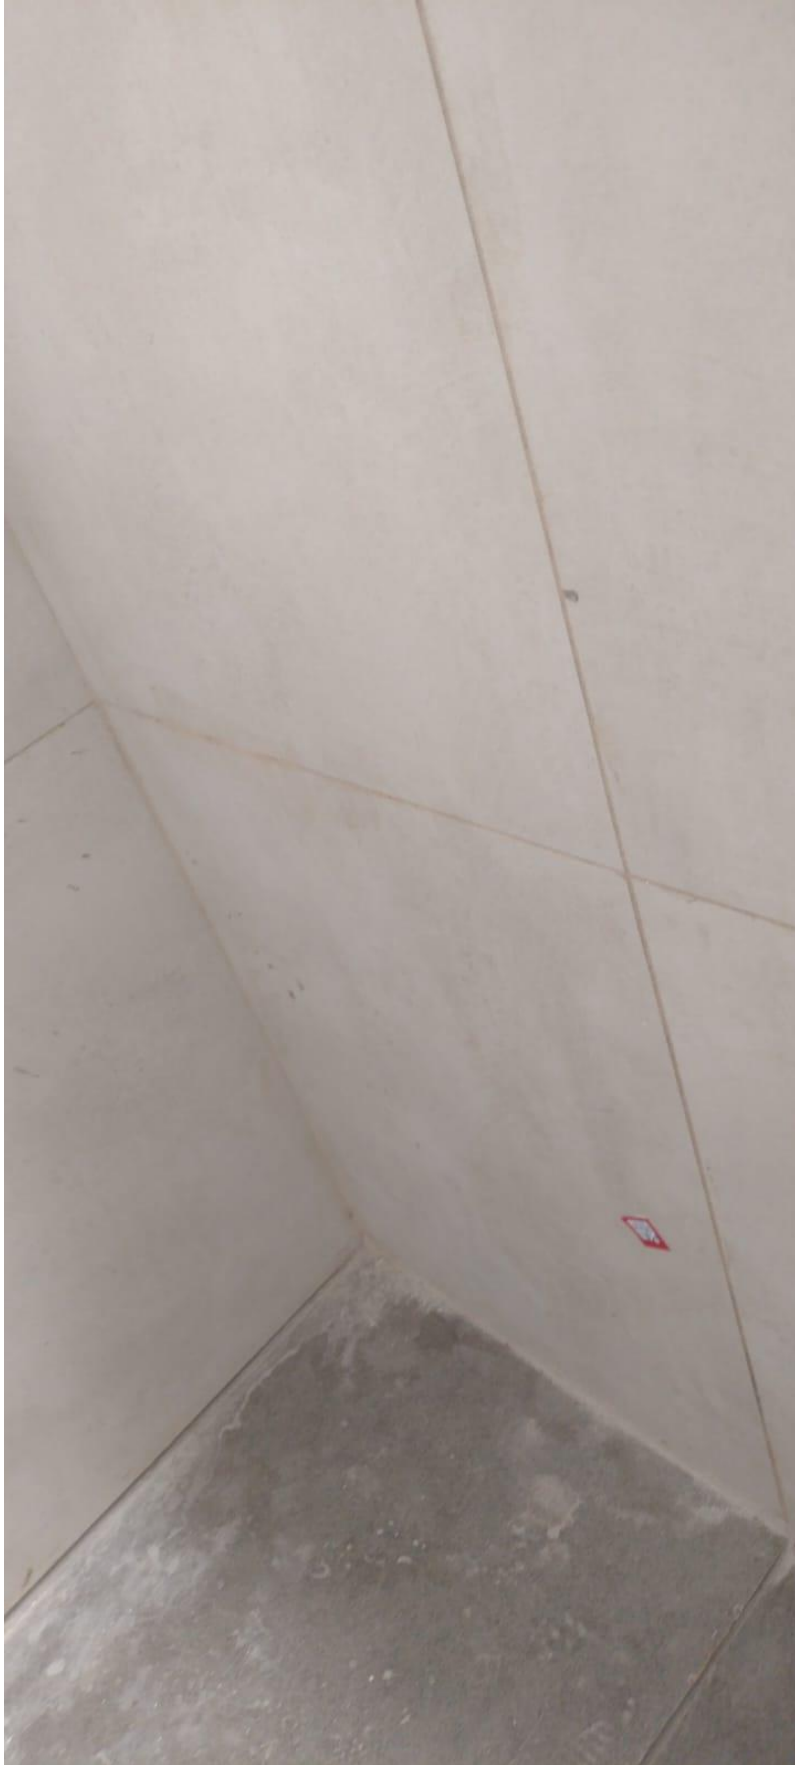
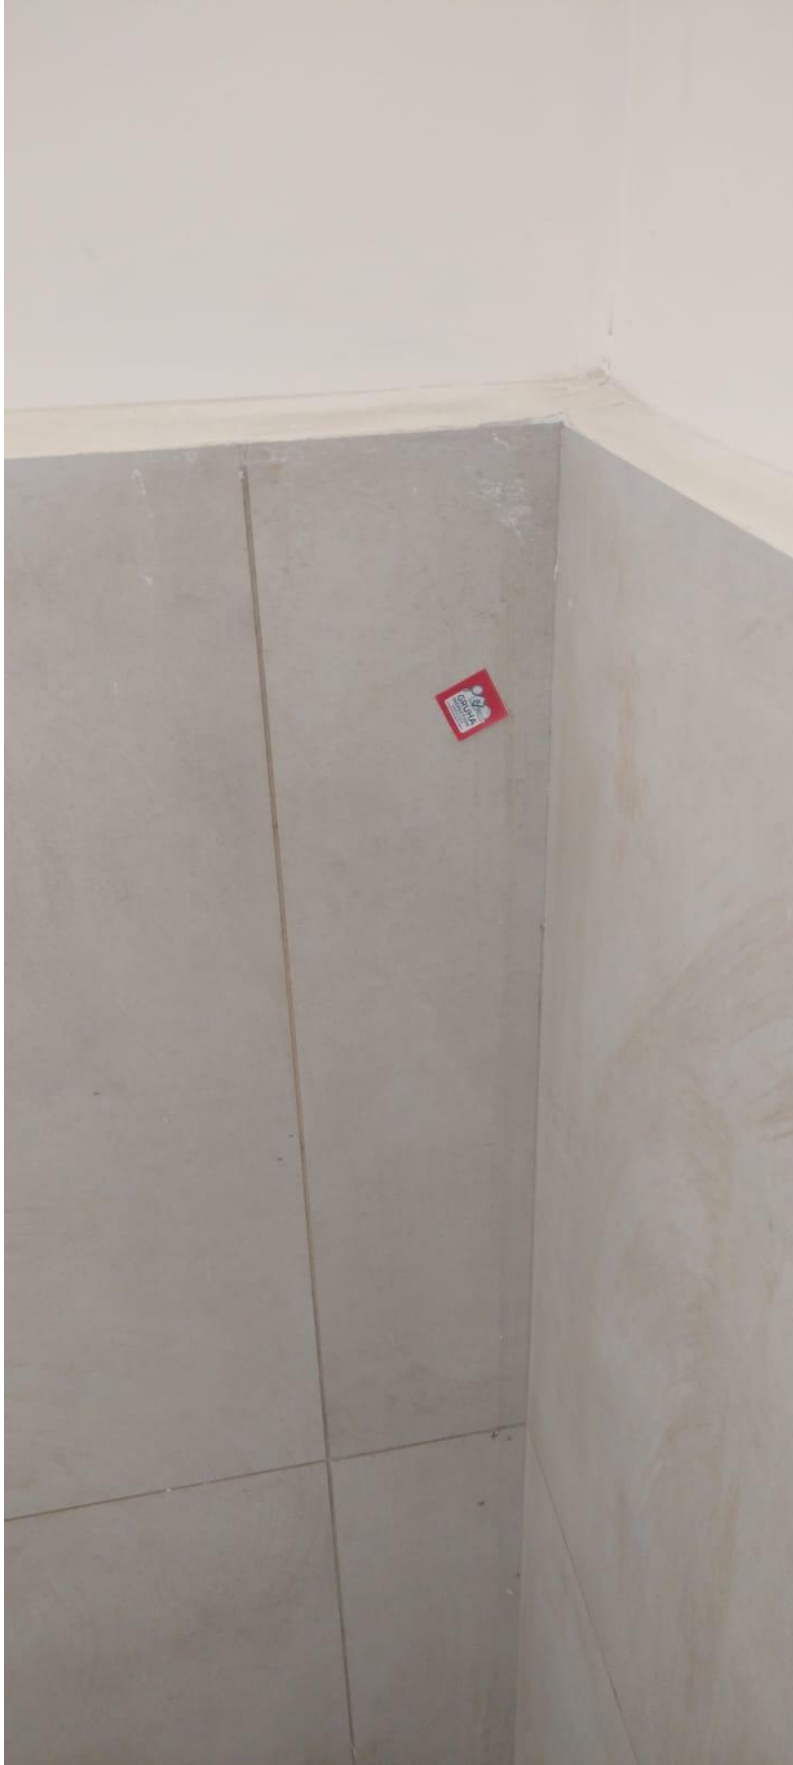
| <b>Observation Description</b> | Hollow sound and debonding observed in 6 wall dado tiles in the utility area upon tap-testing. This condition indicates inadequate adhesive coverage or air voids/gaps in the bedding mortar behind the tiles, leaving them unsupported. Over time, exposure to moisture, thermal expansion, or accidental impact can lead to tile cracking, grout failure, or complete detachment from the wall surface. |

| <b>Recommendation</b> | <p><b>Step 1</b></p> <p><b>Tile Removal:</b> Carefully cut around the grout lines and gently lift the hollow floor tile to avoid chipping or disturbing adjacent tiles.</p> <p><b>Step 2</b></p> <p><b>Surface Preparation:</b> Chip off the loose mortar or old adhesive down to a firm, clean floor base and clear away all dust and debris.</p> <p><b>Step 3</b></p> <p><b>Adhesive Application:</b> Apply a fresh, high-bonding tile adhesive evenly across the floor bed and the back of the tile using a notched trowel to ensure 100% full coverage without empty spaces.</p> <p><b>Step 4</b></p> <p><b>Refitting &amp; Leveling:</b> Set the tile firmly in place, ensuring it is perfectly flush with the surrounding floor and properly aligned to maintain correct slope/drainage toward the floor trap.</p> <p><b>Step 5</b></p> <p><b>Curing &amp; Grouting:</b> Allow the adhesive to set undisturbed for 24 hours, then seal all surrounding tile joints thoroughly with water-resistant tile grout.</p> |

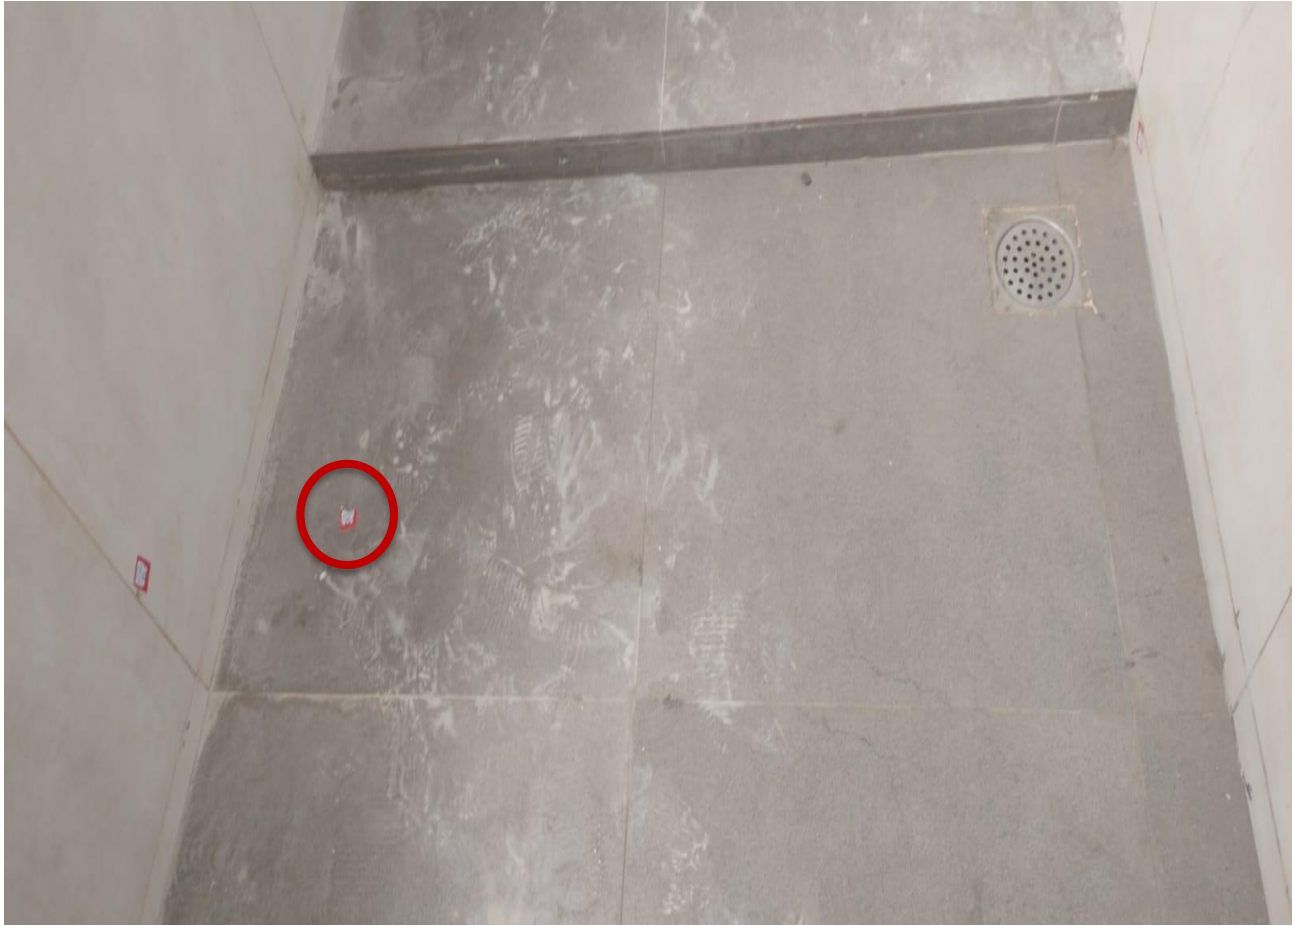
| <b>Observation Description</b> | A hollow sound and debonding were detected in 1 floor tile in the utility area during tap-testing. This indicates poor adhesive coverage or air voids in the bedding layer underneath. On floor tiles subjected to regular foot traffic and moisture exposure, un bonded areas can cause the tile to crack, loosen further, or allow water ingress into the floor base over time. |

| <b>Recommendation</b> | <p><b>Step 1</b></p> <p><b>Tile Removal:</b> Carefully cut around the grout lines and gently lift the hollow floor tile to avoid chipping or disturbing adjacent tiles.</p> <p><b>Step 2</b></p> <p><b>Surface Preparation:</b> Chip off the loose mortar or old adhesive down to a firm, clean floor base and clear away all dust and debris.</p> <p><b>Step 3</b></p> <p><b>Adhesive Application:</b> Apply a fresh, high-bonding tile adhesive evenly across the floor bed and the back of the tile using a notched trowel to ensure 100% full coverage without empty spaces.</p> <p><b>Step 4</b></p> <p><b>Refitting &amp; Leveling:</b> Set the tile firmly in place, ensuring it is perfectly flush with the surrounding floor and properly aligned to maintain correct slope/drainage toward the floor trap.</p> <p><b>Step 5</b></p> <p><b>Curing &amp; Grouting:</b> Allow the adhesive to set undisturbed for 24 hours, then seal all surrounding tile joints thoroughly with water-resistant tile grout.</p> |

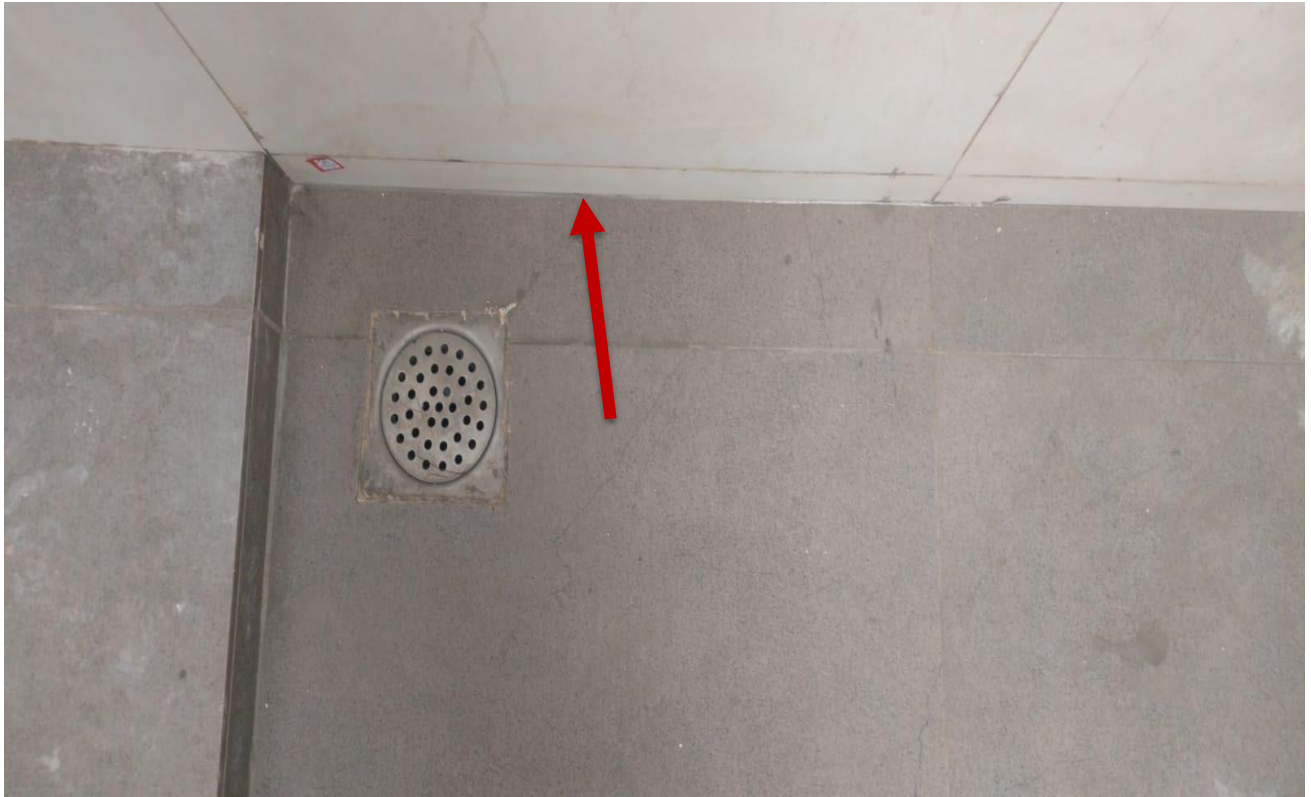
| <b>Observation Description</b> | Water accumulation/stagnation observed near the floor drain along the wall edge in the utility area due to improper floor sloping. Standing water in utility zones leads to persistent moisture buildup, tile grout deterioration, white mineral deposits (efflorescence), and increases the risk of water seepage into adjacent walls or lower floors over time. |

| <b>Recommendation</b> | <p><b>Step 1</b></p> <p><b>Slope Assessment:</b> Conduct a water flow test to mark the exact area where water pools and fails to drain smoothly toward the floor trap.</p> <p><b>Step 2</b></p> <p><b>Tile Removal:</b> Dismantle and remove the affected flooring tiles around the drain and wall section without damaging nearby wall dado tiles.</p> <p><b>Step 3</b></p> <p><b>Base Correction &amp; Slope Adjustment:</b> Chisel down the underlying mortar screed layer and re-lay a fresh polymer-modified base bed with a precise downward slope directed straight into the drain outlet.</p> <p><b>Step 4</b></p> <p><b>Waterproofing Verification:</b> Apply a waterproof slurry coating over the modified base and drain joints to prevent future moisture seepage into the slab.</p> <p><b>Step 5</b></p> <p><b>Tile Re-laying &amp; Joint Sealing:</b> Re-lay the floor tiles following the corrected slope, ensure flush alignment, and seal all tile joints and wall-floor intersections using high-grade epoxy grout.</p> |

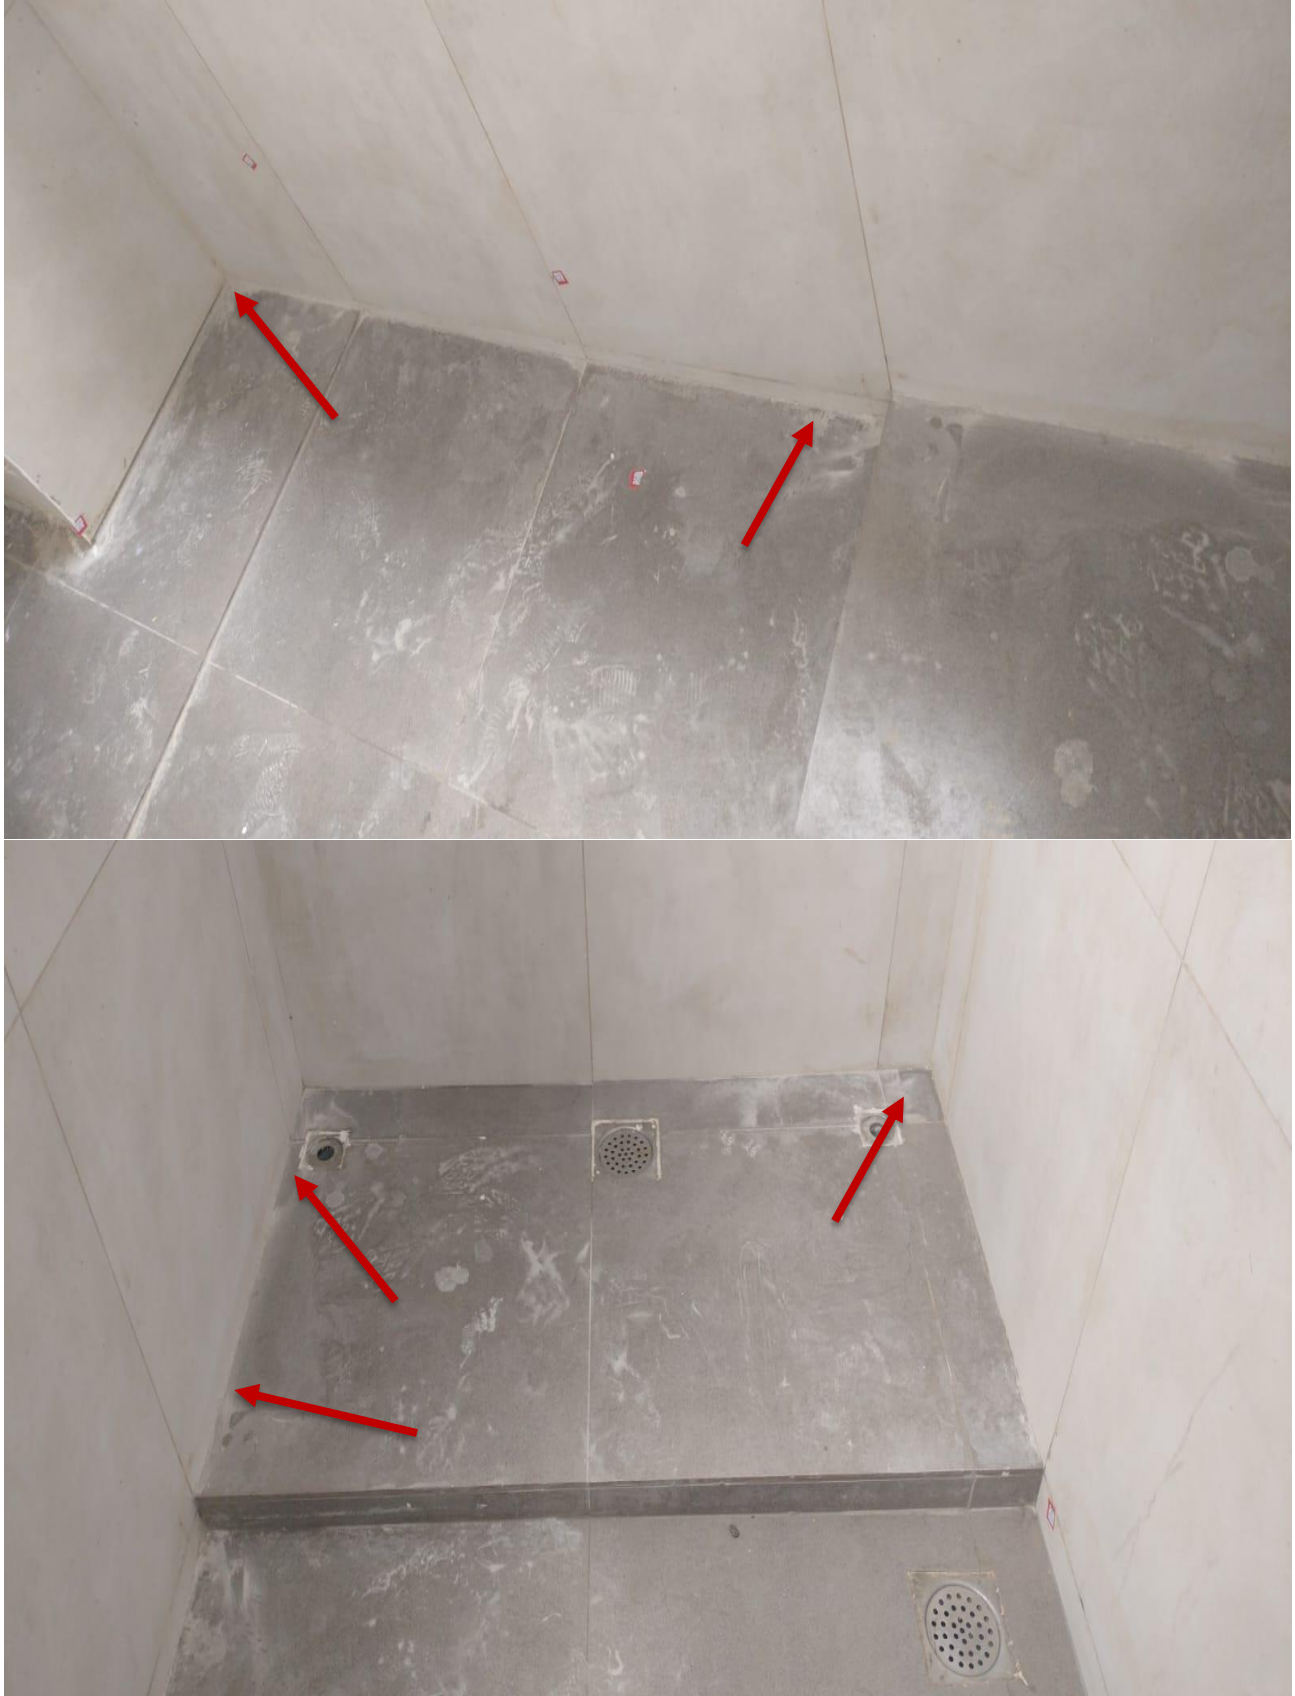
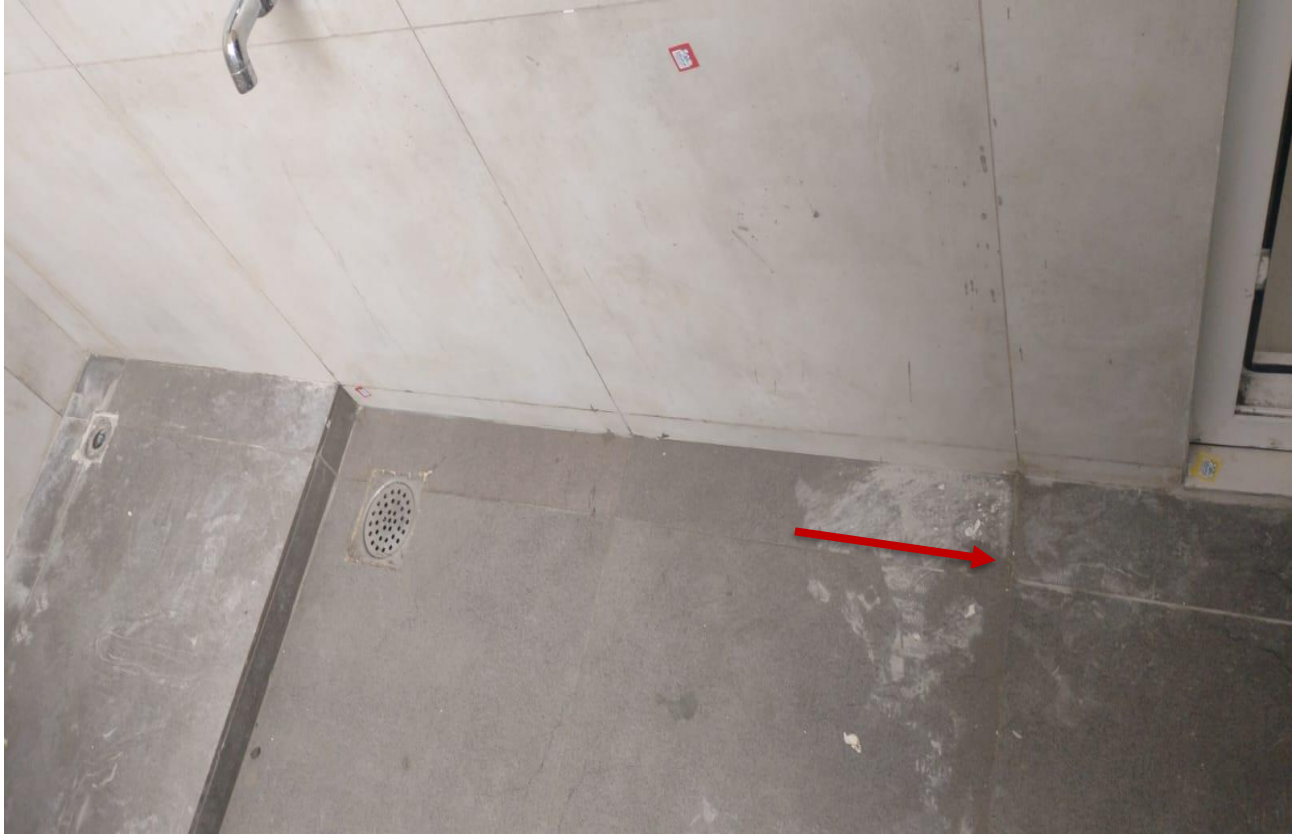
| <b>Observation Description</b> | Incomplete/pending corner tile grouting observed along the floor-to-wall skirtings in the utility area. Moisture meter readings in the adjacent walls indicate elevated moisture levels between 13% and 20%. The unsealed perimeter gaps allow water to penetrate behind the tile substrate, leading to dampness, paint peeling, salt damp/efflorescence, and potential water seepage into adjoining internal rooms over time. |

| <b>Recommendation</b> | <p><b>Step 1</b></p> <p><b>Surface Raking &amp; Cleaning:</b> Rake out all loose dirt, construction debris, and temporary filler material along the entire utility wall-to-floor corner joints using a grooving tool or brush.</p> <p><b>Step 2</b></p> <p><b>Drying the Area:</b> Allow the wall base and floor joints to dry out naturally or use forced air/heat drying until moisture levels in the adjacent walls stabilize to safe limits.</p> <p><b>Step 3</b></p> <p><b>Joint Preparation:</b> Ensure the corner gaps are completely dry, dust-free, and clean to guarantee proper adhesion of the waterproofing sealant.</p> <p><b>Step 4</b></p> <p><b>Grouting &amp; Sealing Application:</b> Fill all perimeter corner joints thoroughly using a high-performance, water-resistant epoxy grout or flexible polyurethane sealant.</p> <p><b>Step 5</b></p> <p><b>Finishing &amp; Inspection:</b> Smooth and tool the grout lines neatly along the skirting junction. Re-check moisture levels in the adjacent walls after a week to confirm effective sealing.</p> |

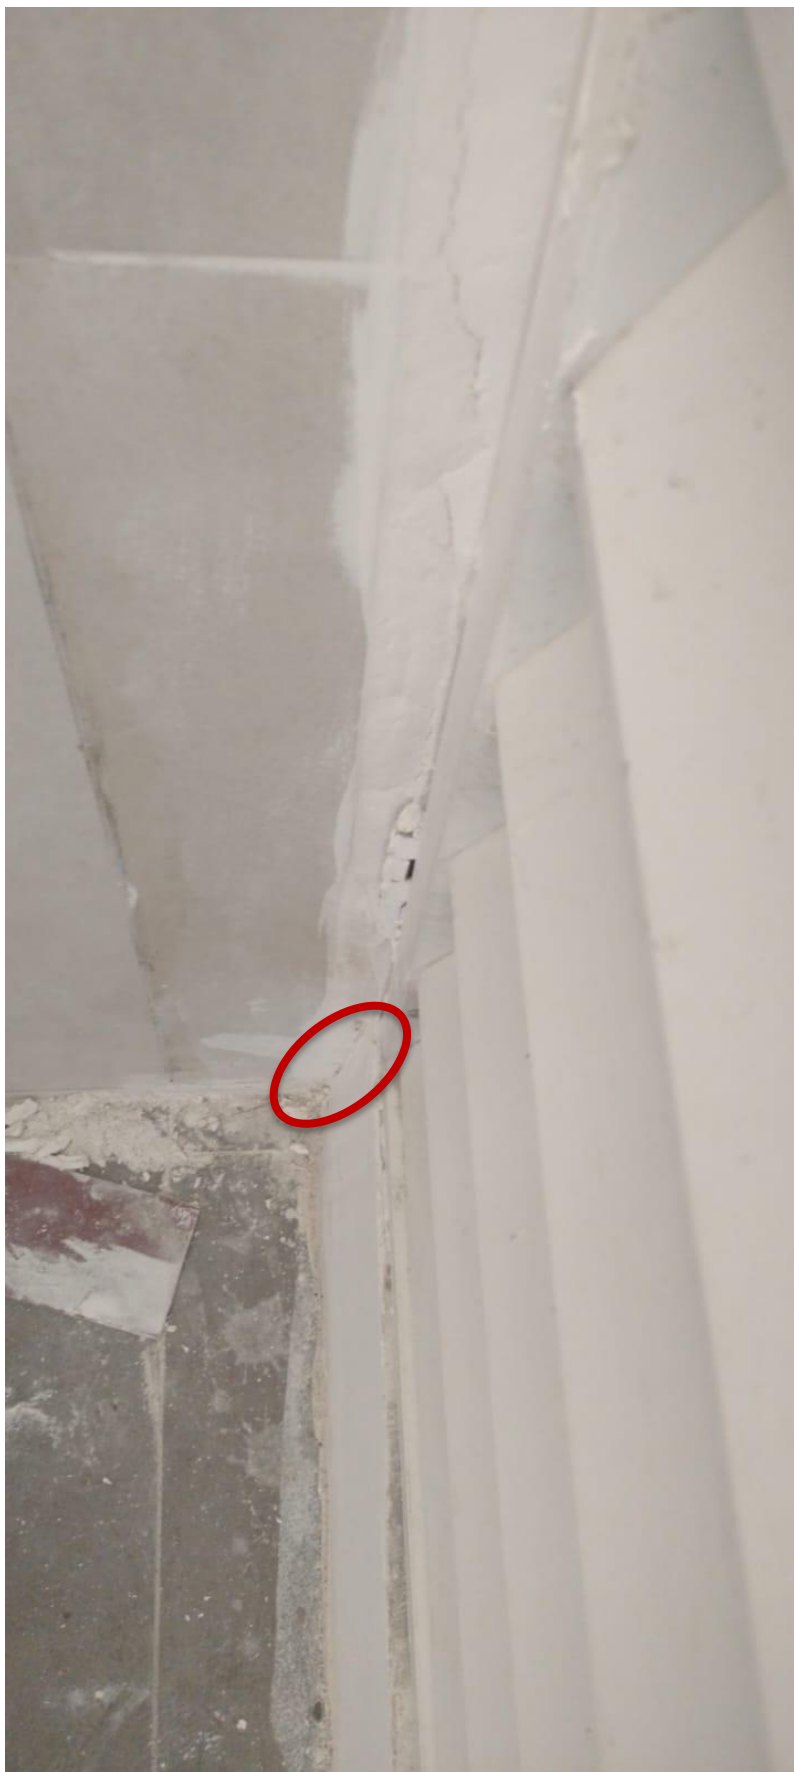
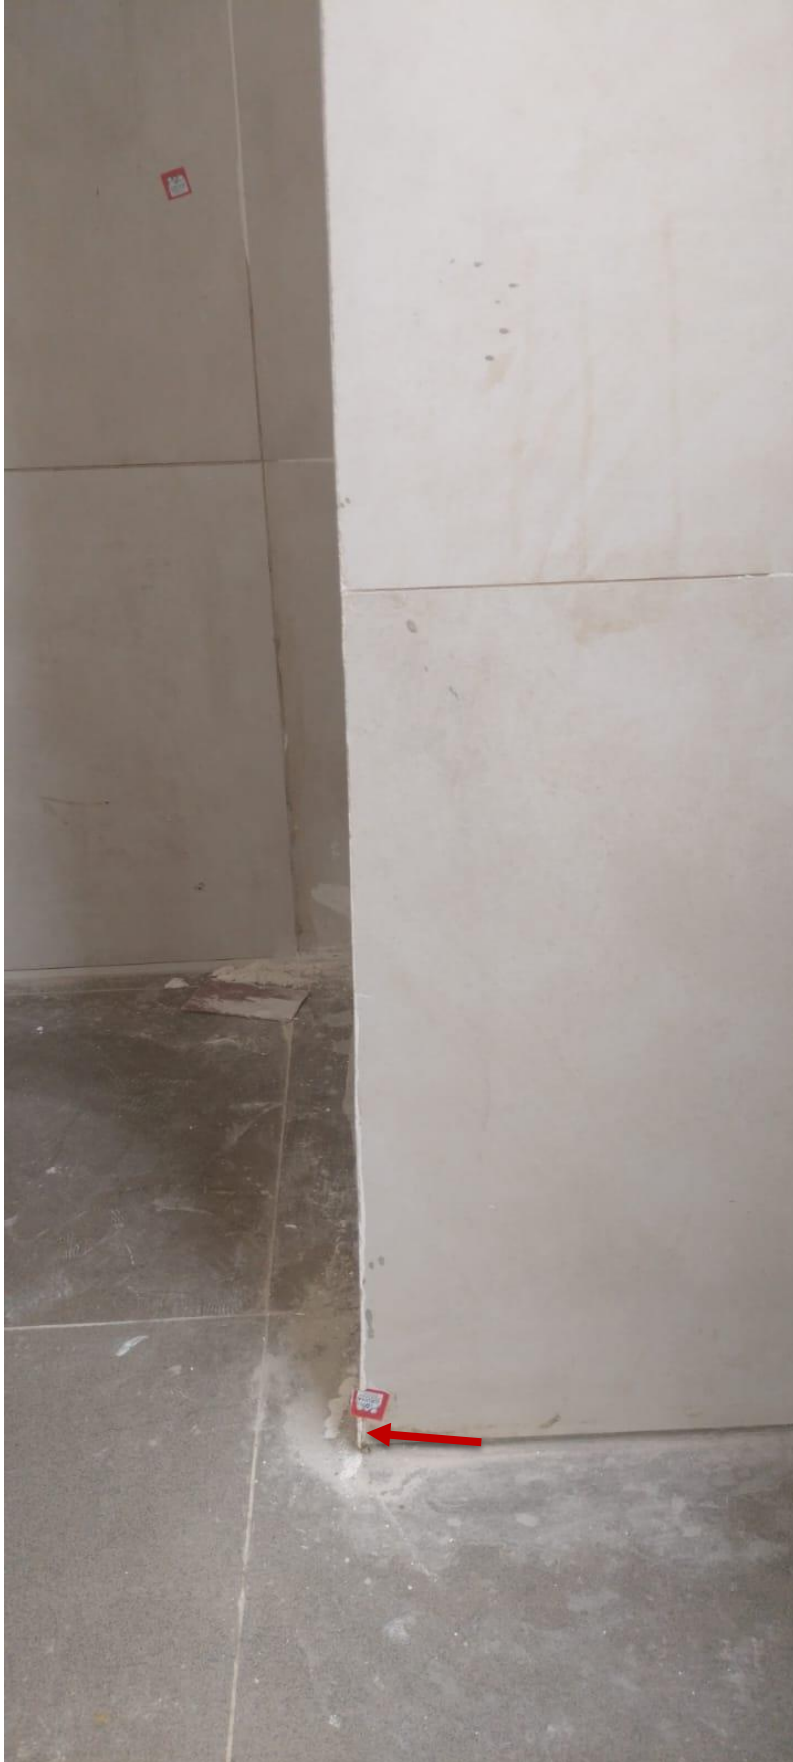
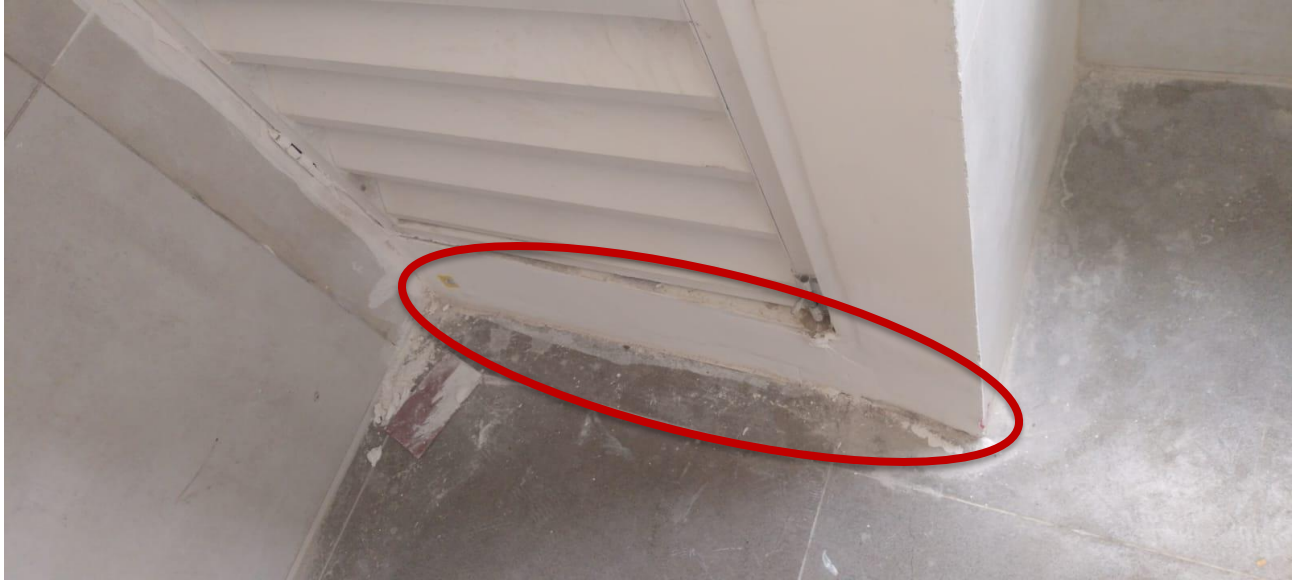
| <b>Observation Description</b> | The utility plumbing shaft sill wall is out of vertical and horizontal alignment. Additionally, wall dado/skirting tiles have not been installed around the sill base and frame area; instead, it is finished with gypsum plaster. Gypsum absorbs moisture easily and is strictly non-recommended for semi-wet utility areas. |

| <b>Recommendation</b> | <p><b>Step 1</b></p> <p><b>Gypsum Removal:</b> Chisel and scrape off all gypsum plaster coating completely from the shaft sill wall base, frame borders, and surrounding wet zones down to the bare masonry surface.</p> <p><b>Step 2</b></p> <p><b>Surface &amp; Alignment Correction:</b> Re-plaster the sill wall using a waterproof cement-sand mortar mixed with water-resistant additives, correcting both vertical plumb and horizontal level alignment.</p> <p><b>Step 3</b></p> <p><b>Waterproofing Coat:</b> Apply two coats of elastomeric waterproofing slurry over the newly plastered sill wall and joint junctions to create a watertight barrier.</p> <p><b>Step 4</b></p> <p><b>Dado / Skirting Tile Installation:</b> Fix full-height or matching dado/skirting ceramic tiles over the sill wall surface using high-bond tile adhesive, ensuring complete bed coverage.</p> <p><b>Step 5</b></p> <p><b>Joint Grouting &amp; Sealing:</b> Grout all tile joints and seal the frame-to-tile perimeter junctions using waterproof epoxy grout to protect against future moisture exposure.</p> |

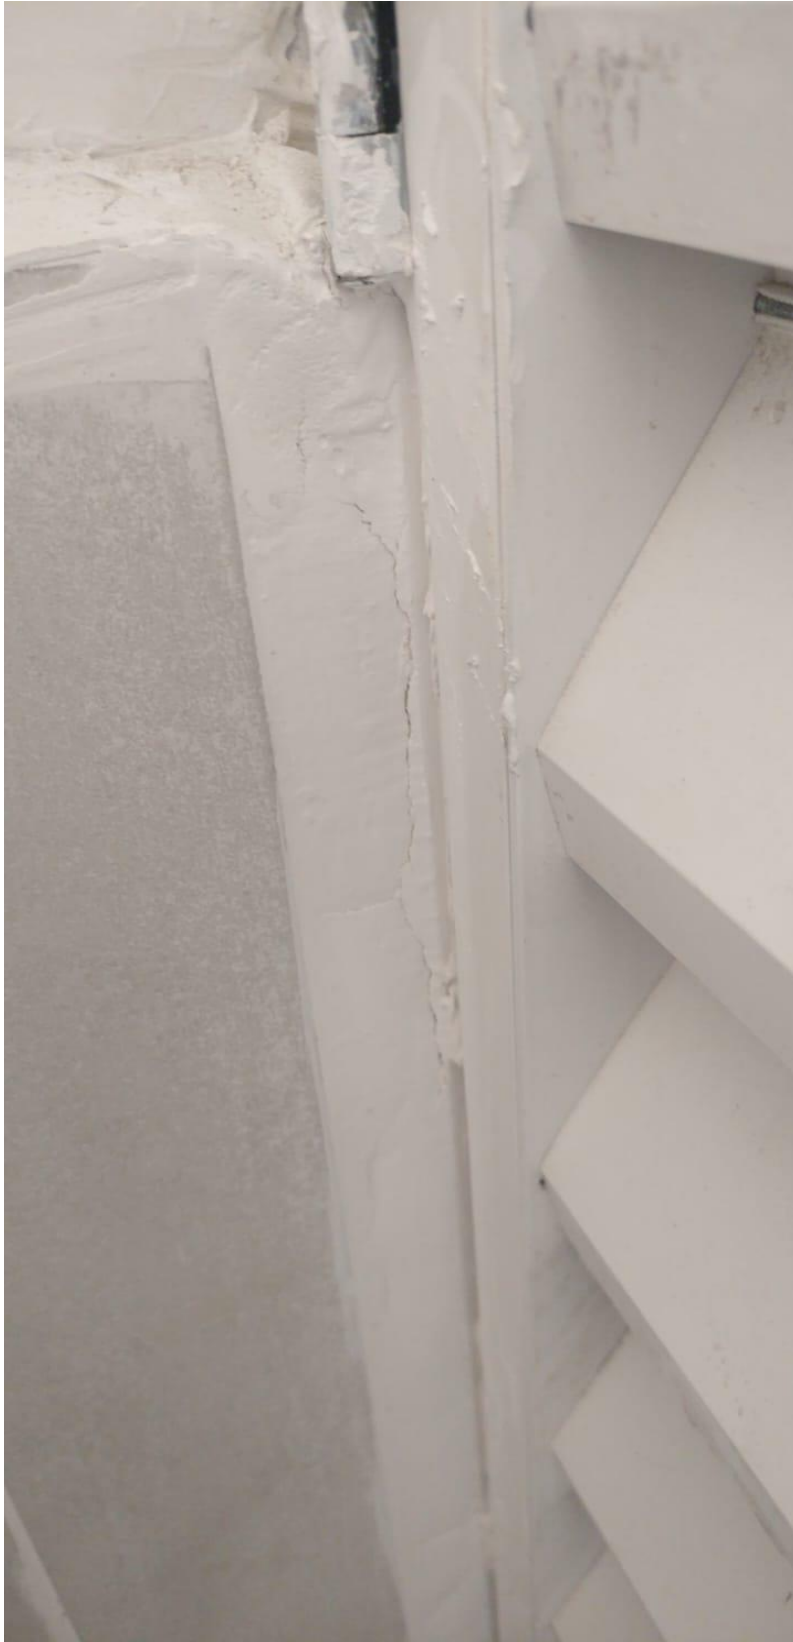
| <b>Observation Description</b> | <p>The gap between the utility plumbing shaft frame and the adjacent dado wall tile has been filled with gypsum plaster instead of extending the tile work. Visible cracking has already developed along this gypsum fill line. Gypsum plaster is highly moisture-sensitive and prone to shrinkage cracking; using it in utility areas leaves the substrate vulnerable to moisture ingress, deterioration, and paint failure.</p> |

| <b>Recommendation</b> | <p><b>Step 1</b></p> <p><b>Gypsum Chipping &amp; Removal:</b> Carefully scrape and chisel out all applied gypsum plaster filling from the corner gap along the frame junction down to the solid masonry/substrate surface.</p> <p><b>Step 2</b></p> <p><b>Substrate Cleaning:</b> Clean the revealed gap thoroughly, removing all dust, loose debris, and plaster residue to prepare for tiling.</p> <p><b>Step 3</b></p> <p><b>Tile Installation:</b> Fix the cut tiles firmly using a high-bond tile adhesive, ensuring complete adhesive bed coverage behind each tile piece.</p> <p><b>Step 4</b></p> <p><b>Grouting &amp; Perimeter Sealing:</b> Allow the adhesive to set, then seal all tile joints and the perimeter interface with the louver frame using water-resistant epoxy grout or flexible sealant.</p> |

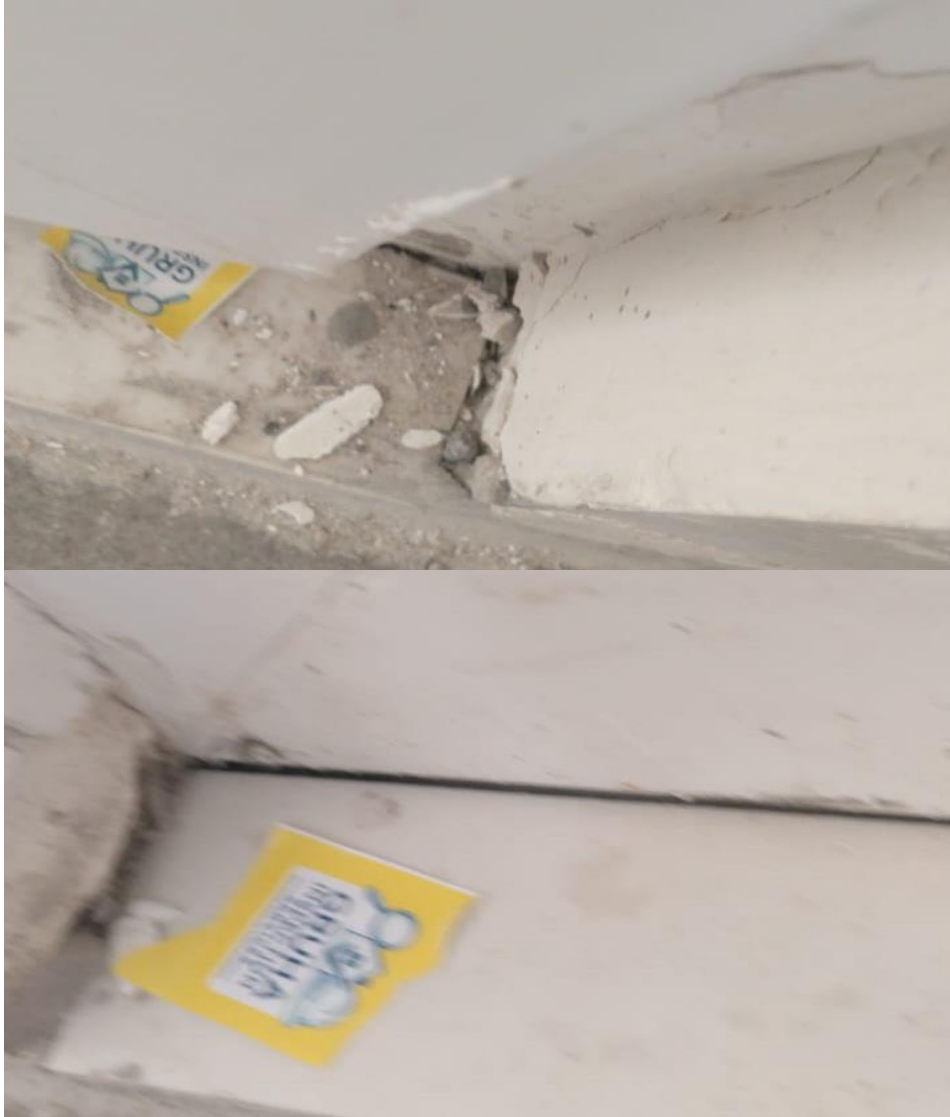
| <b>Observation Description</b> | Open gaps and unsealed voids observed along the utility door frame jambs and bottom threshold level. Unsealed gaps around frame perimeters in utility areas allow washing water or splash moisture to seep underneath the frame, leading to sub-floor dampness, frame damage, and potential paint peeling or water migration into internal floor areas. |

| <b>Recommendation</b> | <p><b>Step 1</b></p> <p><b>Gap Cleaning:</b> Rake out all loose plaster, debris, and dust accumulation from the gaps between the frame jambs, tile threshold, and wall corners using a scraper or wire brush.</p> <p><b>Step 2</b></p> <p><b>Substrate Drying &amp; Preparation:</b> Ensure the entire threshold and frame perimeter gap is completely dry and clean before applying any sealant.</p> <p><b>Step 3</b></p> <p><b>Non-Shrink Mortar Packing (if deep):</b> Pack deep gaps or voids underneath the jamb base with non-shrink polymer mortar to create a solid, stable base.</p> <p><b>Step 4</b></p> <p><b>Waterproof Grouting &amp; Sealing:</b> Fill and seal the perimeter joints neatly using a high-performance waterproof epoxy grout or flexible, moisture-resistant polyurethane sealant.</p> |

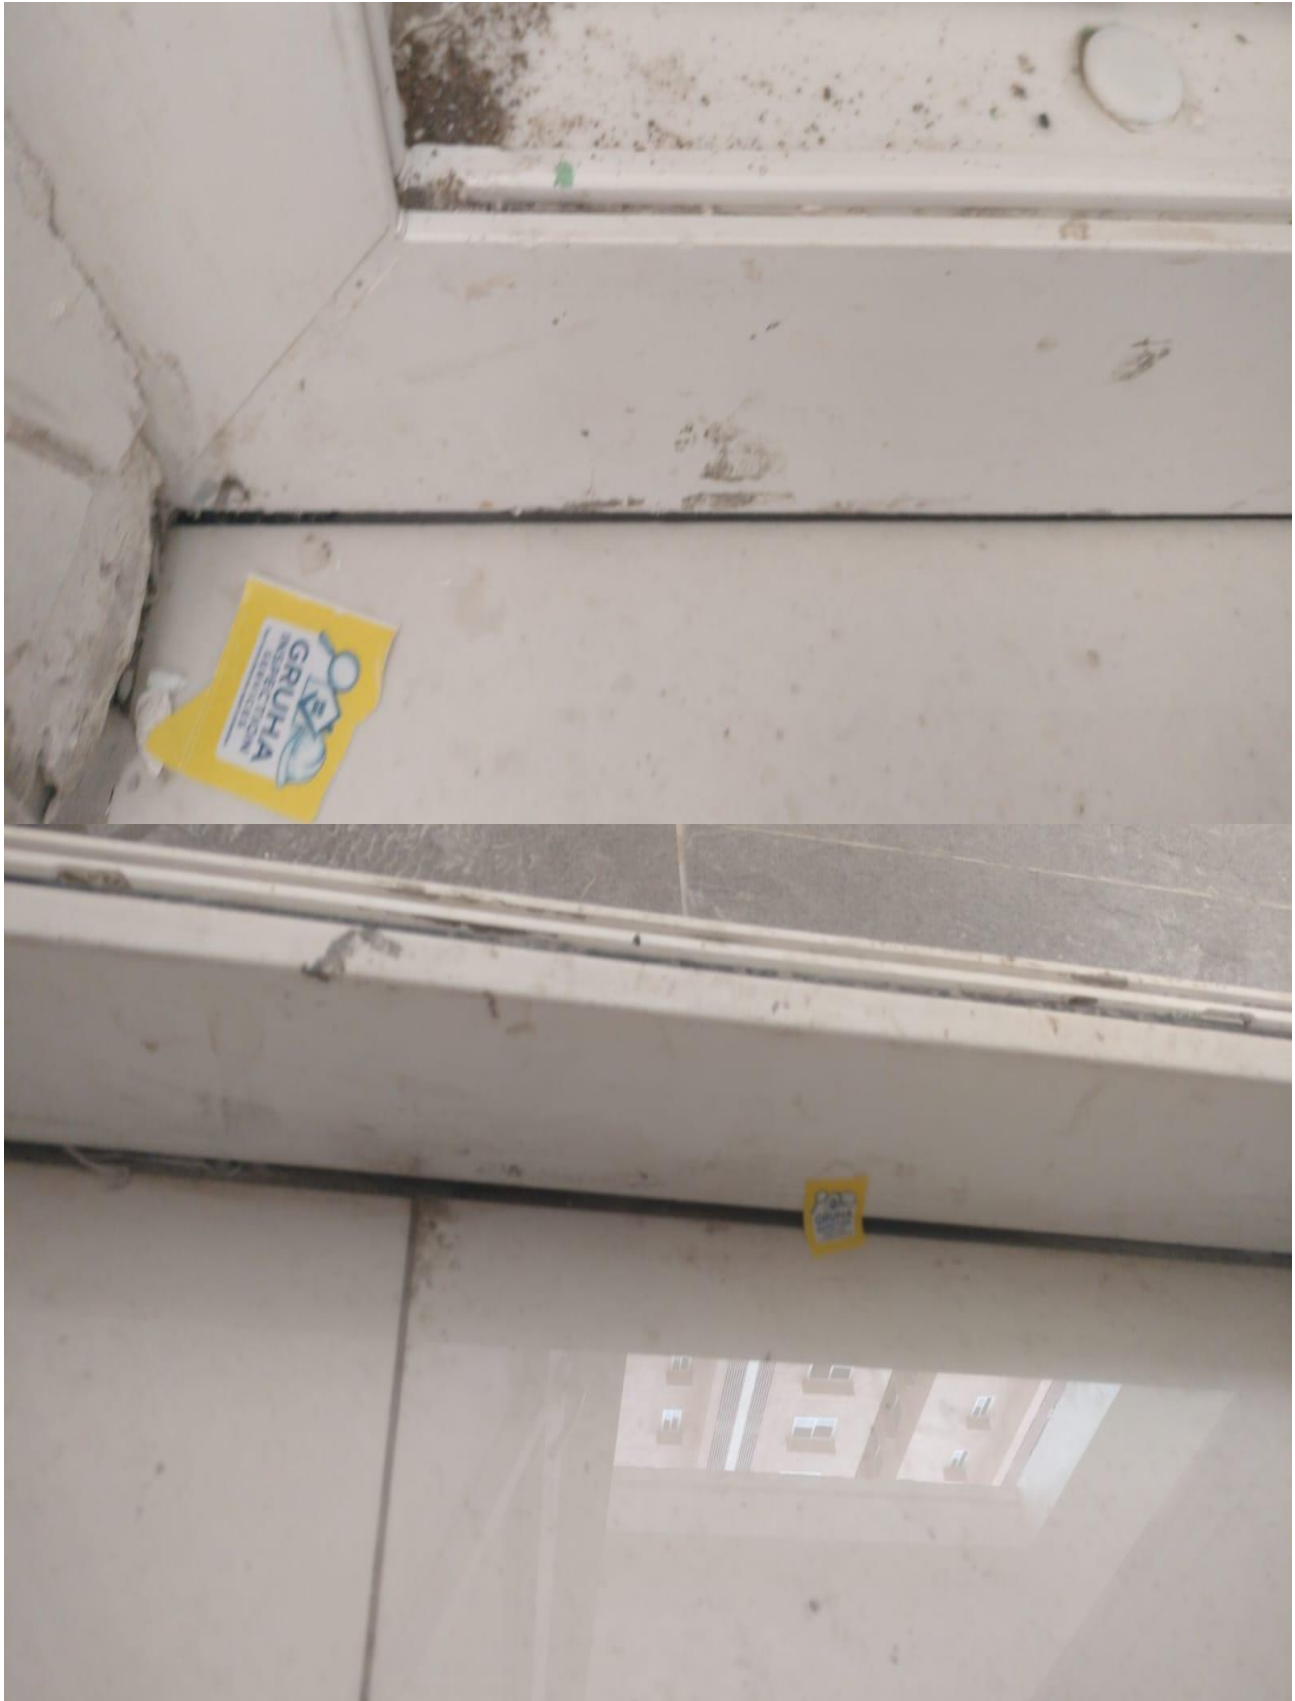
| <b>Observation Description</b> | The bottom track/frame junction gaps of the utility door and the balcony sliding (SLD) door track have not been filled with silicone/polyurethane sealant. |

| <b>Recommendation</b> | <p><b>Step 1</b></p> <p><b>Gap Raking &amp; Cleaning:</b> Rake out dirt, dust, mortar residue, and loose particles completely from the continuous gap along the bottom of the utility door and balcony sliding door frames.</p> <p><b>Step 2</b></p> <p><b>Degreasing &amp; Drying:</b> Wipe the underside of the door tracks and threshold tile surfaces clean with a dry cloth to ensure proper sealant bonding.</p> <p><b>Step 3</b></p> <p><b>Masking Tape Application:</b> Apply masking tape neatly along both edges of the frame joint to achieve a clean, professional finish.</p> <p><b>Step 4</b></p> <p><b>Sealant Application:</b> Apply a continuous bead of high-performance weather-resistant silicone or polyurethane (PU) sealant completely filling the bottom perimeter gap.</p> <p><b>Step 5</b></p> <p><b>Tooling &amp; Curing:</b> Tool and smooth the sealant bead immediately to ensure a complete watertight bond, then carefully remove the masking tape and allow it to cure fully.</p> |
