# ULTRA PREMIUM HOME INSPECTION REPORT

**GRUHA  
INSPECTION  
SERVICES**

| Project / Apartment | Rajapushpa Imperia |
| Location | Tellapur |

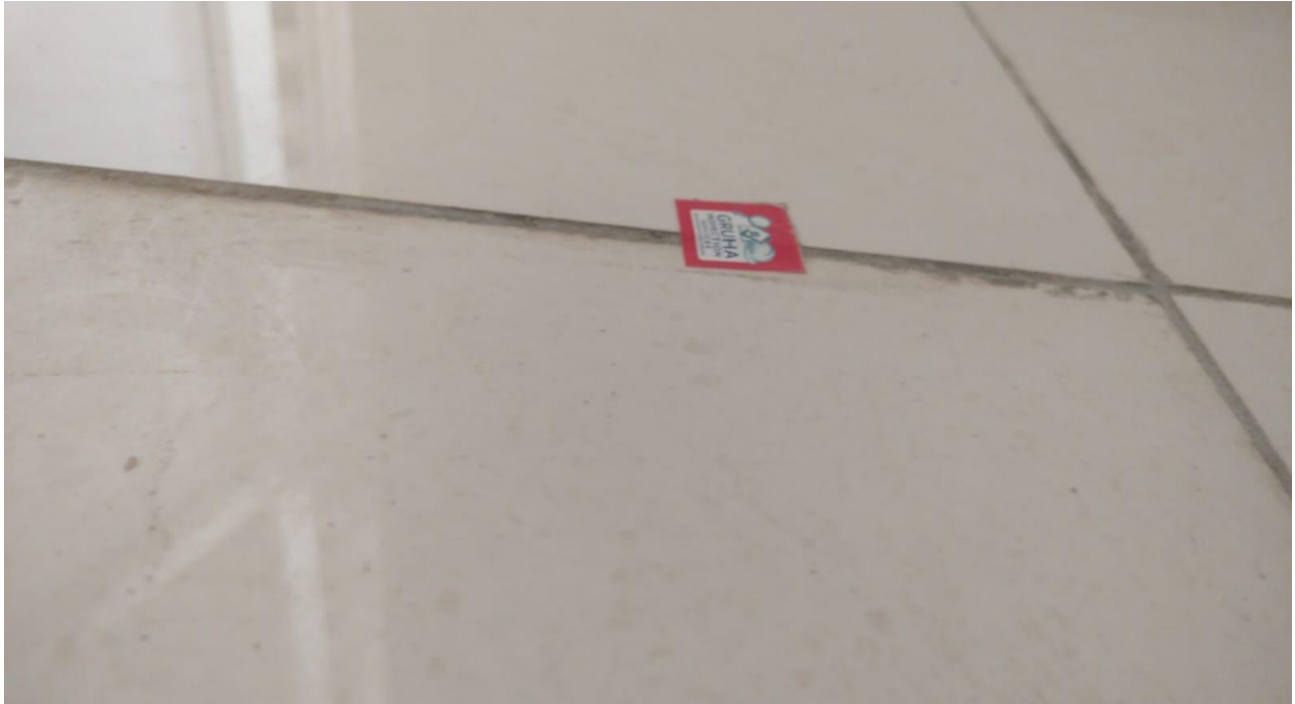
| <b>Observation Description</b> | <p>Tile lipping (uneven elevation between the edges of adjacent floor tiles) was observed across multiple areas, including the kitchen, dining room, and Master Bedroom (MBR). Lipping is caused by improper levelling during installation, uneven bed mortar, or failure to use tile levelling clips. Beyond creating an uneven surface, lipping poses a tripping hazard, makes maintenance difficult, and leaves tile edges vulnerable to chipping or cracking under foot traffic.</p> |

| <b>Recommendation</b> | <p><b>Step 1</b></p> <p><b>Removal of Affected Tiles:</b> Carefully rake out the grout around the identified lipped tiles and gently remove them without damaging surrounding undamaged tiles.</p> <p><b>Step 2</b></p> <p><b>Bed Preparation:</b> Chisel down the underlying bed mortar/adhesive layer to ensure a level base substrate.</p> <p><b>Step 3</b></p> <p><b>Re-installation with Levelling Systems:</b> Re-lay fresh tiles using proper adhesive and tile levelling clips/spacers to guarantee a perfectly flush surface across all adjacent tile edges.</p> <p><b>Step 4</b></p> <p><b>Grouting:</b> Allow the adhesive to cure, remove levelling clips, and neatly fill all joints with matching waterproof tile grout.</p> |

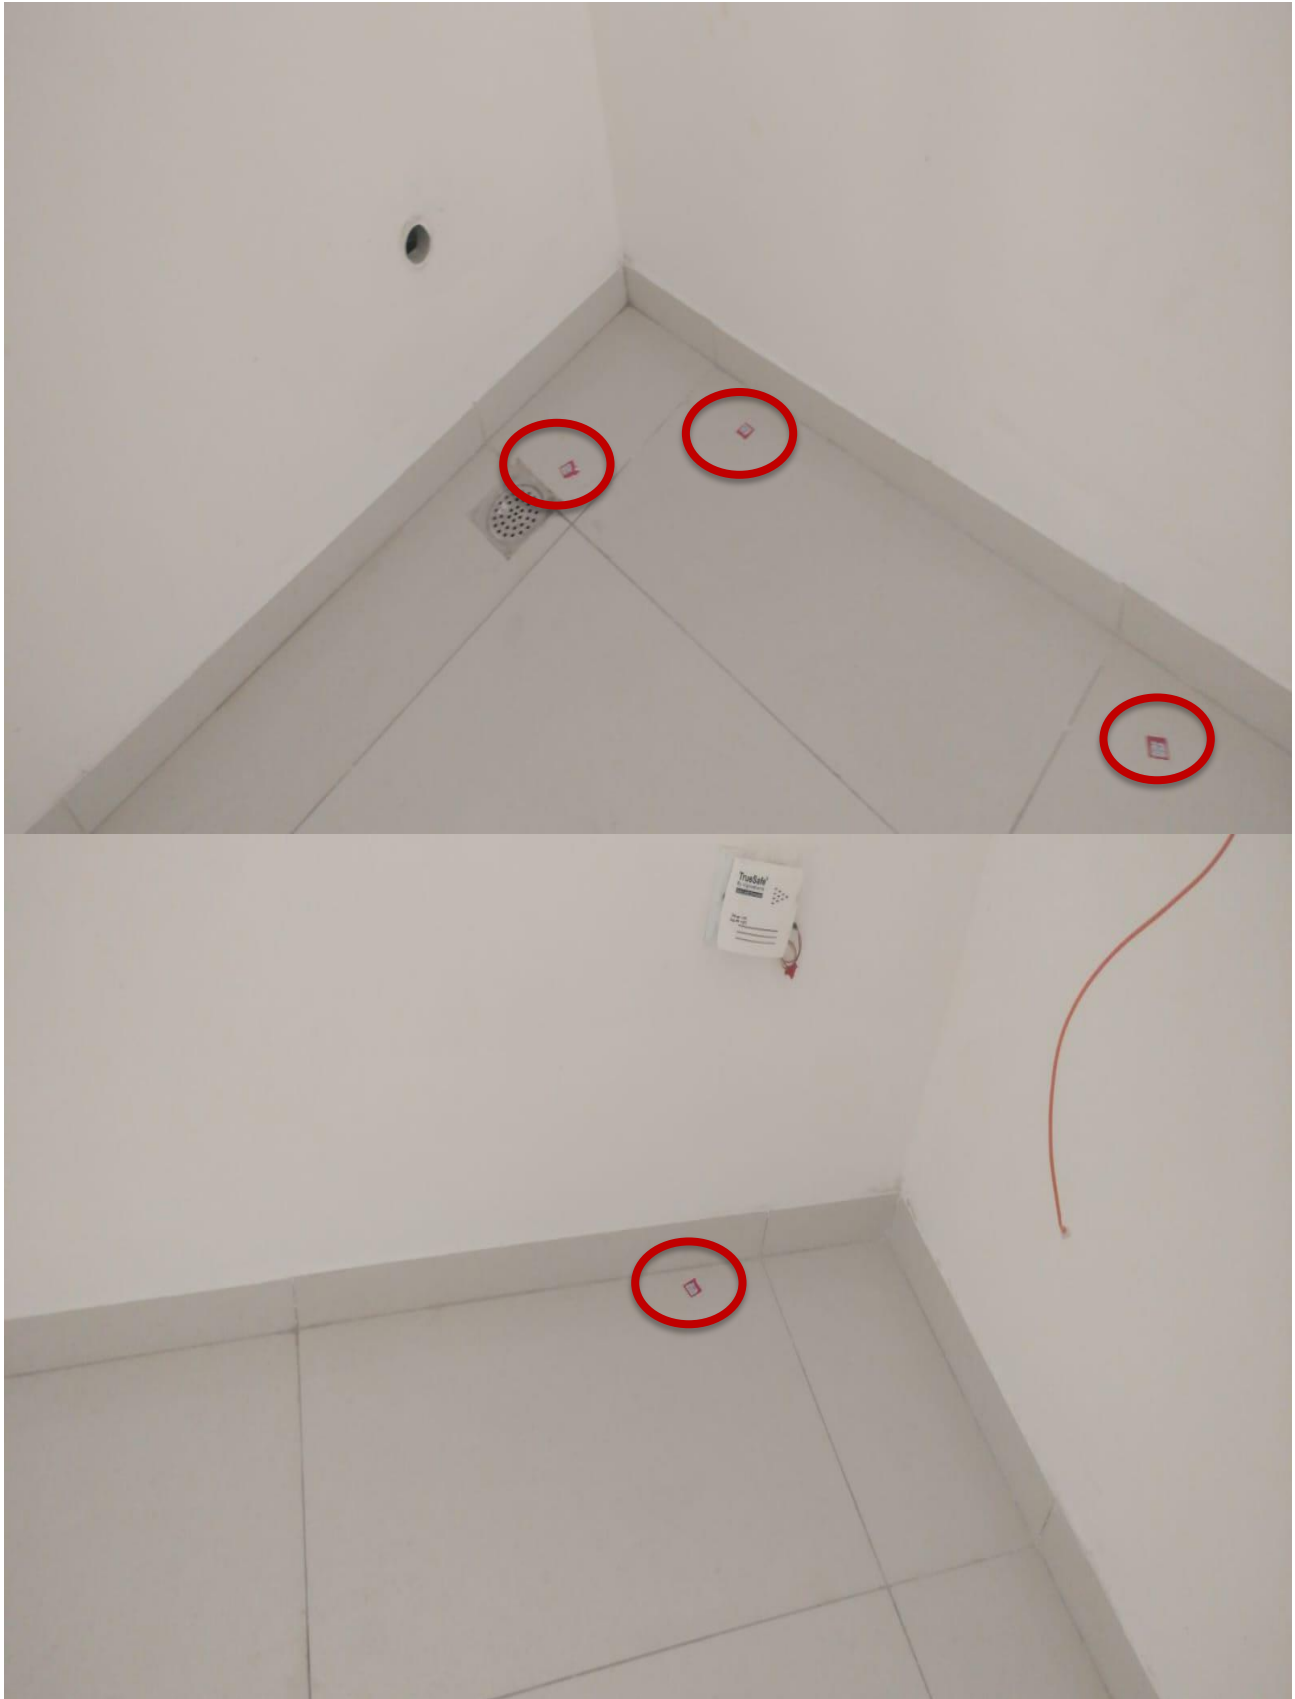
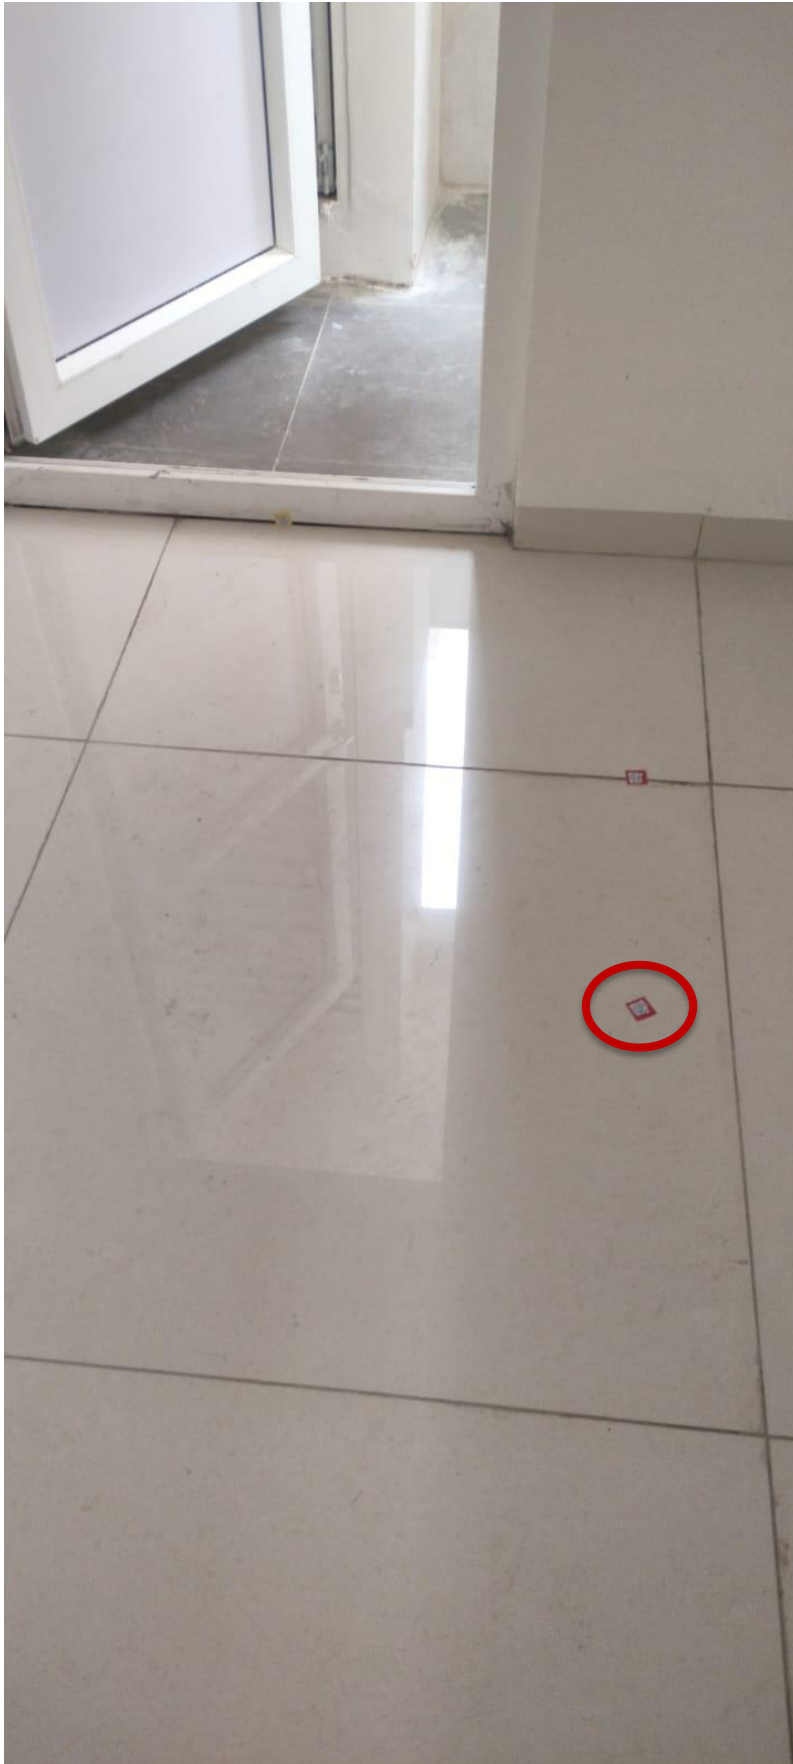
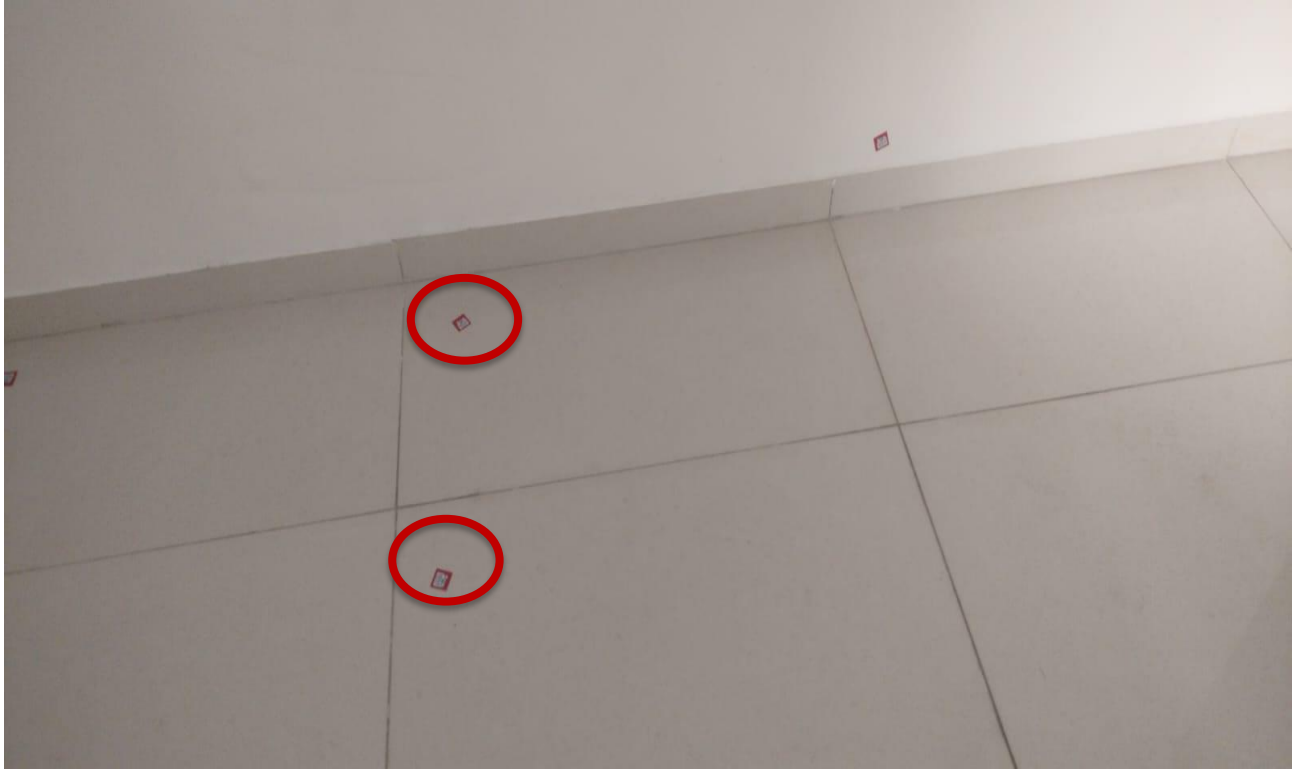
| <b>Observation Description</b> | Hollow sounding area observed under kitchen floor tiles (6/20 tiles identified with hollow response during tapping test). Hollow sounds indicate air pockets, insufficient adhesive/bed mortar coverage, or poor bonding between the tile and the floor slab beneath. |

| <b>Recommendation</b> | <p><b>Step 1</b></p> <p><b>Mapping &amp; Grout Removal:</b> Mark the perimeter of all 6 hollow tiles clearly. Carefully rake out and clear the tile grout around these tiles to isolate them and prevent damage to surrounding intact tiles.</p> <p><b>Step 2</b></p> <p><b>Non-Destructive Epoxy Injection (For Partial Voids):</b> Drill small pilot holes along the tile grout lines at the hollow zones and pressure-inject high-flow, low-viscosity epoxy grouting resin until all voids beneath are completely filled.</p> <p><b>Step 3</b></p> <p><b>Tile Removal &amp; Re-laying (For Extensively Hollow Tiles):</b> If de-bonding is extensive, carefully lift the affected tiles, remove the loose bed mortar down to the solid base slab, apply a fresh uniform bed of high-polymer tile adhesive, and re-lay the tiles level with adjacent flooring.</p> <p><b>Step 4</b></p> <p><b>Curing &amp; Re-Grouting:</b> Allow the injected resin or tile adhesive to cure for 24 hours, then re-grout all surrounding tile joints using waterproof tile grout.</p> |

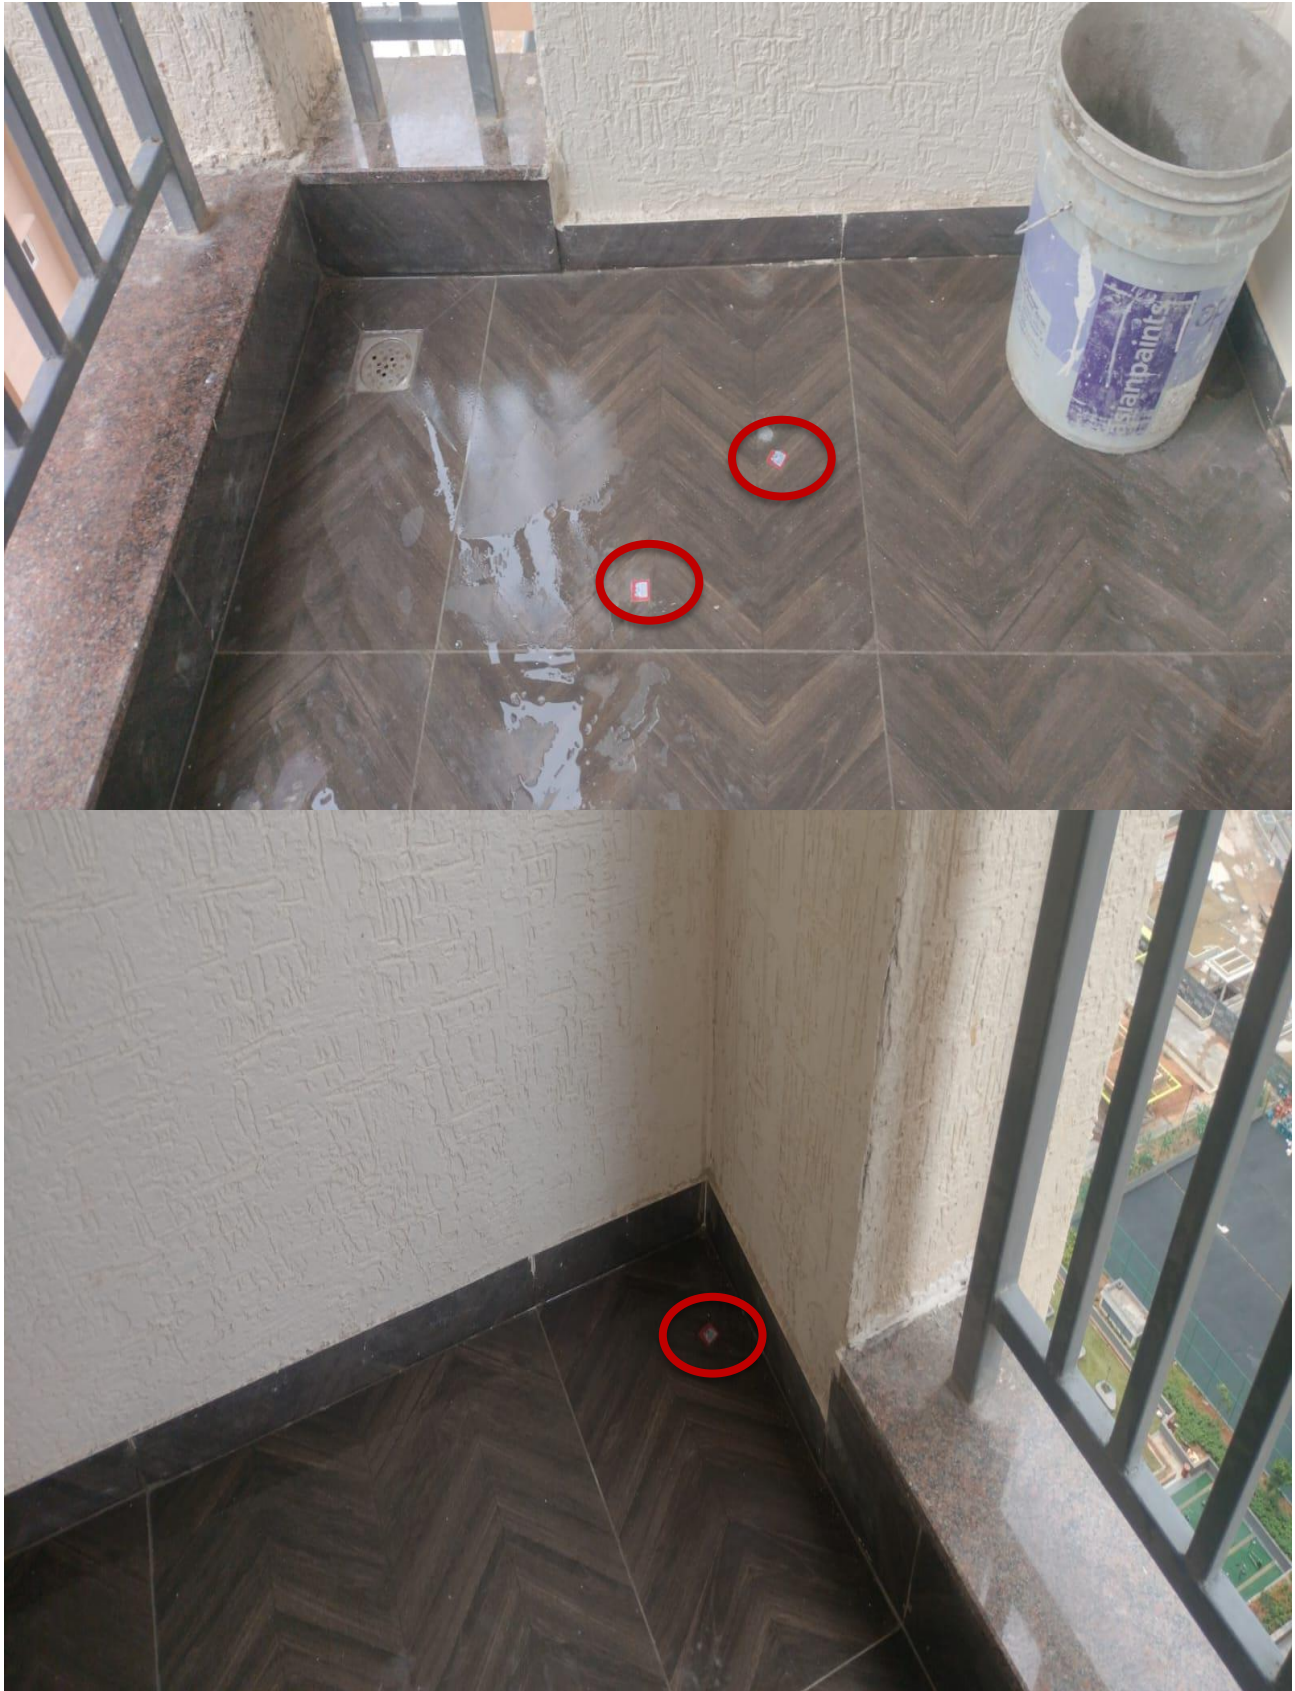
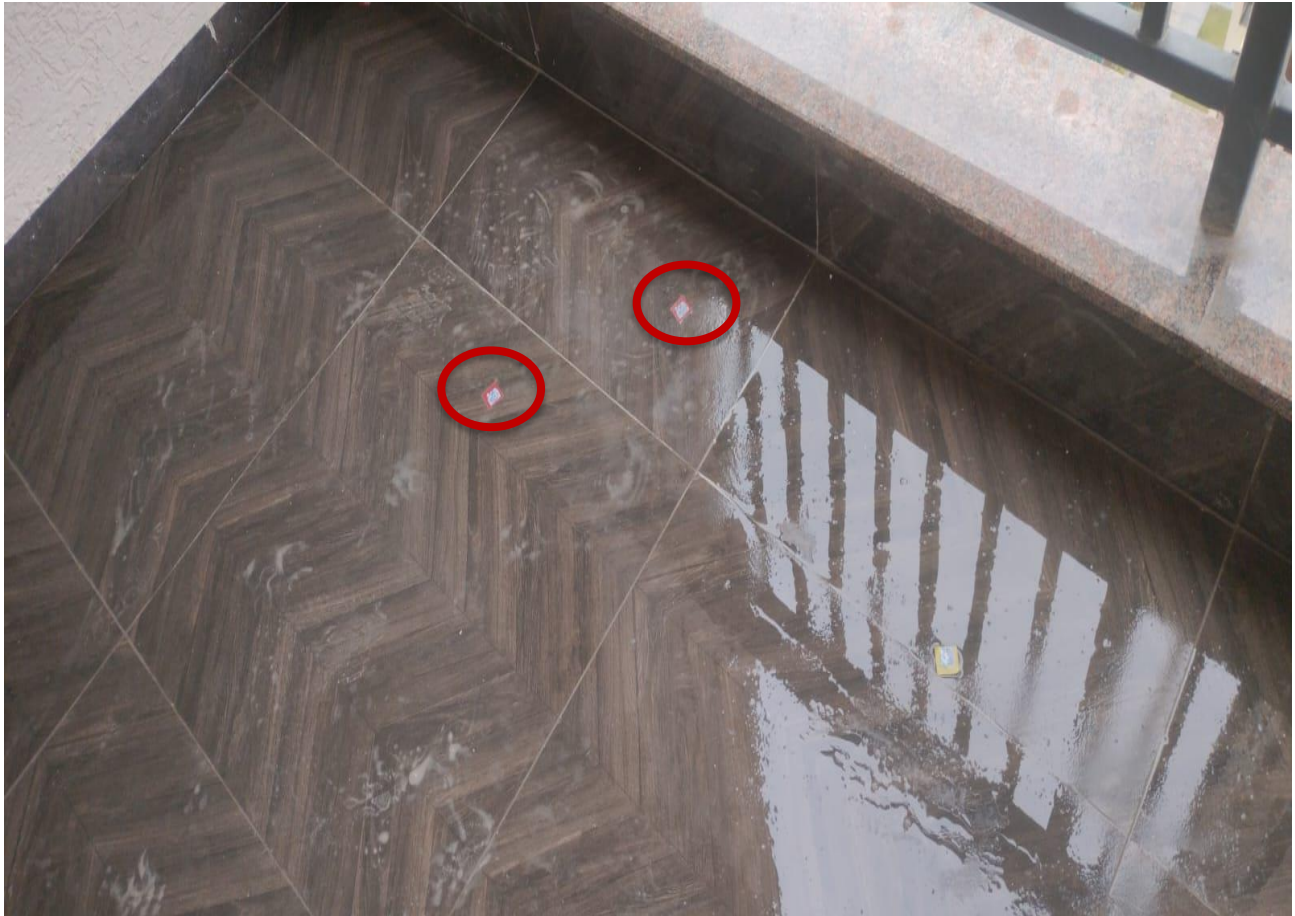
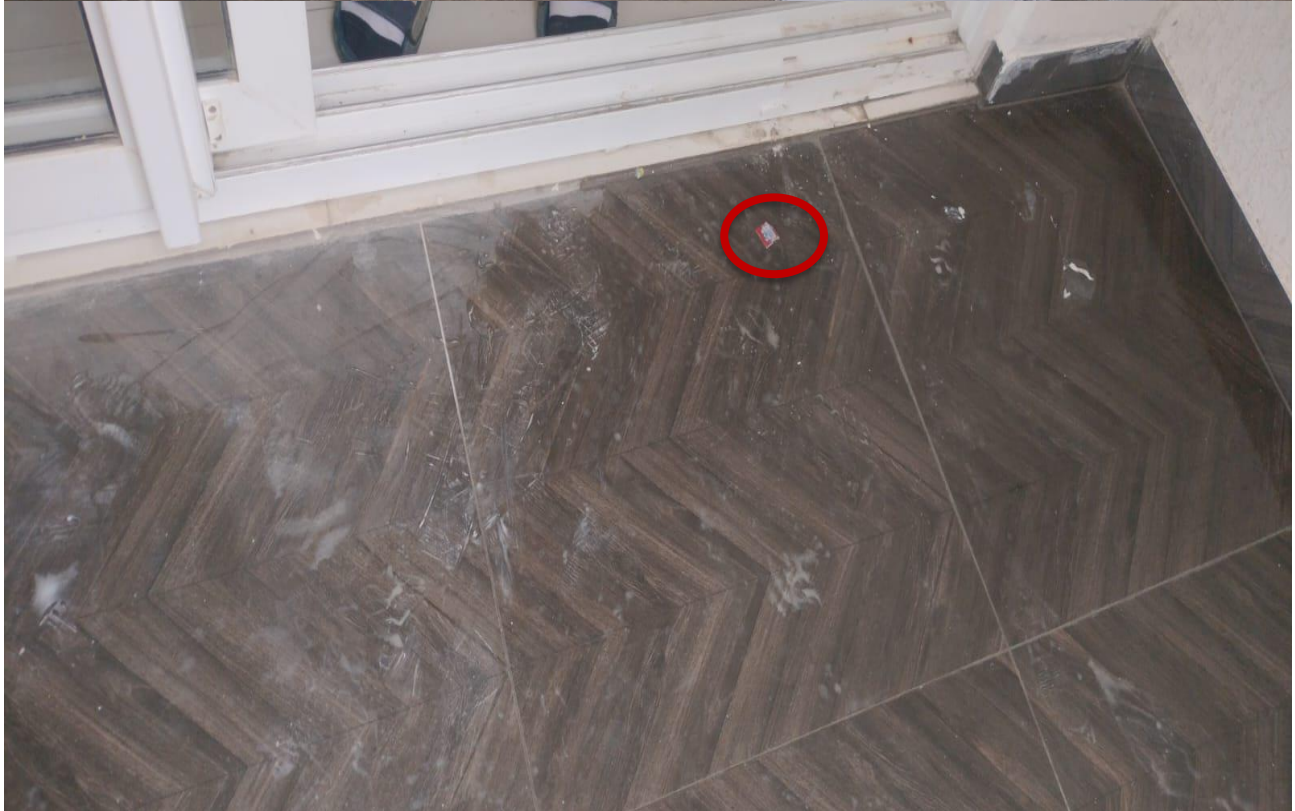
| <b>Observation Description</b> | Hollow sounding area detected across 5 out of 18 floor tiles in the main balcony during tapping tests. |

| <b>Recommendation</b> | <p><b>Step 1</b></p> <p><b>Mapping &amp; Grout Removal:</b> Mark the perimeter of all 5 hollow tiles clearly. Carefully rake out and clear the tile grout around these tiles to isolate them and prevent damage to surrounding intact tiles.</p> <p><b>Step 2</b></p> <p><b>Non-Destructive Epoxy Injection (For Partial Voids):</b> Drill small pilot holes along the tile grout lines at the hollow zones and pressure-inject high-flow, low-viscosity epoxy grouting resin until all voids beneath are completely filled.</p> <p><b>Step 3</b></p> <p><b>Tile Removal &amp; Re-laying (For Extensively Hollow Tiles):</b> If de-bonding is extensive, carefully lift the affected tiles, remove the loose bed mortar down to the solid base slab, apply a fresh uniform bed of high-polymer tile adhesive, and re-lay the tiles level with adjacent flooring.</p> <p><b>Step 4</b></p> <p><b>Curing &amp; Re-Grouting:</b> Allow the injected resin or tile adhesive to cure for 24 hours, then re-grout all surrounding tile joints using waterproof tile grout.</p> |

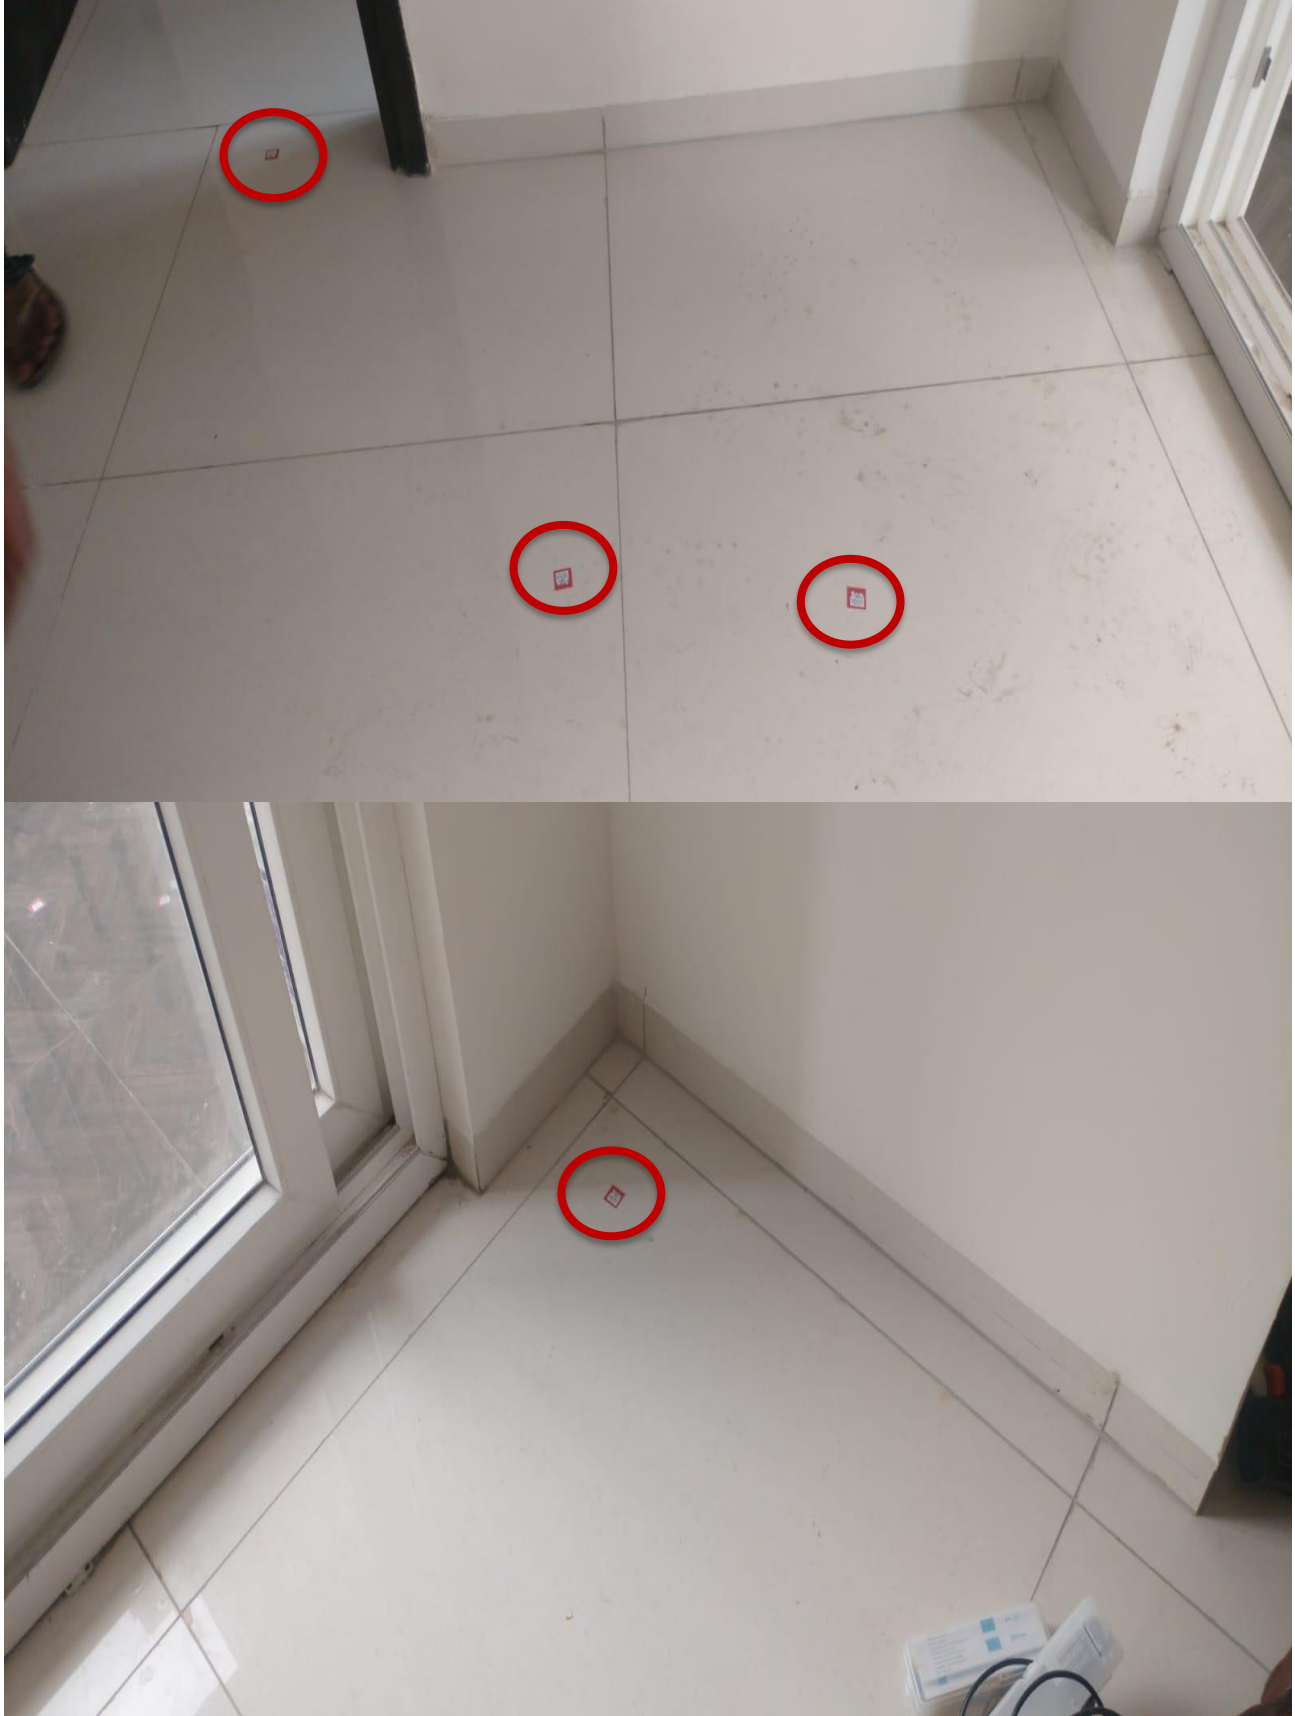
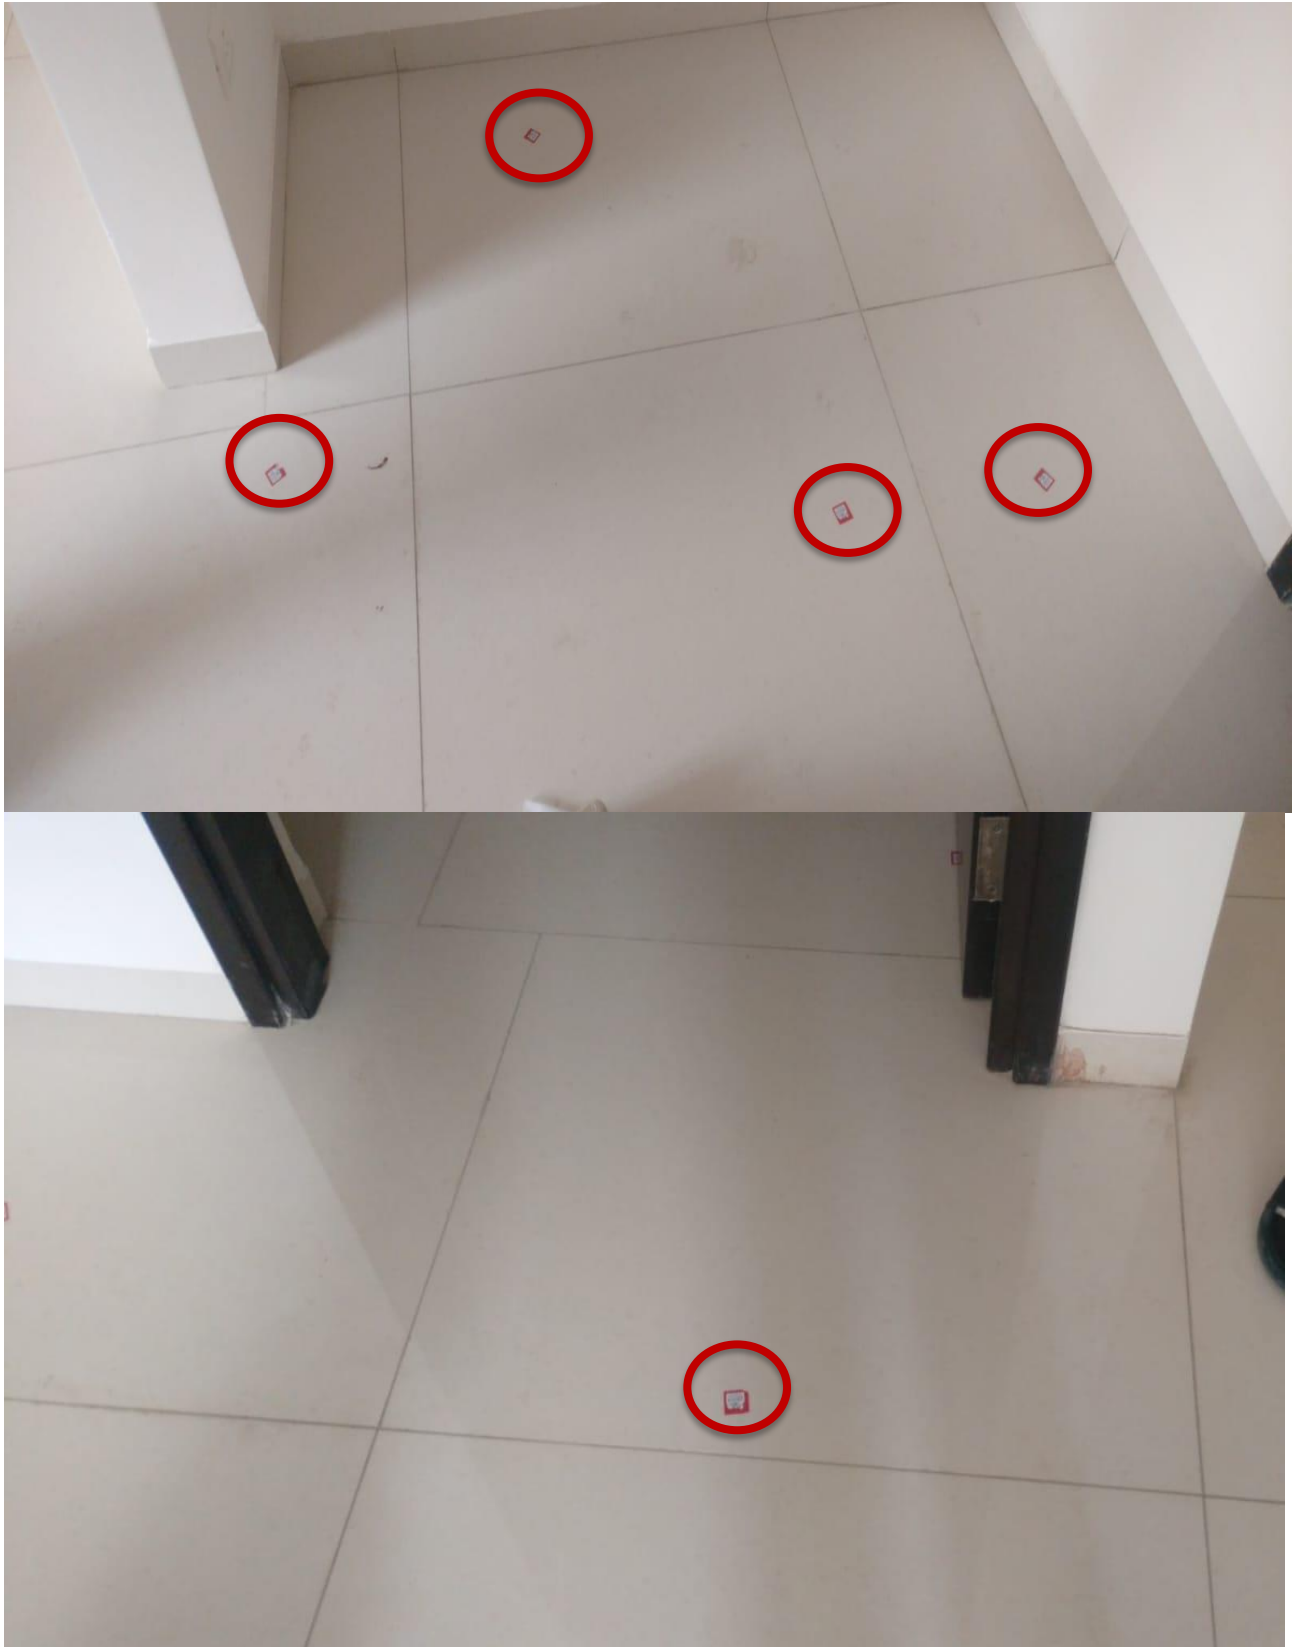
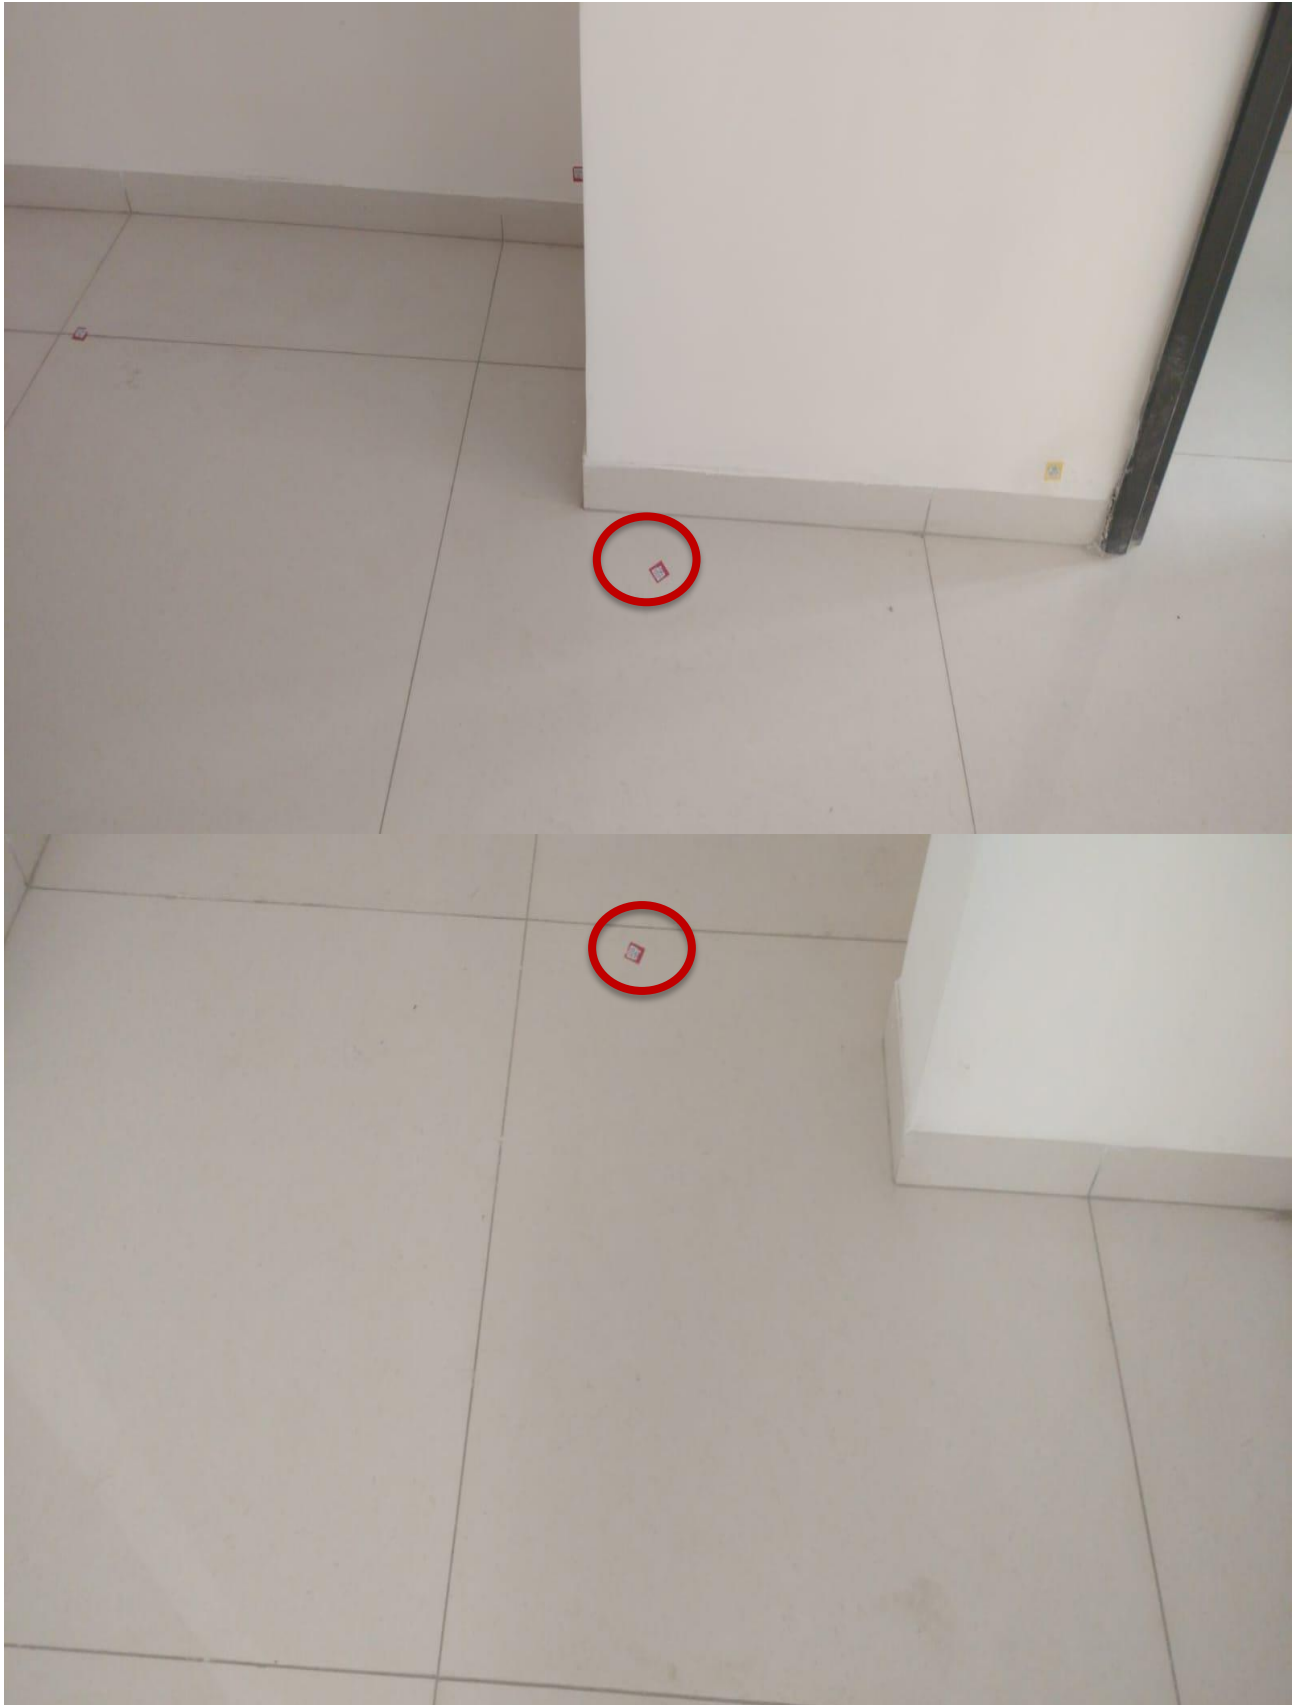
| <b>Observation Description</b> | Hollow sounding area identified across 13 out of 33 floor tiles in the Dining area during acoustic tapping tests. A high concentration of hollow tiles (over 35% of the total area) indicates significant sub-surface voids, poor mortar bed adhesion, or improper comb-spreading of tile adhesive. |

| <b>Recommendation</b> | <p><b>Step 1</b></p> <p><b>Mapping &amp; Grout Removal:</b> Mark the perimeter of all 13 hollow tiles clearly. Carefully rake out and clear the tile grout around these tiles to isolate them and prevent damage to surrounding intact tiles.</p> <p><b>Step 2</b></p> <p><b>Non-Destructive Epoxy Injection (For Partial Voids):</b> Drill small pilot holes along the tile grout lines at the hollow zones and pressure-inject high-flow, low-viscosity epoxy grouting resin until all voids beneath are completely filled.</p> <p><b>Step 3</b></p> <p><b>Tile Removal &amp; Re-laying (For Extensively Hollow Tiles):</b> If de-bonding is extensive, carefully lift the affected tiles, remove the loose bed mortar down to the solid base slab, apply a fresh uniform bed of high-polymer tile adhesive, and re-lay the tiles level with adjacent flooring.</p> <p><b>Step 4</b></p> <p><b>Curing &amp; Re-Grouting:</b> Allow the injected resin or tile adhesive to cure for 24 hours, then re-grout all surrounding tile joints using waterproof tile grout.</p> |
