# ULTRA PREMIUM HOME INSPECTION REPORT

**GRUHA  
INSPECTION  
SERVICES**

| Project / Apartment | Rajapushpa Imperia |
| Location | Tellapur |

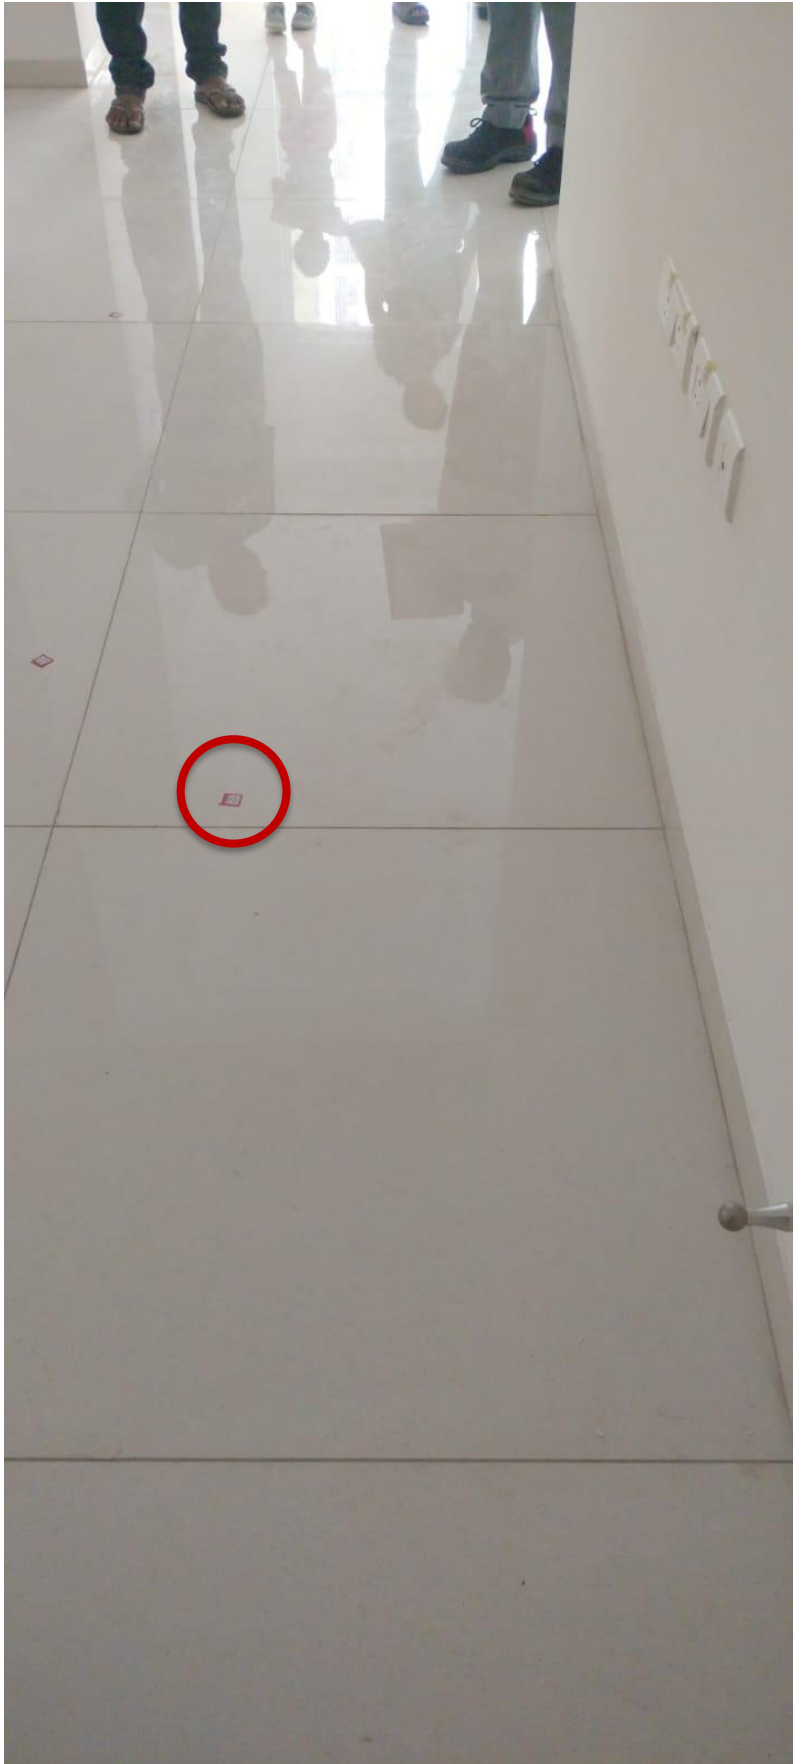
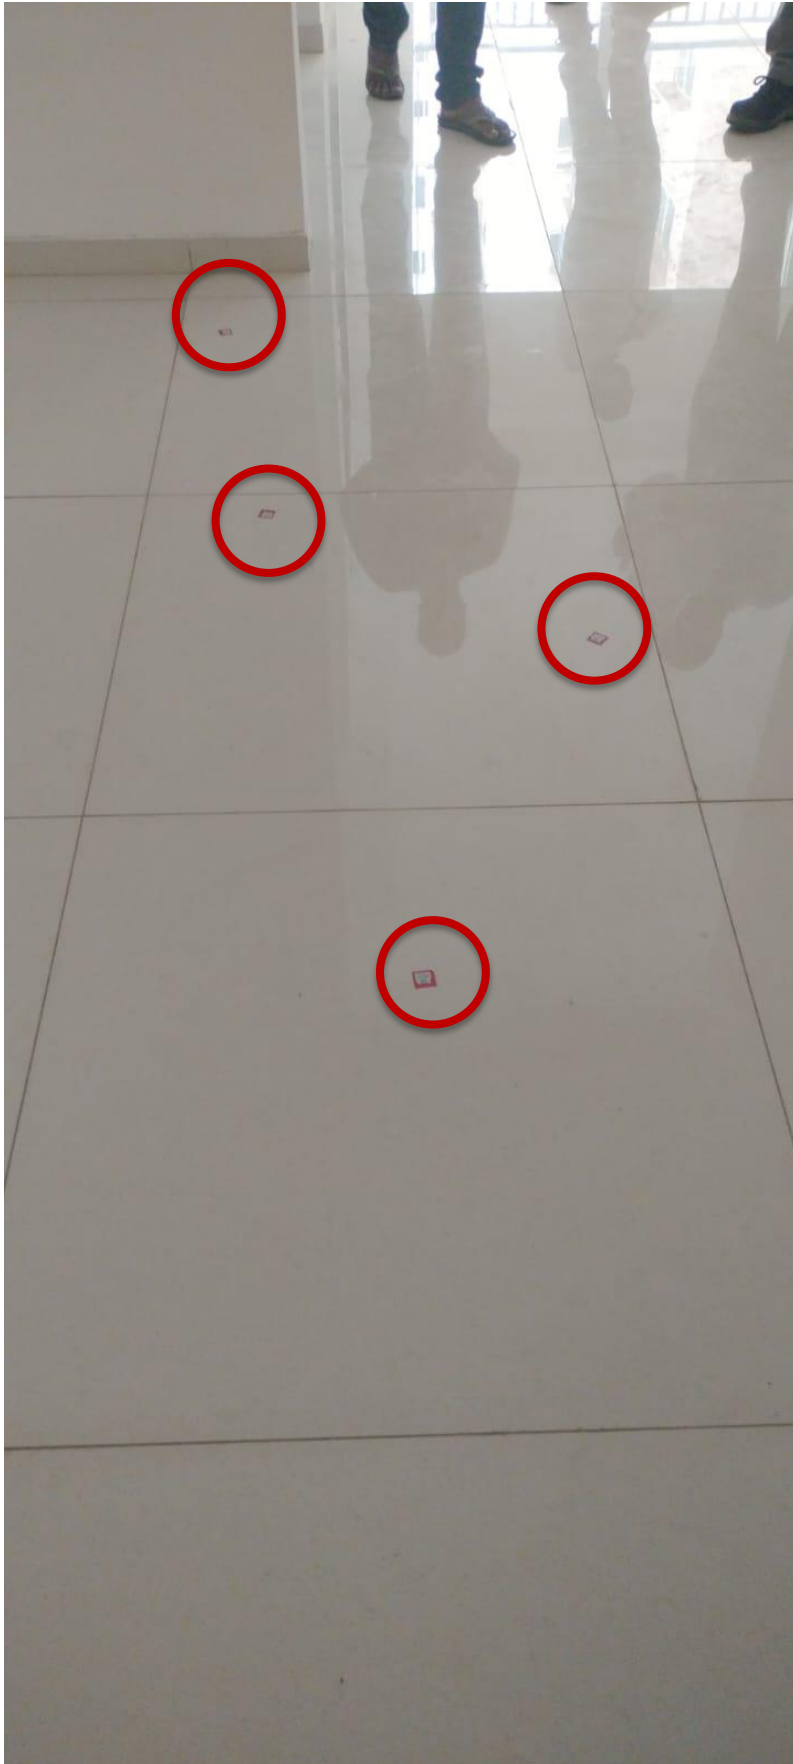
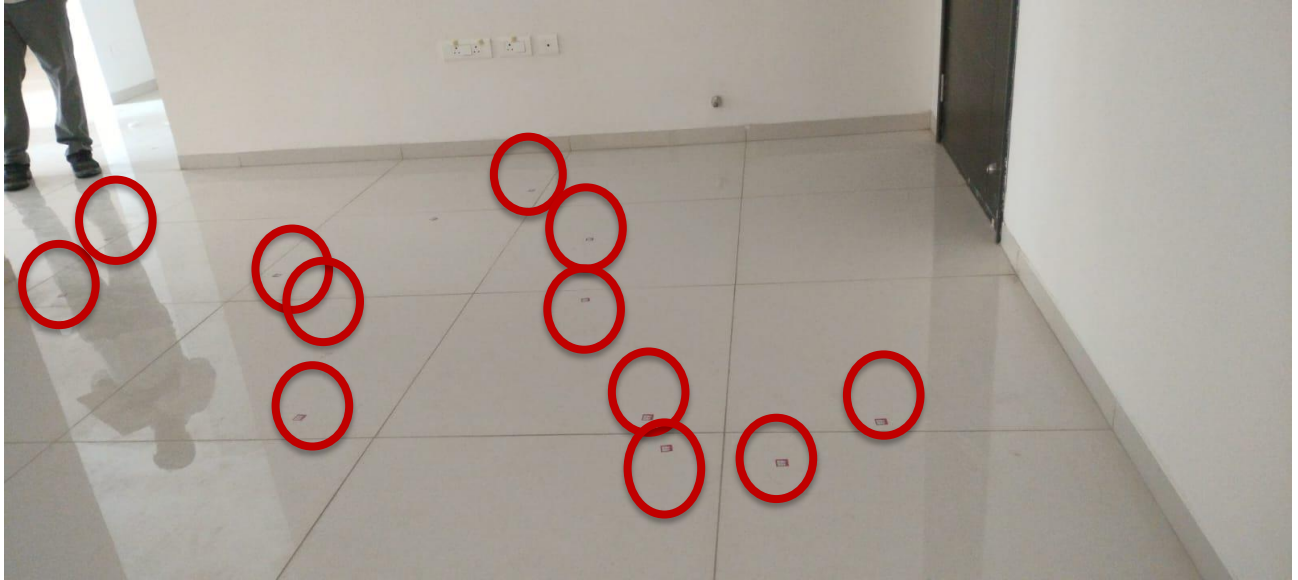
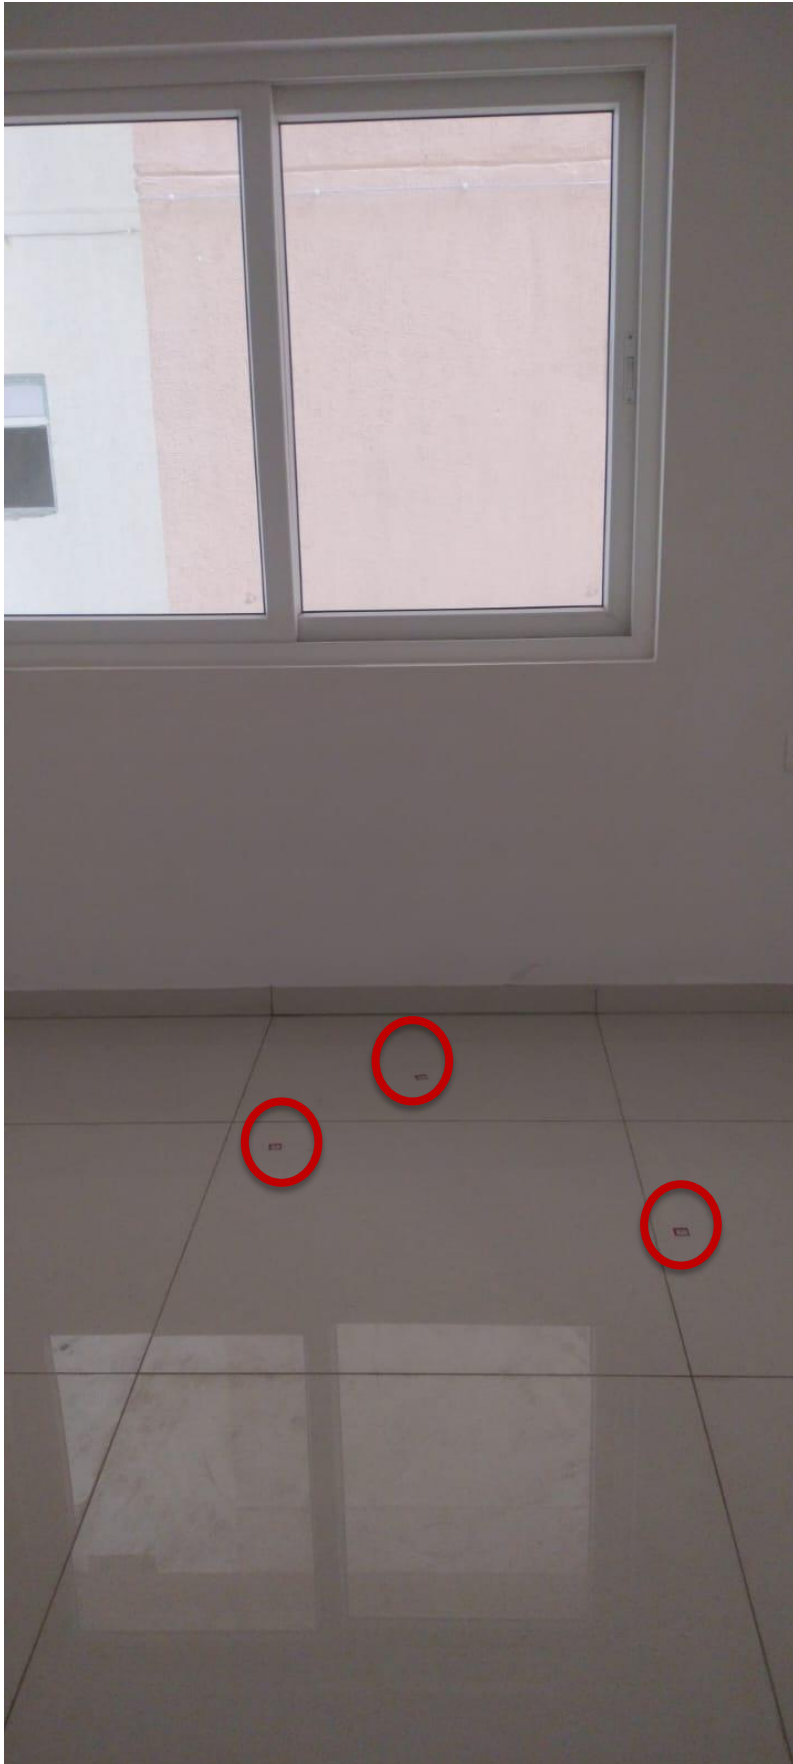
| <b>Observation Description</b> | Hollow sound response detected in 16 out of 28 floor tiles in the Living Room during acoustic tapping tests. Over 50% of the flooring in this area exhibits sub-surface voids caused by poor mortar bedding, lack of adhesive coverage, or improper bonding during installation. |

| <b>Recommendation</b> | <p><b>Step 1</b></p> <p><b>Mapping &amp; Grout Removal:</b> Mark the perimeter of all 16 hollow tiles clearly. Carefully rake out and clear the tile grout around these tiles to isolate them and prevent damage to surrounding intact tiles.</p> <p><b>Step 2</b></p> <p><b>Non-Destructive Epoxy Injection (For Partial Voids):</b> Drill small pilot holes along the tile grout lines at the hollow zones and pressure-inject high-flow, low-viscosity epoxy grouting resin until all voids beneath are completely filled.</p> <p><b>Step 3</b></p> <p><b>Tile Removal &amp; Re-laying (For Extensively Hollow Tiles):</b> If de-bonding is extensive, carefully lift the affected tiles, remove the loose bed mortar down to the solid base slab, apply a fresh uniform bed of high-polymer tile adhesive, and re-lay the tiles level with adjacent flooring.</p> <p><b>Step 4</b></p> <p><b>Curing &amp; Re-Grouting:</b> Allow the injected resin or tile adhesive to cure for 24 hours, then re-grout all surrounding tile joints using waterproof tile grout.</p> |

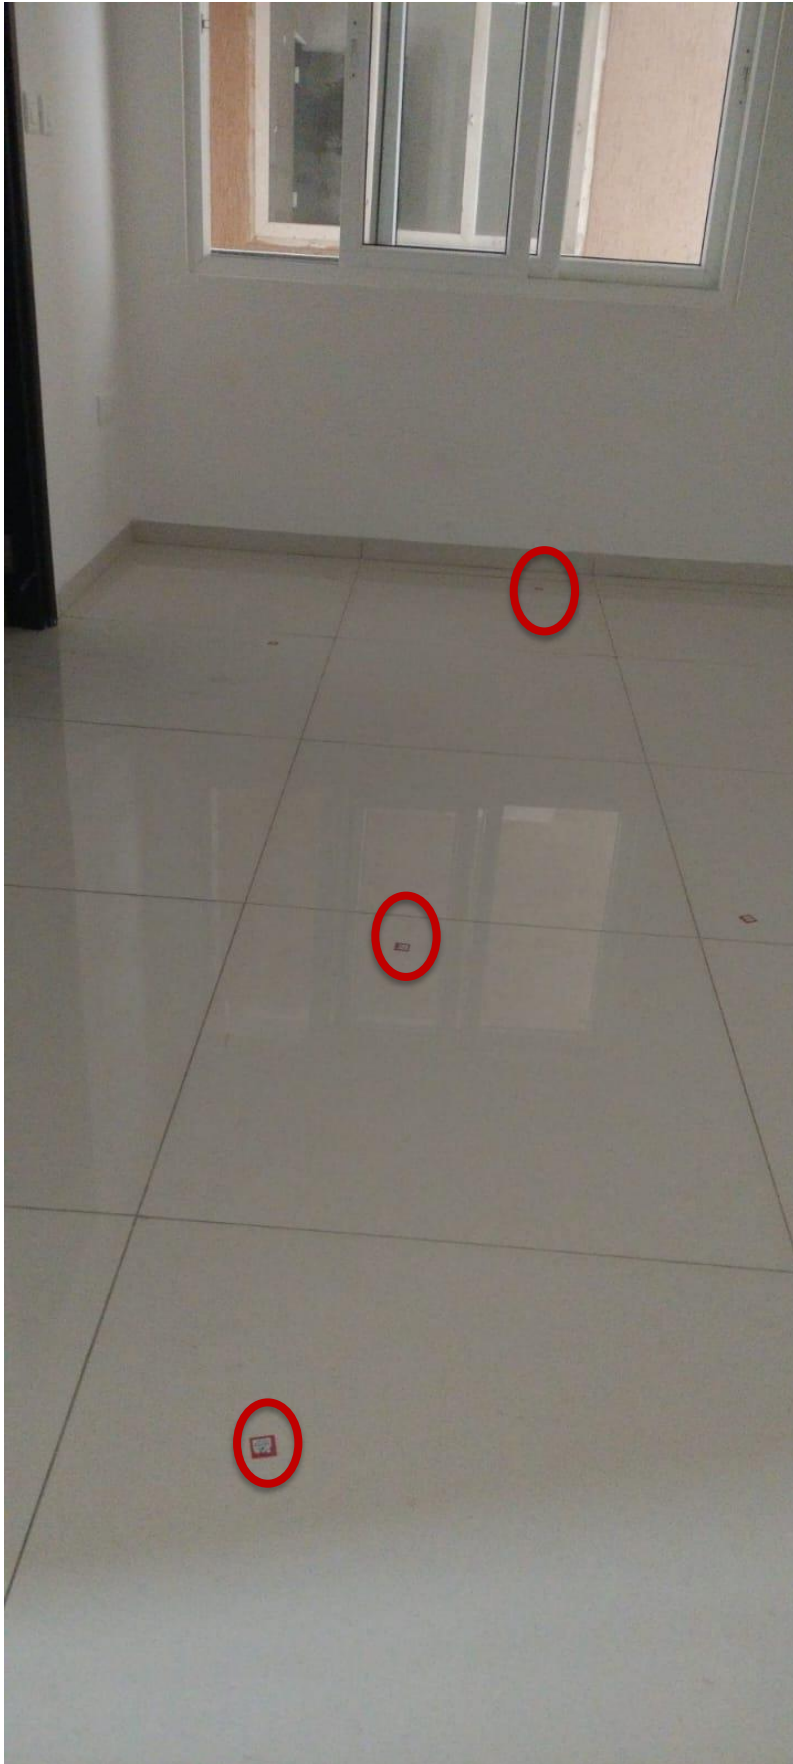
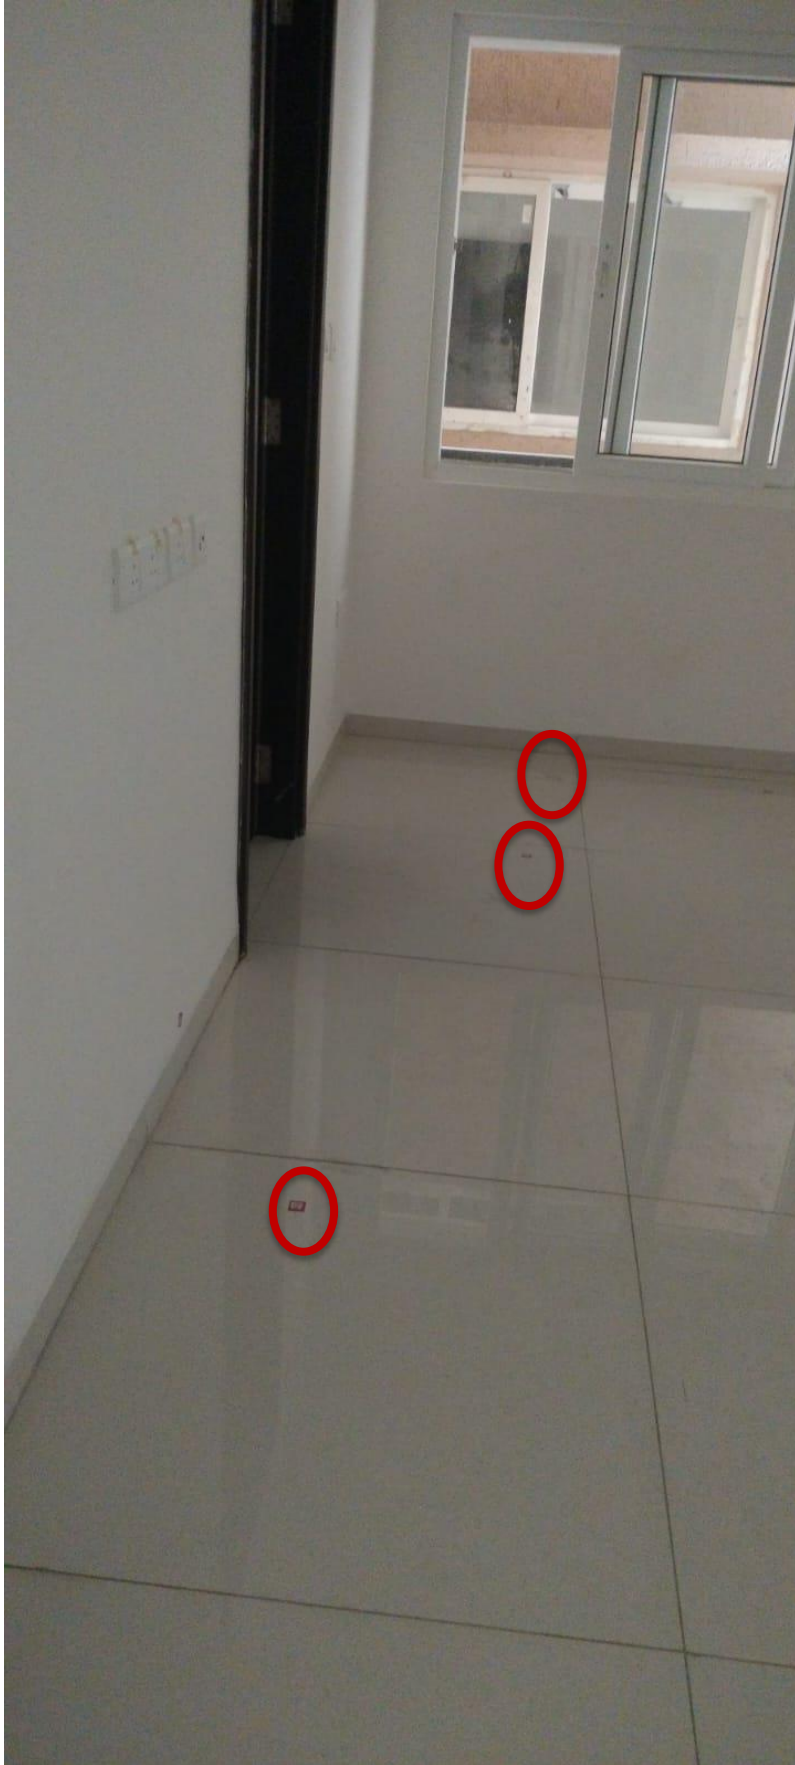
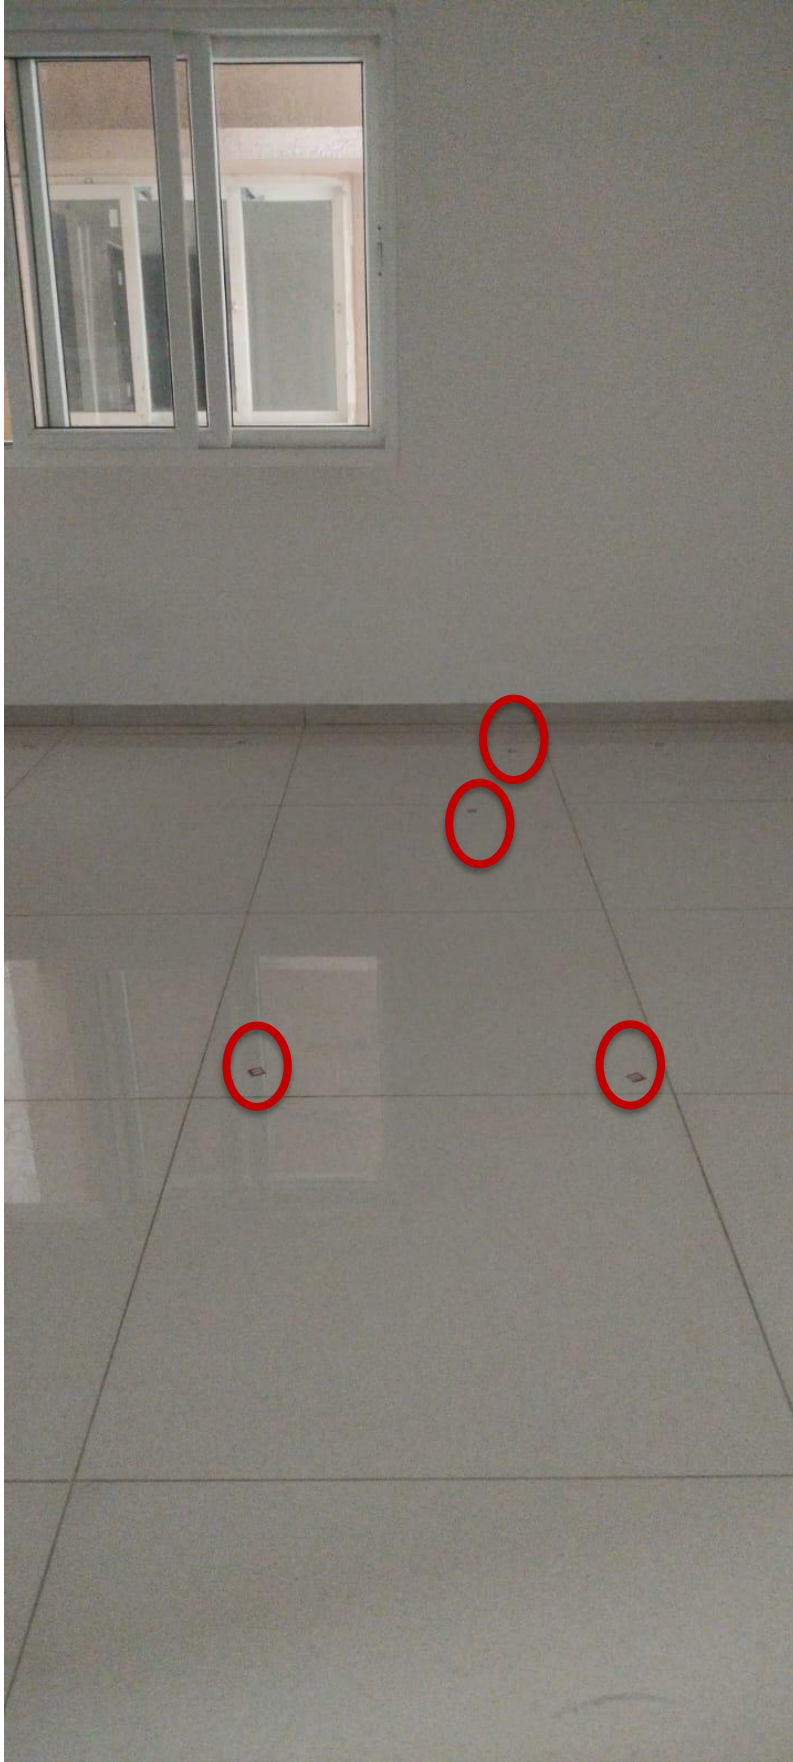
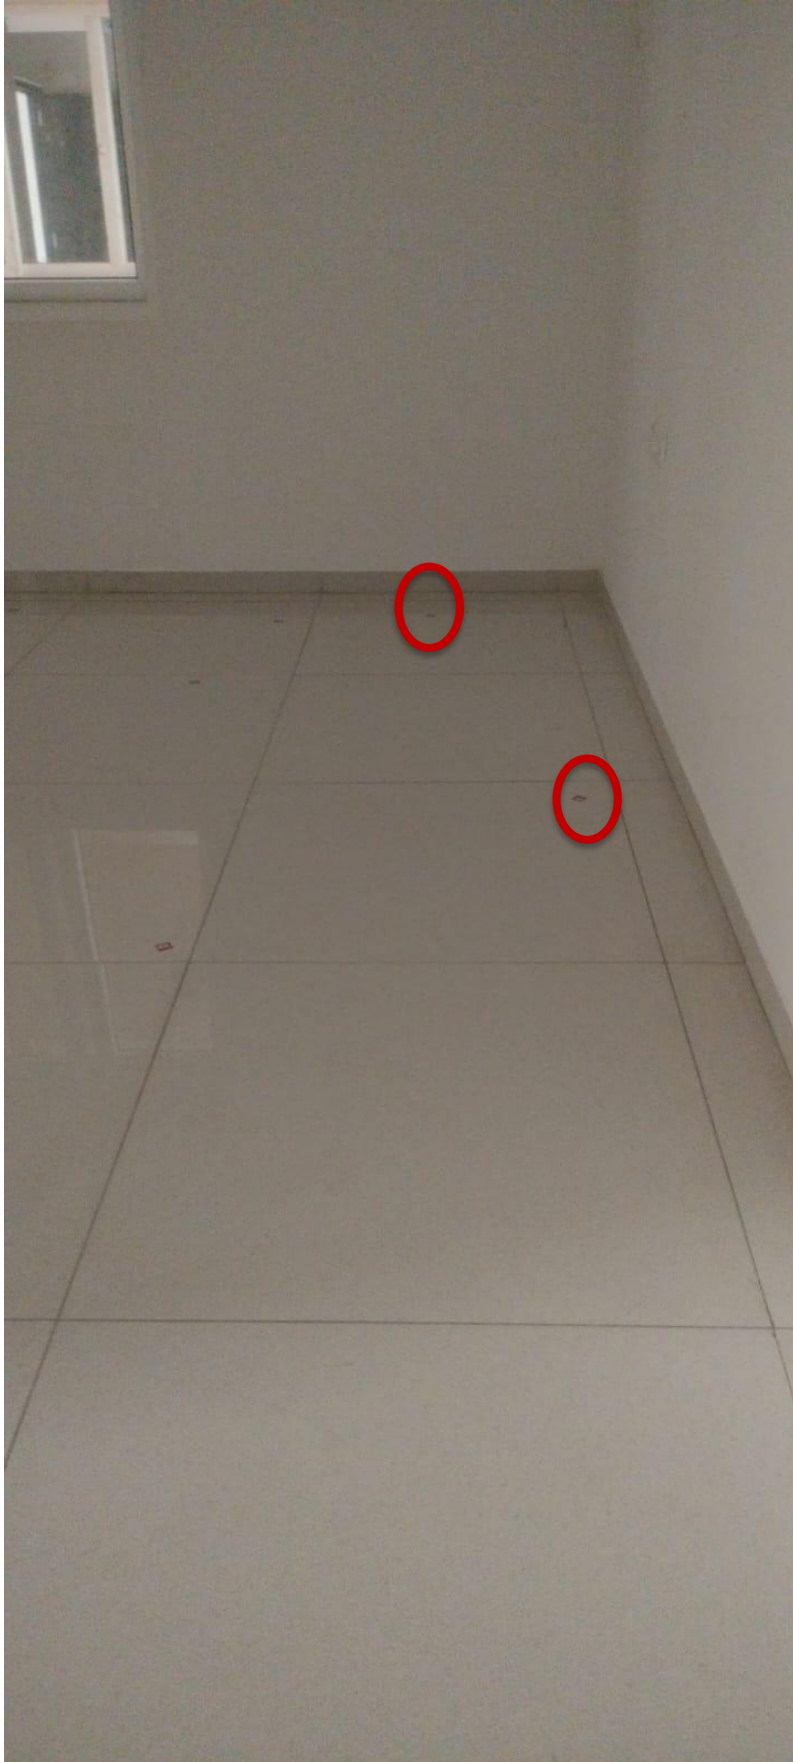
| <b>Observation Description</b> | Hollow sounding response identified in 10 out of 35 floor tiles in the Master Bedroom during tapping tests. |

| <b>Recommendation</b> | <p><b>Step 1</b></p> <p><b>Mapping &amp; Grout Removal:</b> Mark the perimeter of all 10 hollow tiles clearly. Carefully rake out and clear the tile grout around these tiles to isolate them and prevent damage to surrounding intact tiles.</p> <p><b>Step 2</b></p> <p><b>Non-Destructive Epoxy Injection (For Partial Voids):</b> Drill small pilot holes along the tile grout lines at the hollow zones and pressure-inject high-flow, low-viscosity epoxy grouting resin until all voids beneath are completely filled.</p> <p><b>Step 3</b></p> <p><b>Tile Removal &amp; Re-laying (For Extensively Hollow Tiles):</b> If de-bonding is extensive, carefully lift the affected tiles, remove the loose bed mortar down to the solid base slab, apply a fresh uniform bed of high-polymer tile adhesive, and re-lay the tiles level with adjacent flooring.</p> <p><b>Step 4</b></p> <p><b>Curing &amp; Re-Grouting:</b> Allow the injected resin or tile adhesive to cure for 24 hours, then re-grout all surrounding tile joints using waterproof tile grout.</p> |

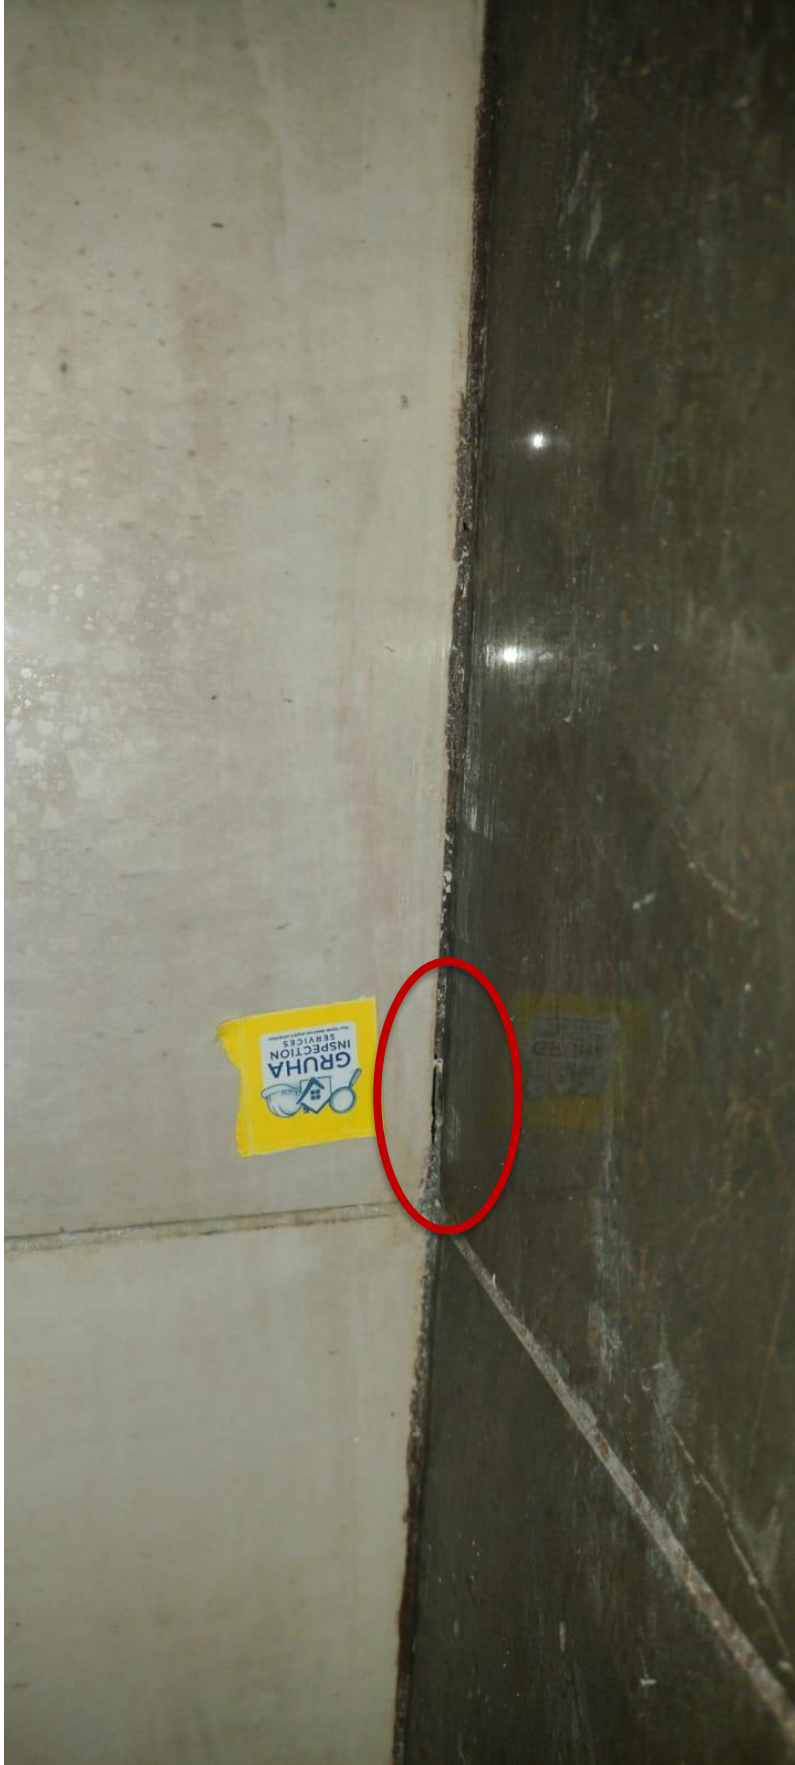
| <b>Observation Description</b> | Grouting voids and gaps observed at the internal vertical corner joint of the dado wall tiles in the Master Bedroom Toilet (MBRT). Corner tile joints in wet areas are primary pathways for water ingress. Unsealed voids allow splash water to penetrate behind the tile cladding, leading to dampness, efflorescence, sub-surface moisture migration into adjoining bedroom walls, and eventual tile debonding. |

| <b>Recommendation</b> | <p><b>Step 1</b></p> <p><b>Cleaning &amp; Preparation:</b> Rake out and remove all loose, deteriorated, or contaminated grout from the vertical corner joint using a grout rake or tile joint scraper. Clean the gap thoroughly with a stiff brush and vacuum to remove dust, moisture, and debris.</p> <p><b>Step 2</b></p> <p><b>Joint Drying:</b> Ensure the internal corner joint is completely dry before applying sealant or epoxy grout.</p> <p><b>Step 3</b></p> <p><b>Waterproof Epoxy Grouting / Silicone Application:</b> Fill the corner joint completely using high-performance, stain-resistant, waterproof epoxy tile grout. Alternatively, apply a neat, continuous bead of sanitary-grade, anti-fungal silicone sealant along the entire corner joint from floor to ceiling level.</p> <p><b>Step 4</b></p> <p><b>Tooling &amp; Curing:</b> Tool the joint smooth for a flush, water-tight seal and allow a minimum curing period of 24 hours before exposed water use.</p> |

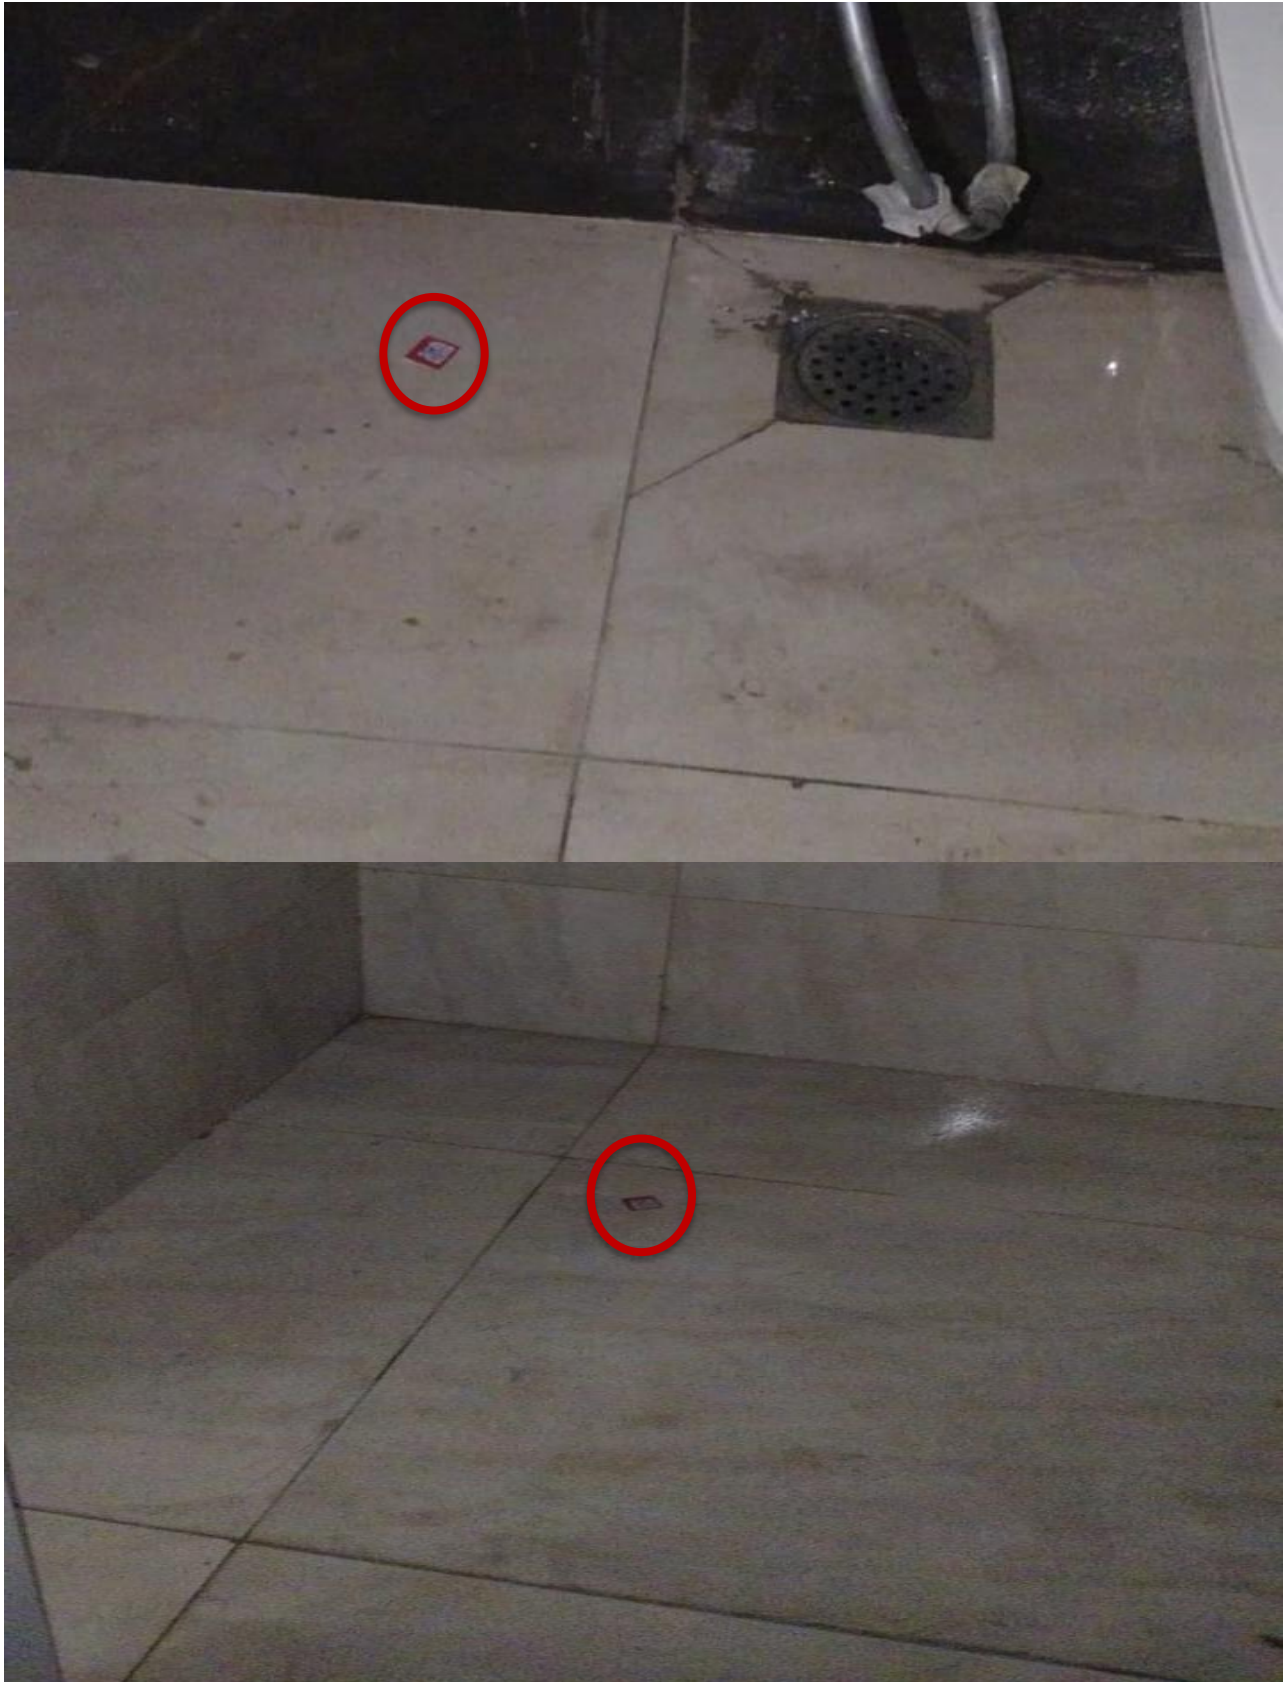
| <b>Observation Description</b> | Hollow sounding response detected in 2 floor tiles in the Master Bedroom Toilet (MBRT) during acoustic tapping tests. |

| <b>Recommendation</b> | <p><b>Step 1</b></p> <p><b>Mapping &amp; Grout Removal:</b> Mark the perimeter of all 2 hollow tiles clearly. Carefully rake out and clear the tile grout around these tiles to isolate them and prevent damage to surrounding intact tiles.</p> <p><b>Step 2</b></p> <p><b>Non-Destructive Epoxy Injection (For Partial Voids):</b> Drill small pilot holes along the tile grout lines at the hollow zones and pressure-inject high-flow, low-viscosity epoxy grouting resin until all voids beneath are completely filled.</p> <p><b>Step 3</b></p> <p><b>Tile Removal &amp; Re-laying (For Extensively Hollow Tiles):</b> If de-bonding is extensive, carefully lift the affected tiles, remove the loose bed mortar down to the solid base slab, apply a fresh uniform bed of high-polymer tile adhesive, and re-lay the tiles level with adjacent flooring.</p> <p><b>Step 4</b></p> <p><b>Curing &amp; Re-Grouting:</b> Allow the injected resin or tile adhesive to cure for 24 hours, then re-grout all surrounding tile joints using waterproof tile grout.</p> |

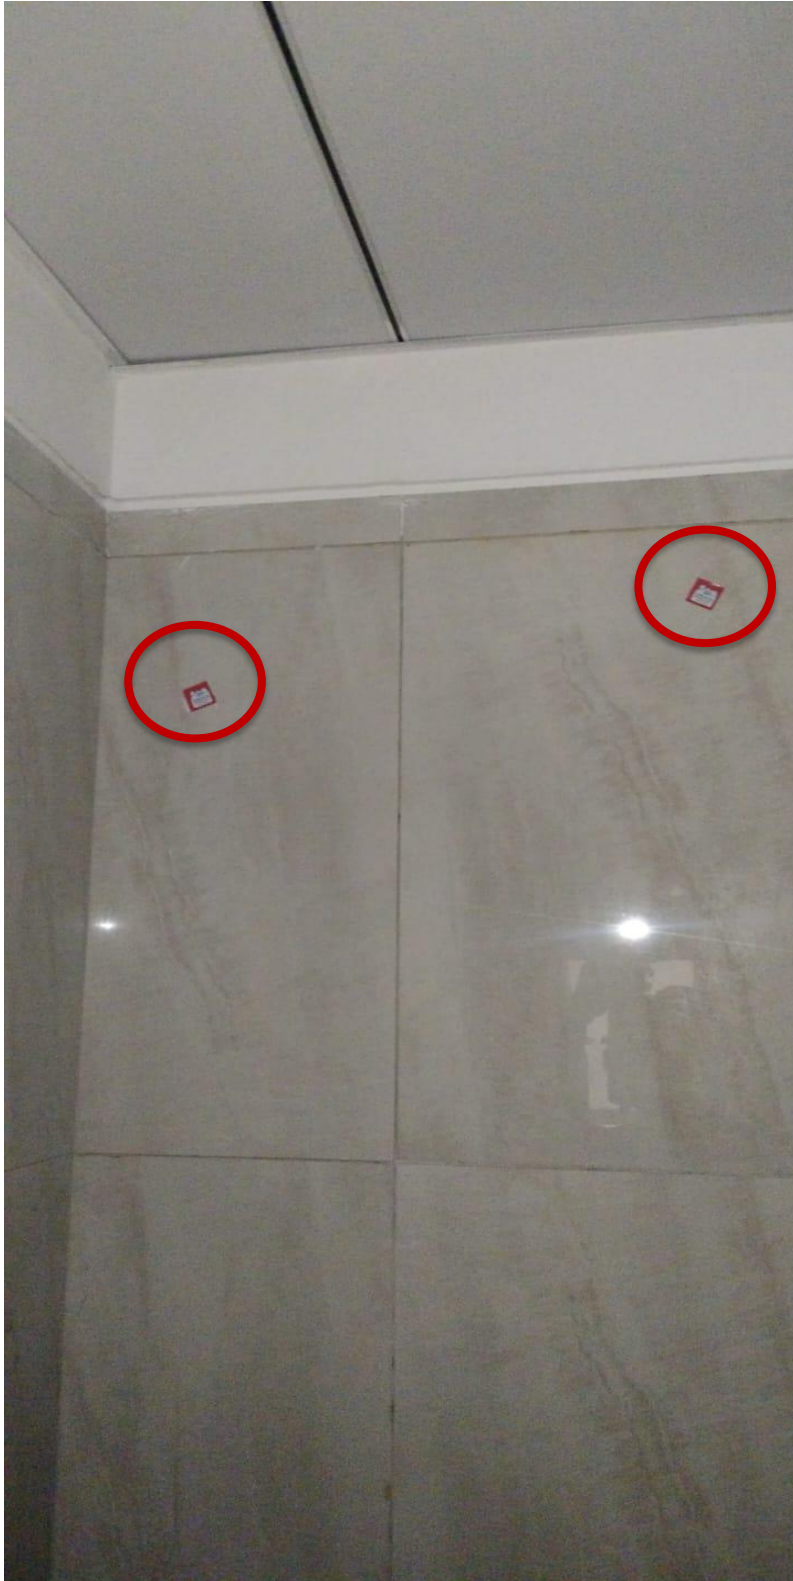
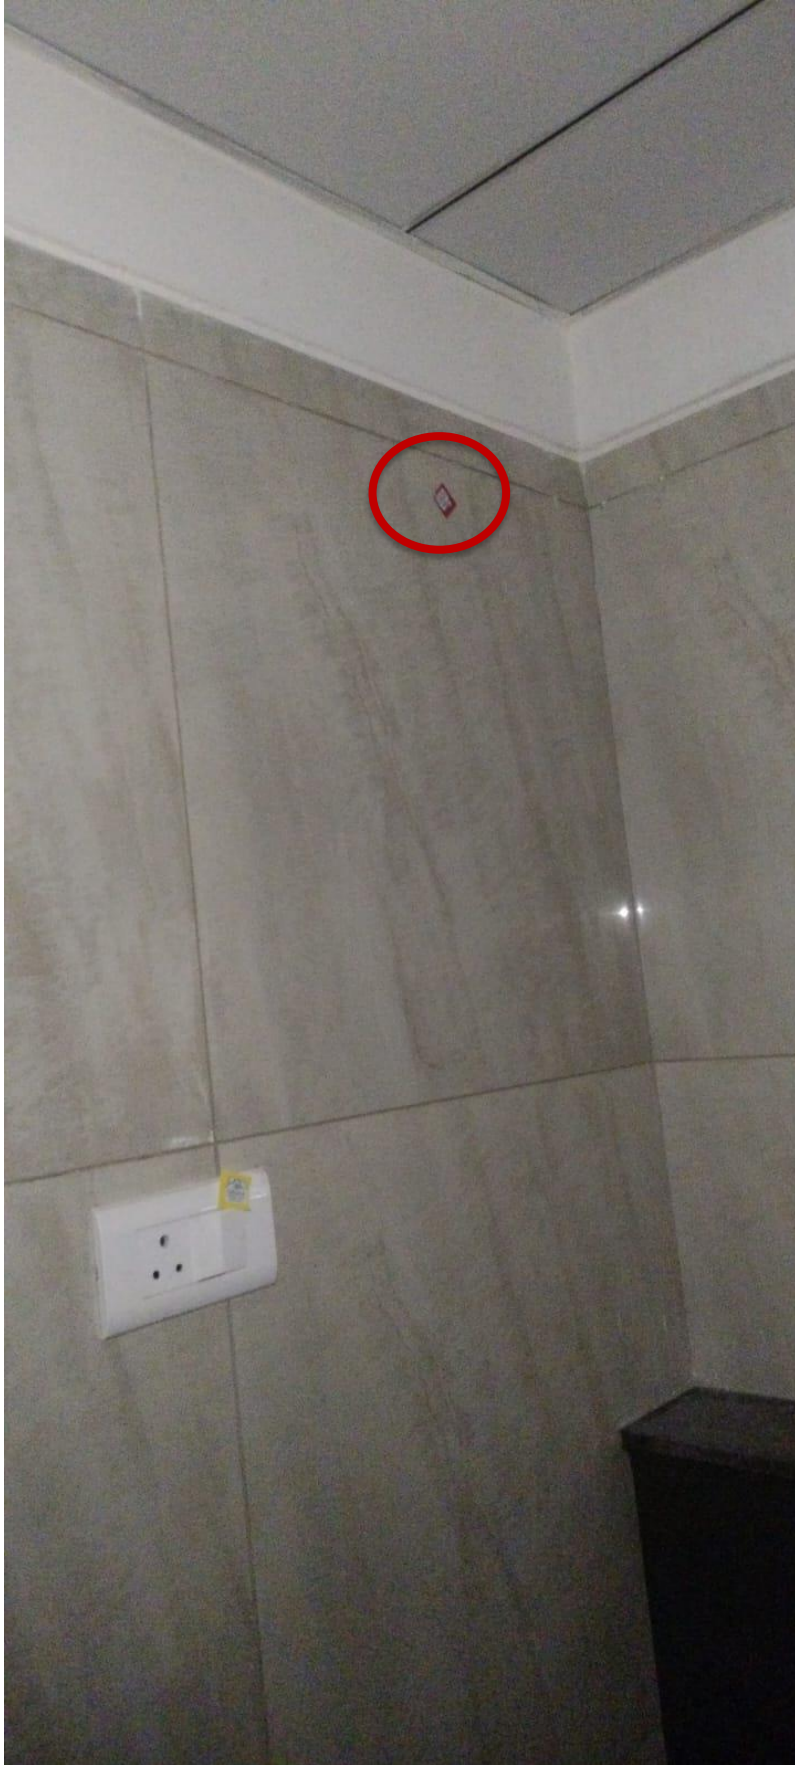
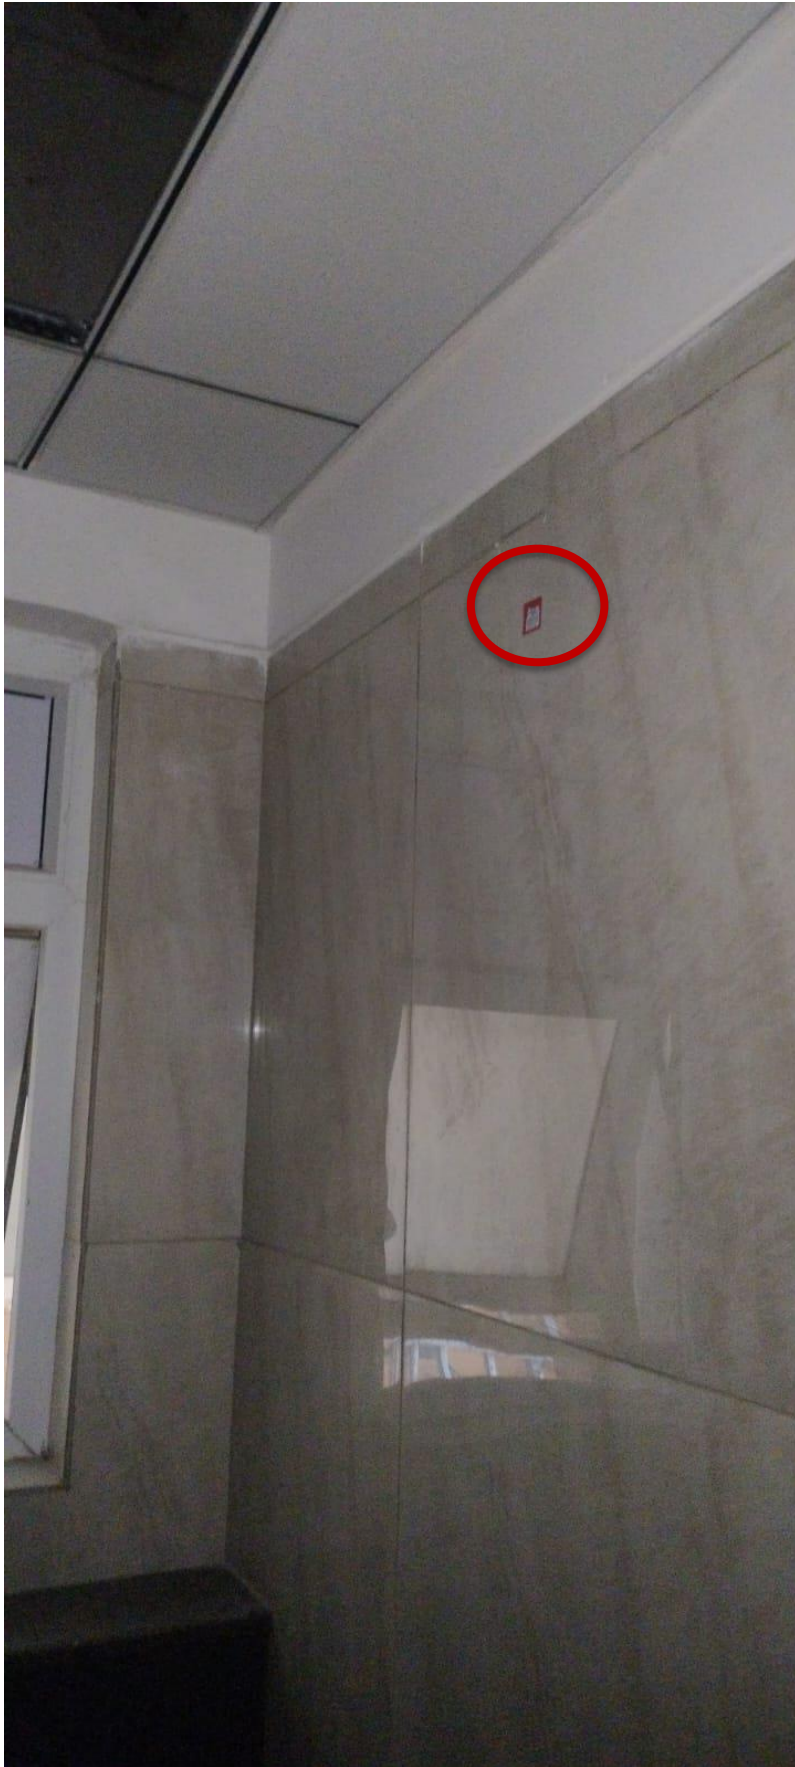
| <b>Observation Description</b> | Hollow sound response detected in 4 wall dado tiles in the Master Bedroom Toilet (MBRT) during tapping tests. Sub-surface voids behind wall tiles indicate inadequate adhesive comb-coverage, localized shrinkage, or poor bonding to the vertical plaster layer. Vertical hollow tiles in wet environments pose a safety hazard of dislodging/falling and can allow trapped moisture to accumulate behind the cladding, leading to dampness transmission through adjacent walls. |

| <b>Recommendation</b> | <p><b>Step 1</b></p> <p><b>Mapping &amp; Grout Removal:</b> Mark the perimeter of all 4 hollow tiles clearly. Carefully rake out and clear the tile grout around these tiles to isolate them and prevent damage to surrounding intact tiles.</p> <p><b>Step 2</b></p> <p><b>Non-Destructive Epoxy Injection (For Partial Voids):</b> Drill small pilot holes along the tile grout lines at the hollow zones and pressure-inject high-flow, low-viscosity epoxy grouting resin until all voids beneath are completely filled.</p> <p><b>Step 3</b></p> <p><b>Tile Removal &amp; Re-laying (For Extensively Hollow Tiles):</b> If de-bonding is extensive, carefully lift the affected tiles, remove the loose bed mortar down to the solid base slab, apply a fresh uniform bed of high-polymer tile adhesive, and re-lay the tiles level with adjacent flooring.</p> <p><b>Step 4</b></p> <p><b>Curing &amp; Re-Grouting:</b> Allow the injected resin or tile adhesive to cure for 24 hours, then re-grout all surrounding tile joints using waterproof tile grout.</p> |

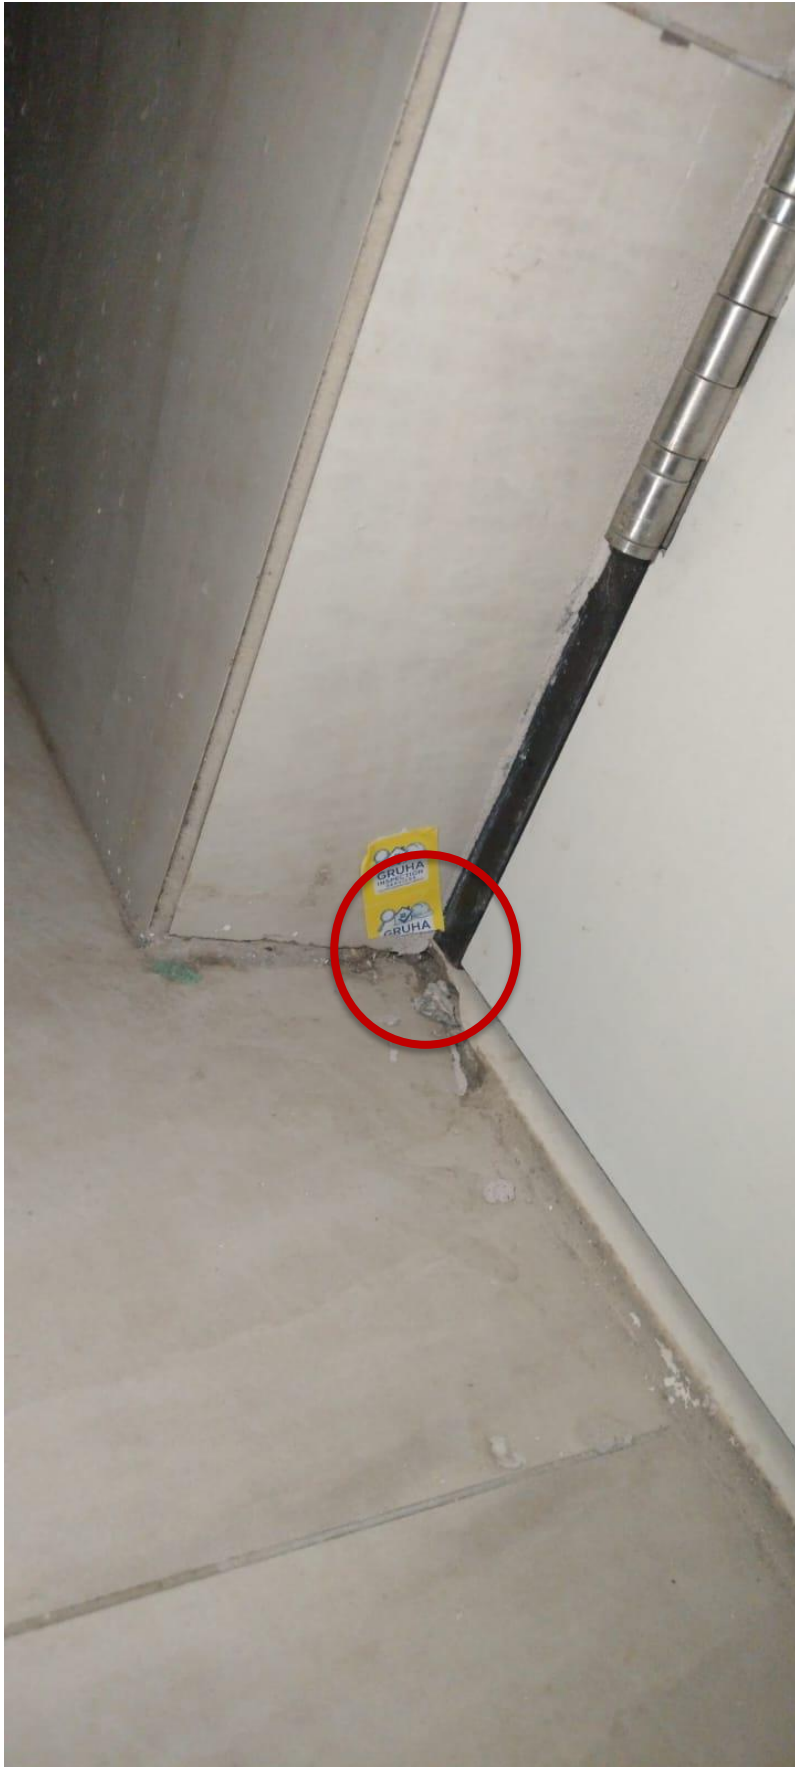
| <b>Observation Description</b> | Unsealed voids and open gaps observed at the base of the Master Bedroom Toilet (MBRT) door threshold and jamb junction. In a toilet entrance, unsealed threshold gaps allow floor wash water or stray splash water to seep directly into the wooden door frame, sub-floor screed, and adjoining master bedroom flooring. |

| <b>Recommendation</b> | <p><b>Step 1</b></p> <p><b>Surface Preparation &amp; Cleaning:</b> Rake out any loose cement particles, dust, and debris from the gap at the threshold junction using a wire brush/scrapper, then vacuum clean thoroughly.</p> <p><b>Step 2</b></p> <p><b>Joint Drying:</b> Ensure the entire threshold cavity and surrounding frame area are completely dry before applying repair materials.</p> <p><b>Step 3</b></p> <p><b>Void Filling &amp; Waterproof Grouting:</b> Fill deeper voids under the threshold slab/frame base with non-shrink mortar or epoxy grout paste to provide a solid, structural backing.</p> <p><b>Step 4</b></p> <p><b>Sealing Joint:</b> Apply a continuous, neat bead of anti-fungal, waterproof epoxy grout along the tile threshold joint, and seal the direct contact point with the wooden/UPVC door jamb using a flexible, sanitary-grade silicone sealant to allow for subtle expansion while keeping the joint water-tight.</p> |
