# ULTRA PREMIUM HOME INSPECTION REPORT

**GRUHA  
INSPECTION  
SERVICES**

| Project / Apartment | Rajapushpa Imperia |
| Location | Tellapur |

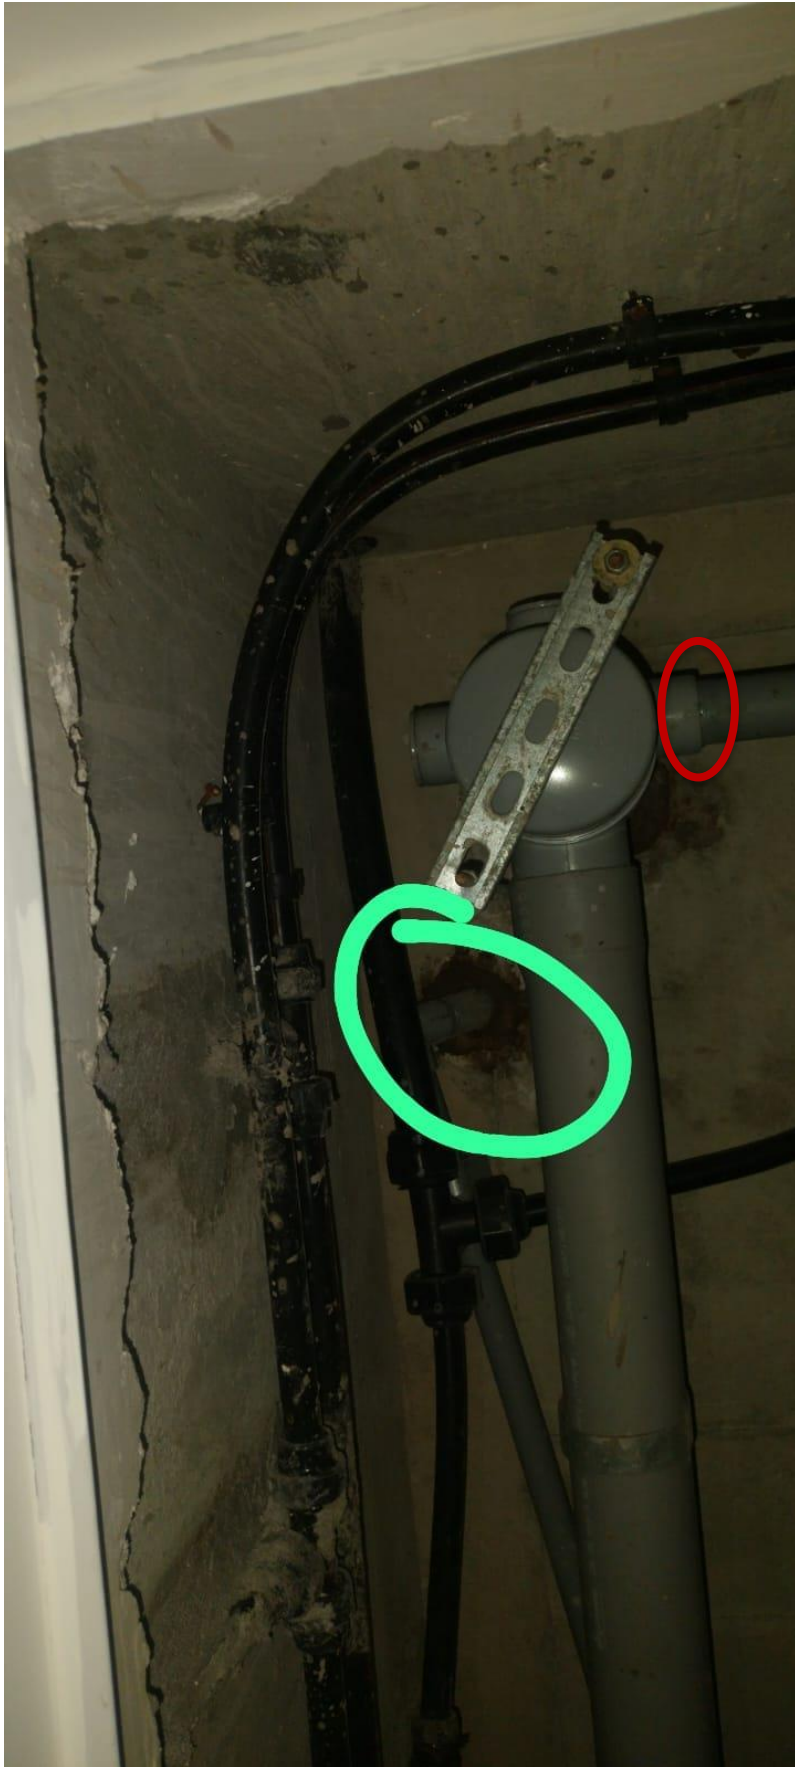
| <b>Observation Description</b> | Active seepage and leakage marks observed around the weep hole pipe provision / core-cut opening in the RCC ceiling slab of the Master Bedroom Toilet (MBRT). Inadequate sealing or improper bore packing around core-cut penetrations allows trapped moisture from the upper floor slab/screed to escape along the pipe perimeter. |

| <b>Recommendation</b> | <p><b>Step 1</b></p> <p><b>Surface Chipping &amp; Core Opening Preparation:</b> Remove the false ceiling tiles to gain full access. Chip away loose, weak concrete, or deteriorated packing material around the weep hole/core cut perimeter using a light chisel. Clean the surface thoroughly using a wire brush and high-pressure air/water to remove dust.</p> <p><b>Step 2</b></p> <p><b>Surface Priming:</b> Apply a coat of SBR latex or polymer-modified cement slurry as a bonding agent on the cleaned RCC core opening surface and pipe interface to ensure a strong chemical and mechanical bond.</p> <p><b>Step 3</b></p> <p><b>Re-Bore packing with Non-Shrink Micro-Concrete / GP2 Grout:</b> Formwork shuttering around the pipe penetration from below. Pour/pack high-strength, non-shrink free-flow grout (e.g., GP2 packing compound) or polymer-modified micro-concrete into the core-cut cavity around the pipe, ensuring complete compaction without air voids.</p> <p><b>Step 4</b></p> <p><b>Waterproofing Elastomeric Coating:</b> Once the grout is fully cured, apply a 2-coat elastic, fiber-reinforced acrylic polymer waterproofing membrane (e.g., Brush bond RFX) over the repaired annular core surface, extending at least 100 mm onto the pipe collar and adjacent RCC slab soffit.</p> |

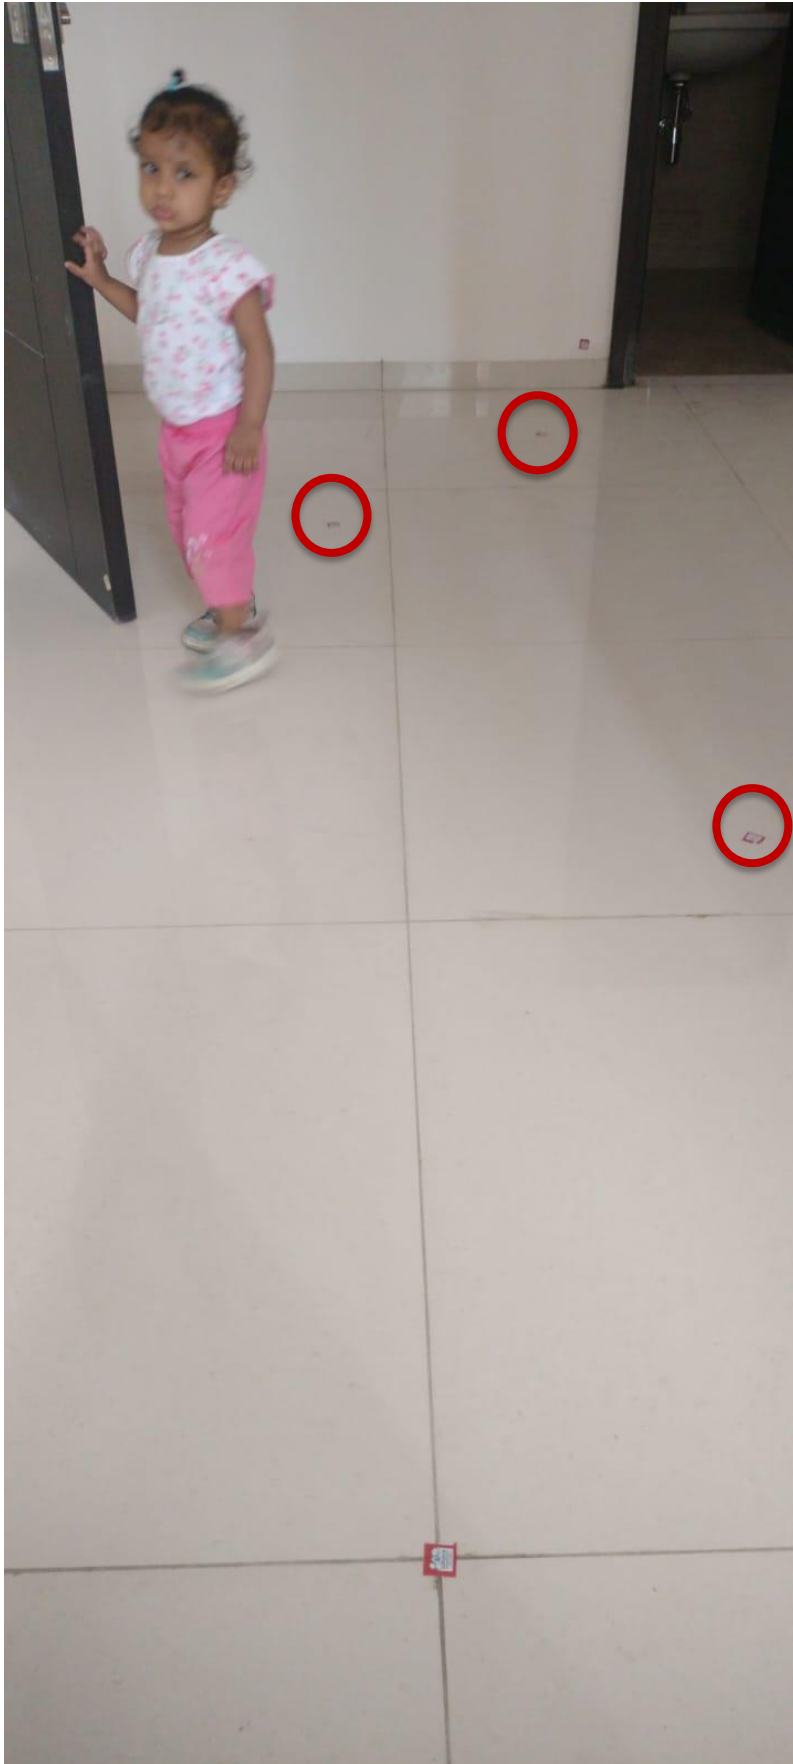
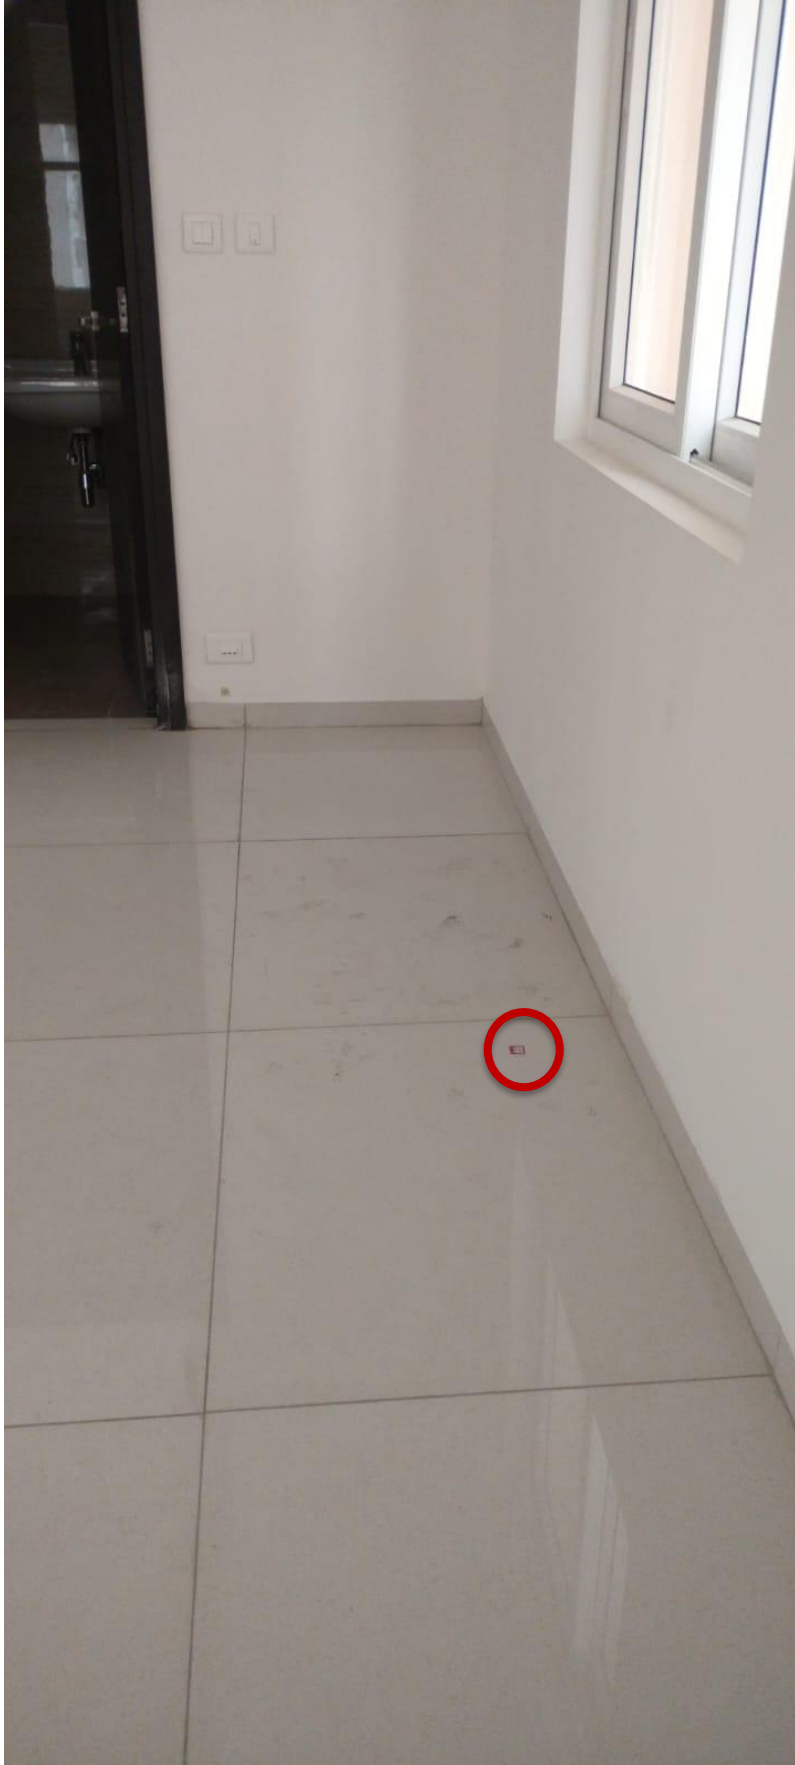
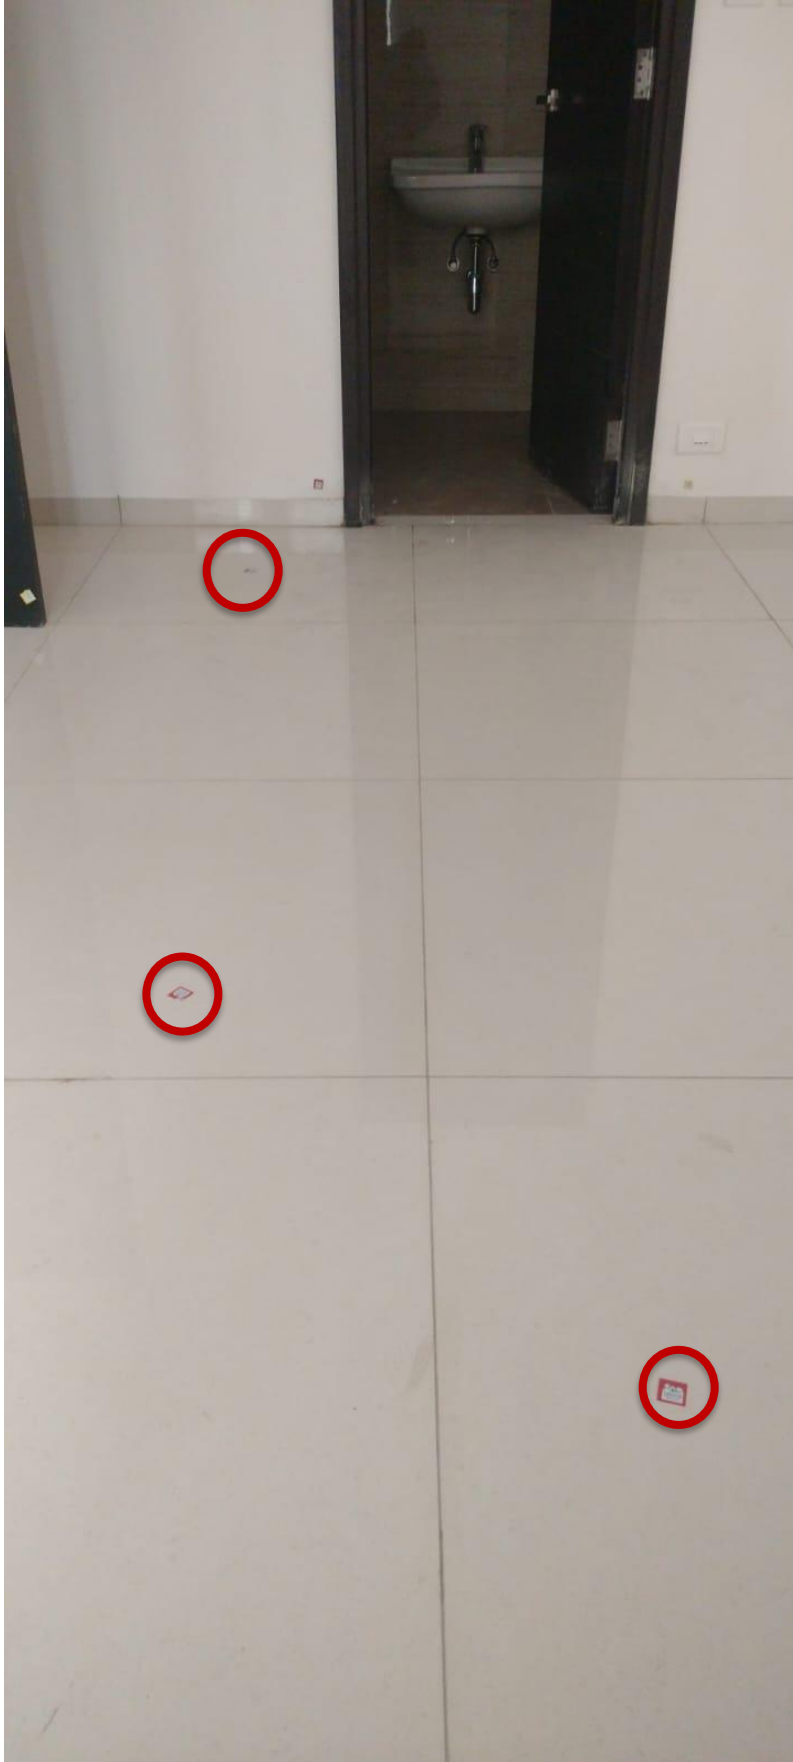
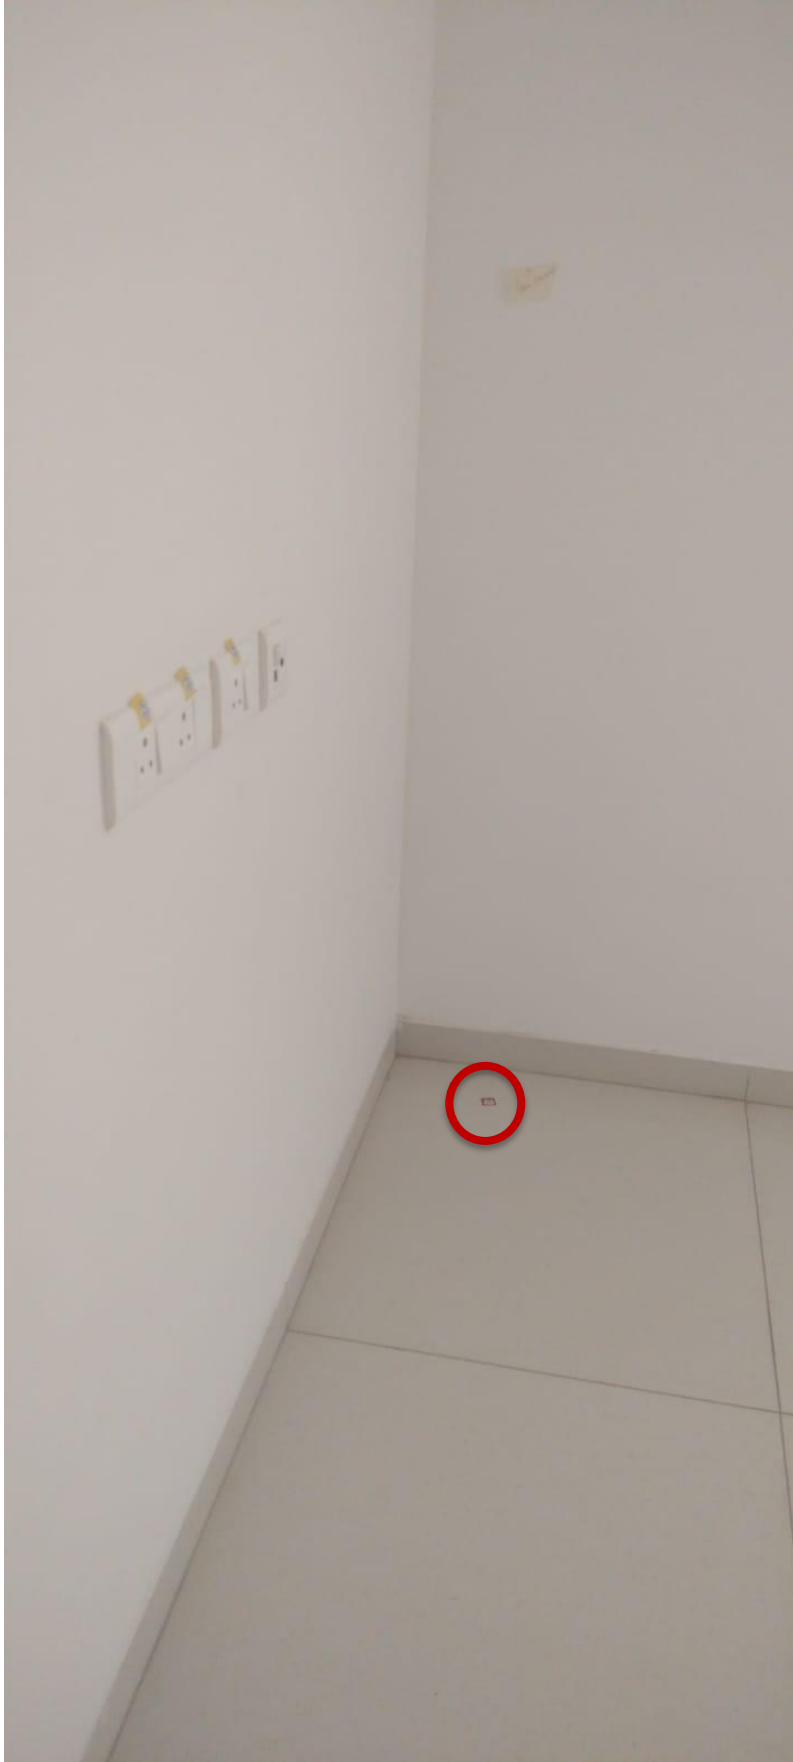
| <b>Observation Description</b> | Hollow sounding response detected in 7 out of 20 floor tiles in the Children's Bedroom (CBR) during acoustic tapping tests. |

| <b>Recommendation</b> | <p><b>Step 1</b></p> <p><b>Mapping &amp; Grout Removal:</b> Mark the perimeter of all 7 hollow tiles clearly. Carefully rake out and clear the tile grout around these tiles to isolate them and prevent damage to surrounding intact tiles.</p> <p><b>Step 2</b></p> <p><b>Non-Destructive Epoxy Injection (For Partial Voids):</b> Drill small pilot holes along the tile grout lines at the hollow zones and pressure-inject high-flow, low-viscosity epoxy grouting resin until all voids beneath are completely filled.</p> <p><b>Step 3</b></p> <p><b>Tile Removal &amp; Re-laying (For Extensively Hollow Tiles):</b> If de-bonding is extensive, carefully lift the affected tiles, remove the loose bed mortar down to the solid base slab, apply a fresh uniform bed of high-polymer tile adhesive, and re-lay the tiles level with adjacent flooring.</p> <p><b>Step 4</b></p> <p><b>Curing &amp; Re-Grouting:</b> Allow the injected resin or tile adhesive to cure for 24 hours, then re-grout all surrounding tile joints using waterproof tile grout.</p> |

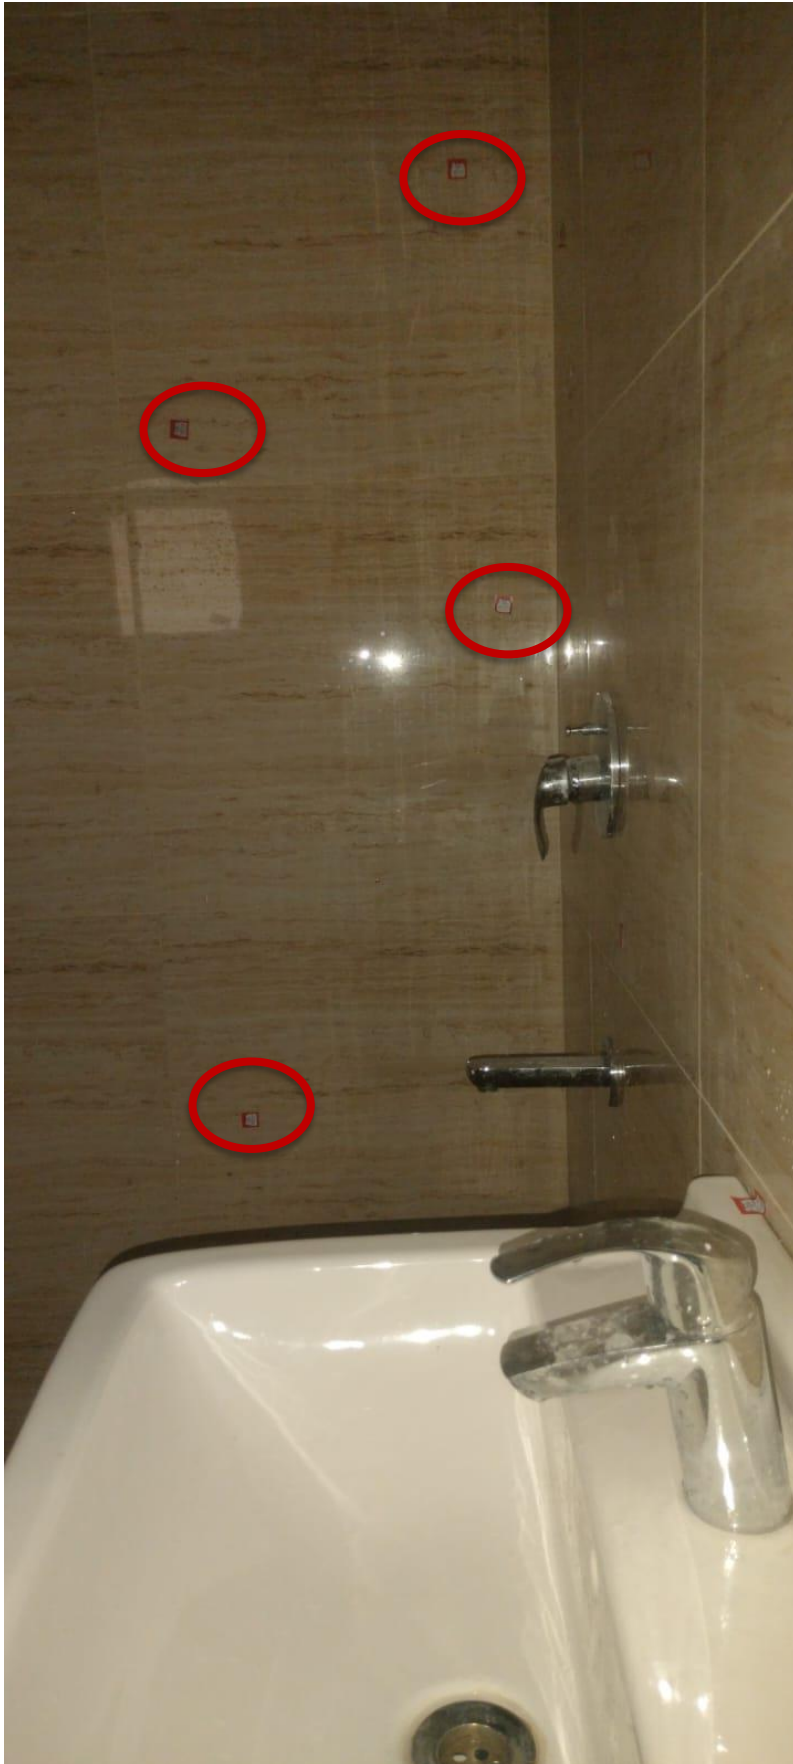
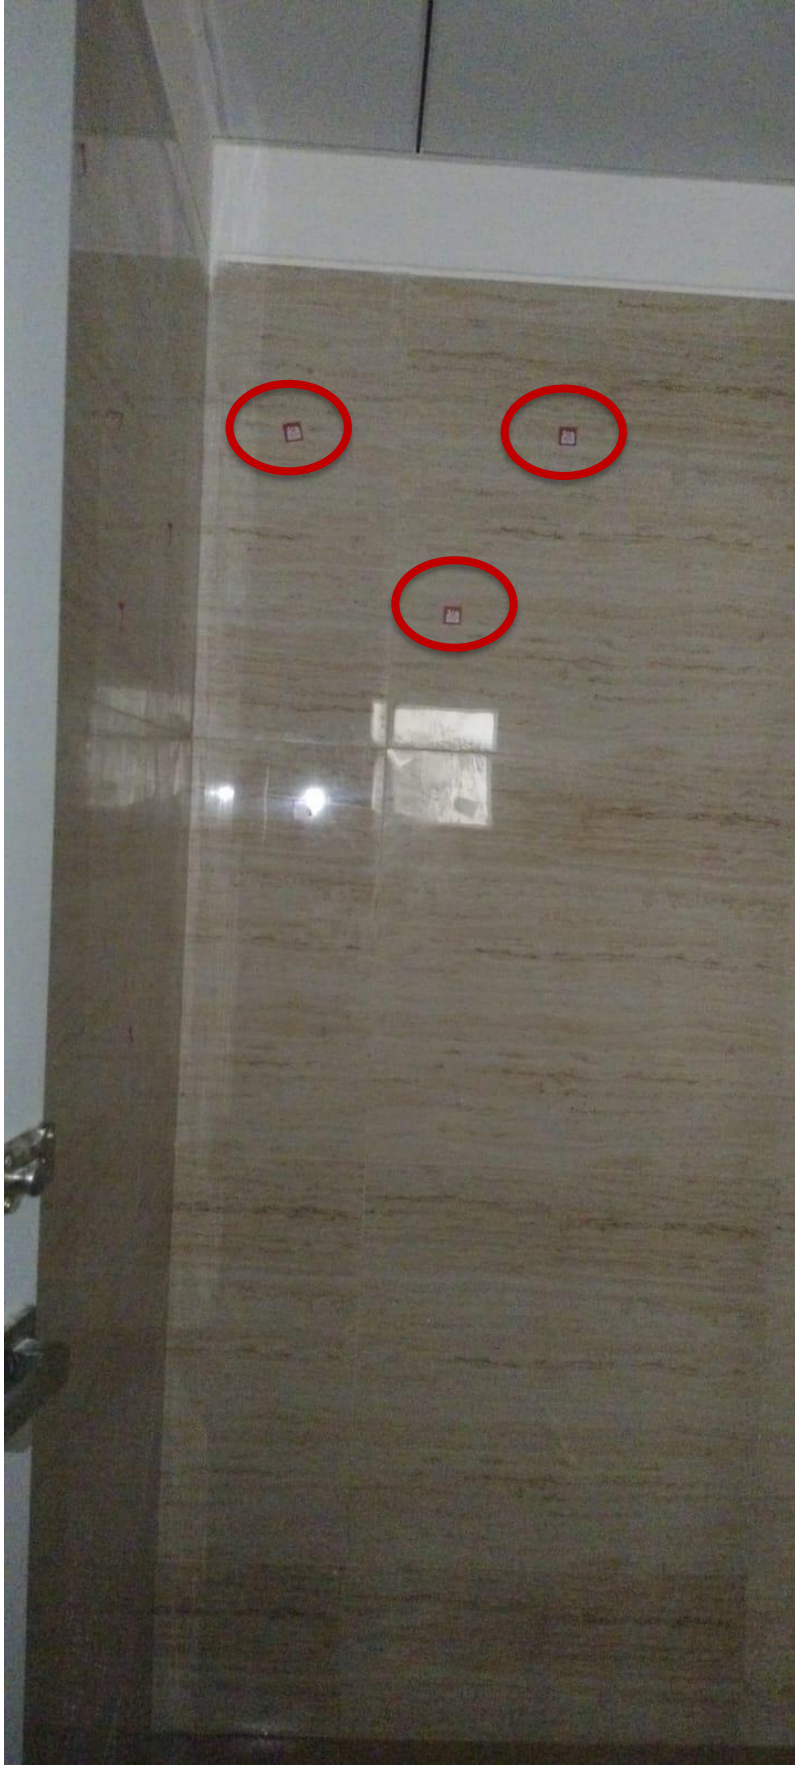
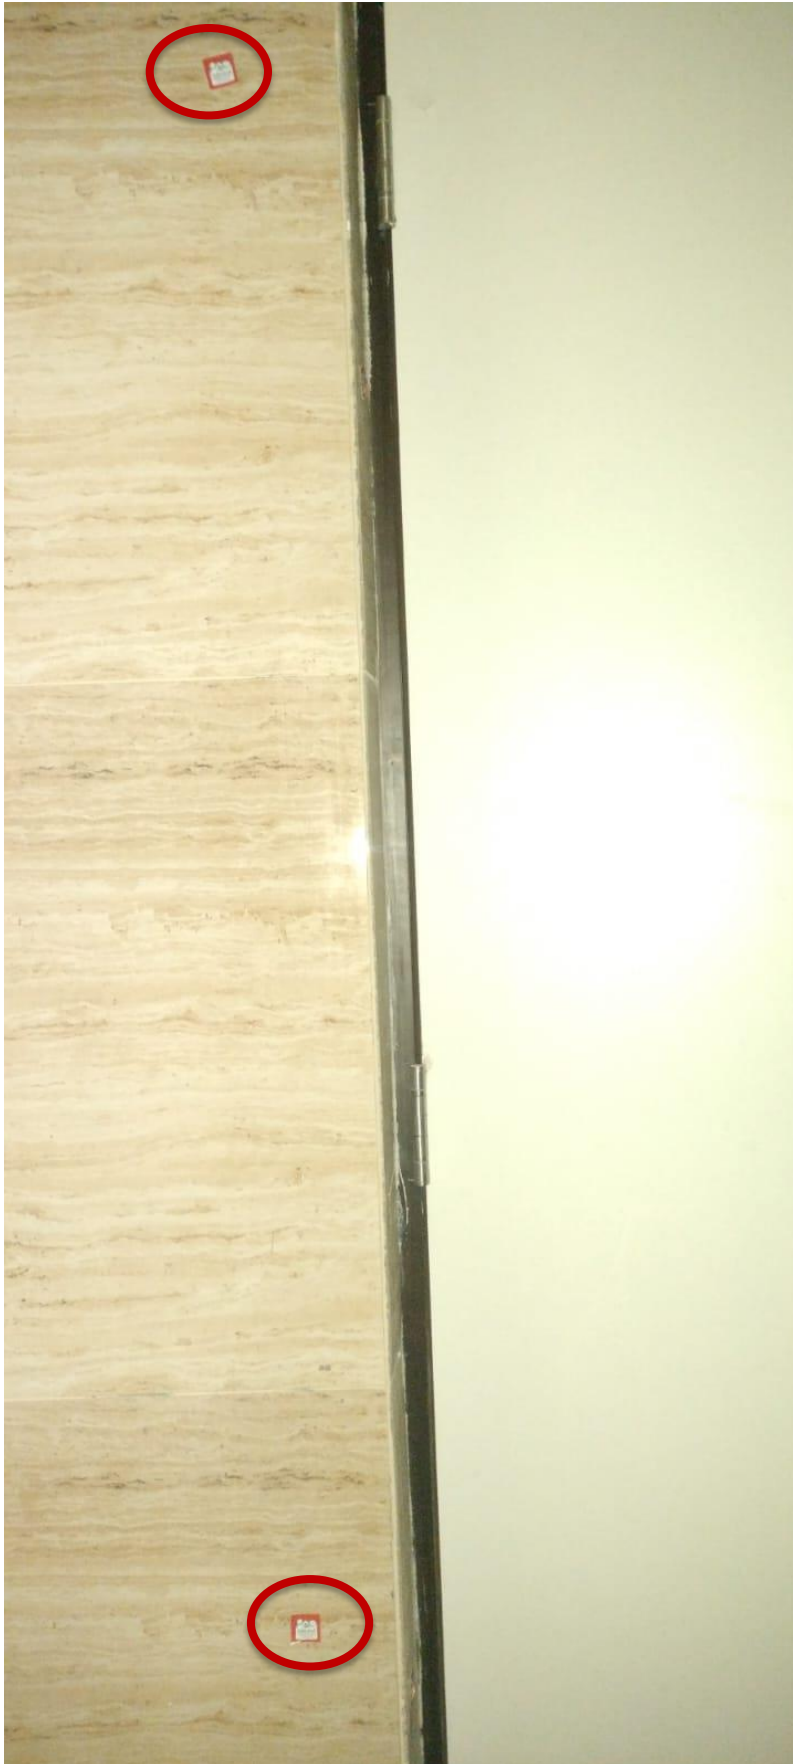
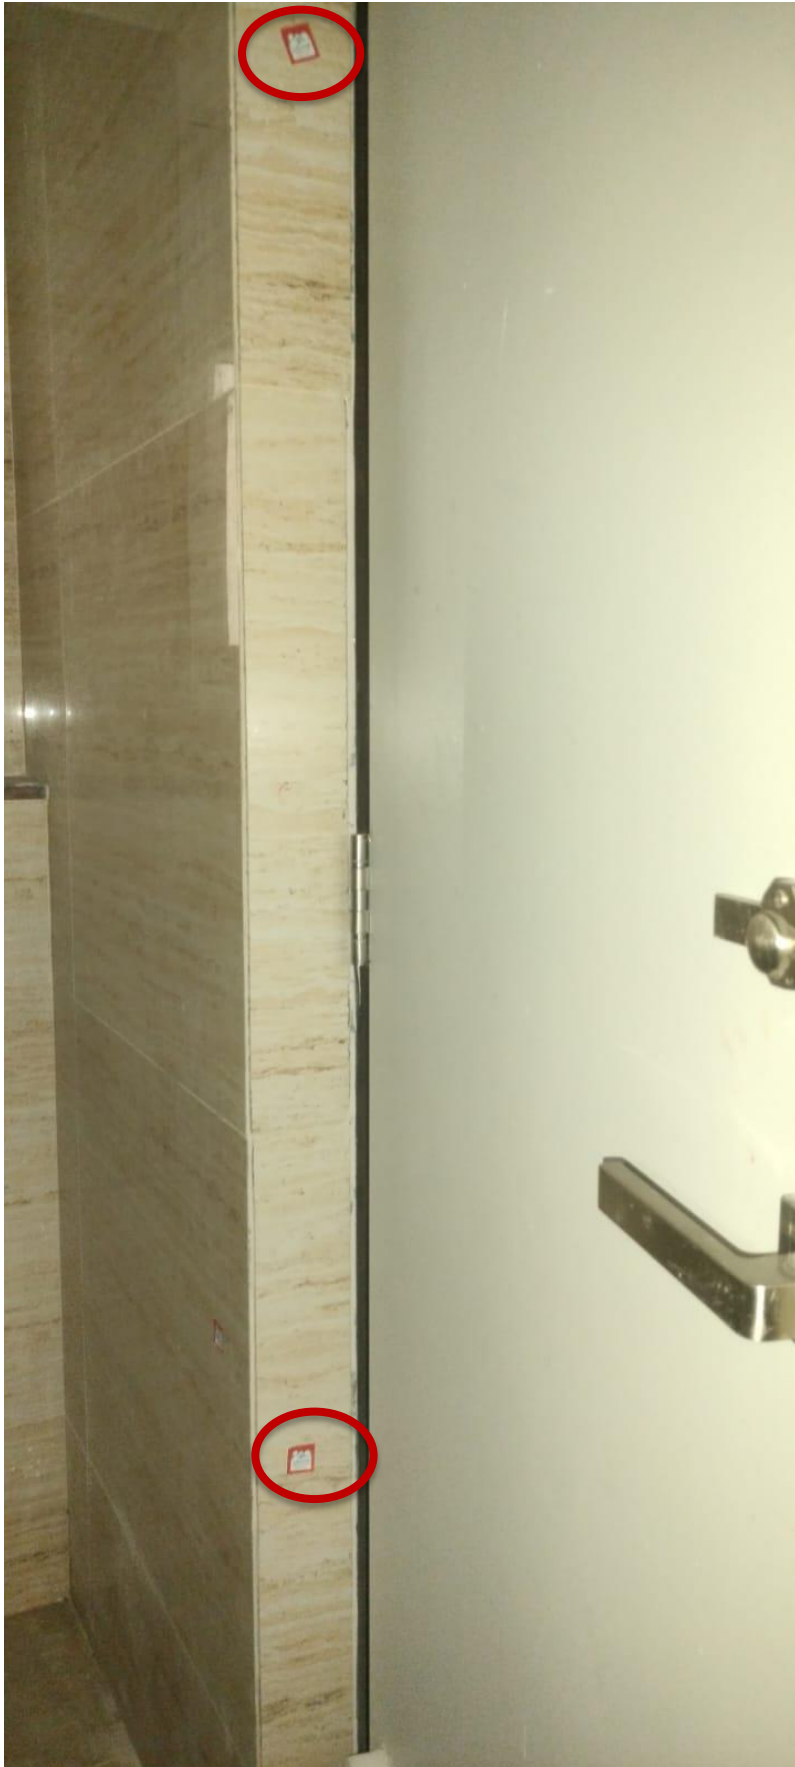
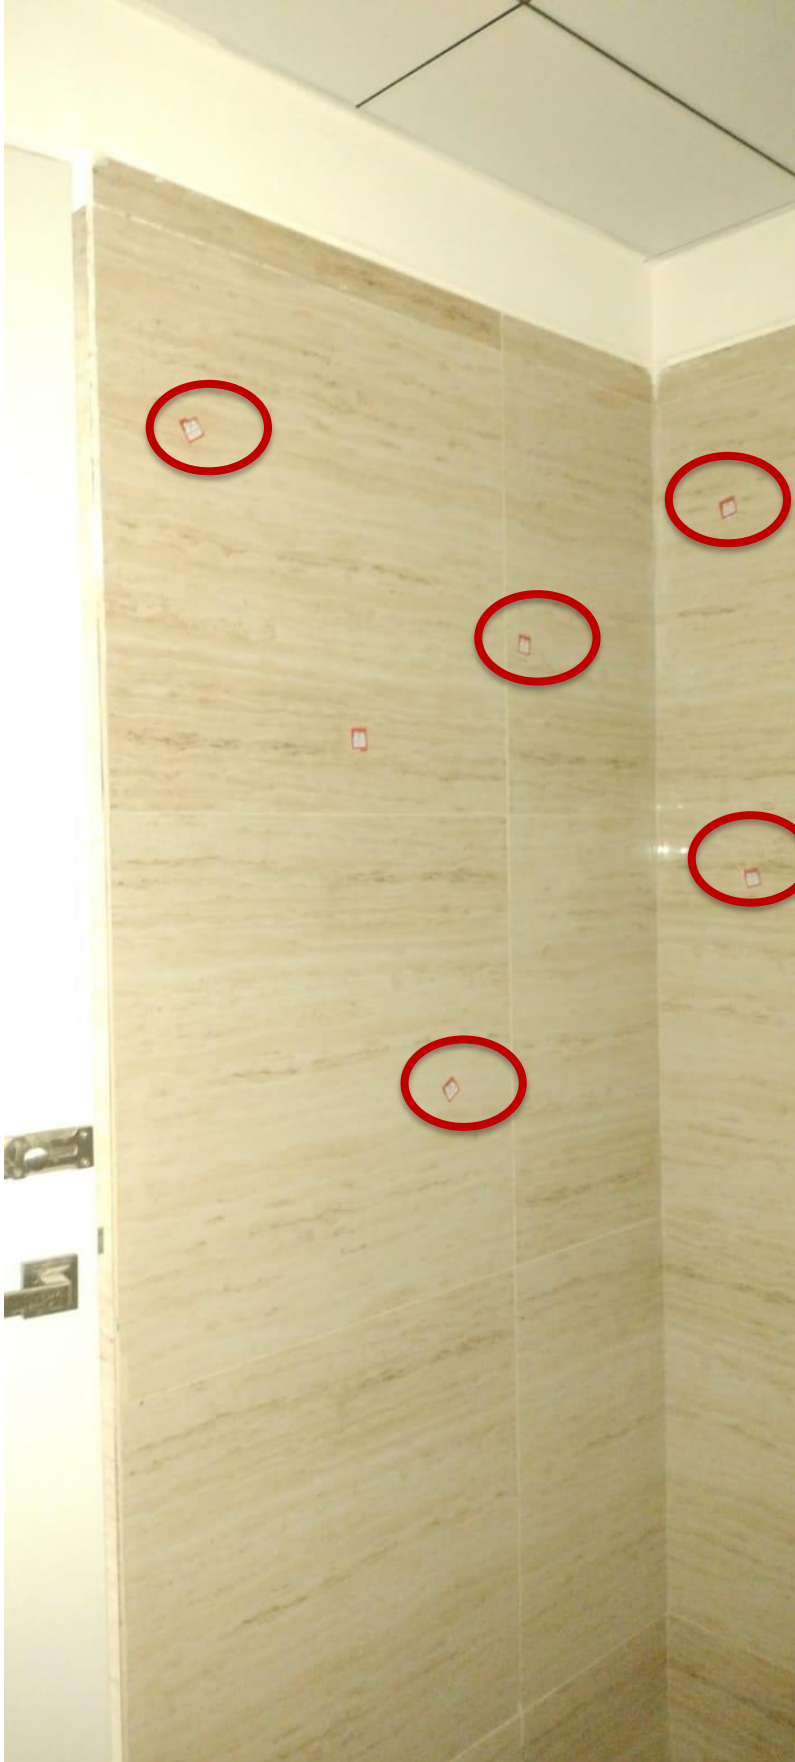
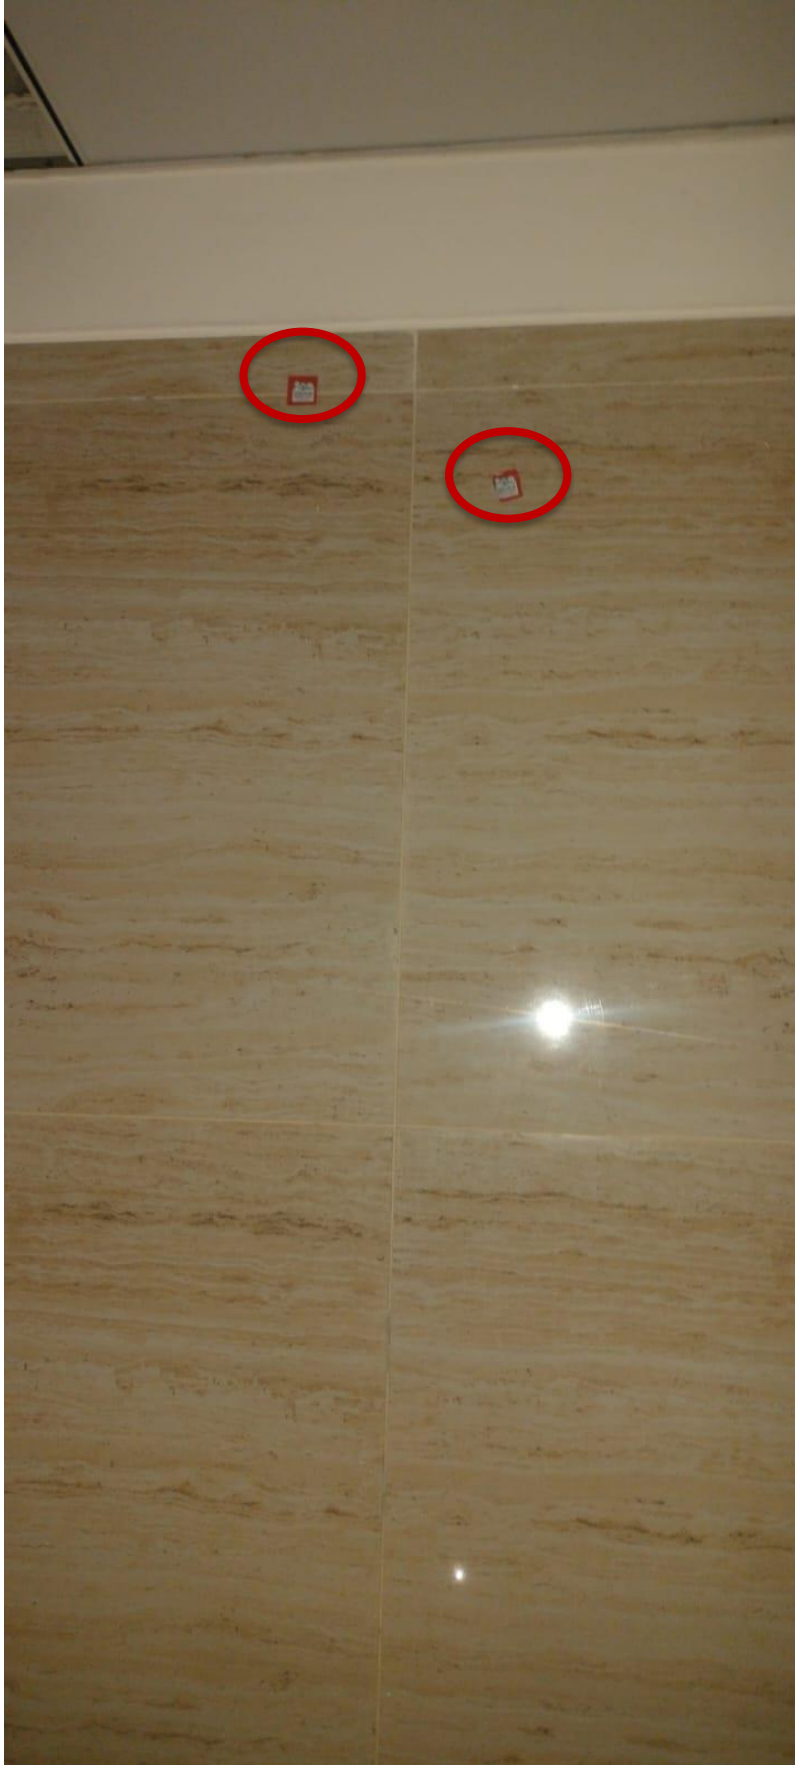
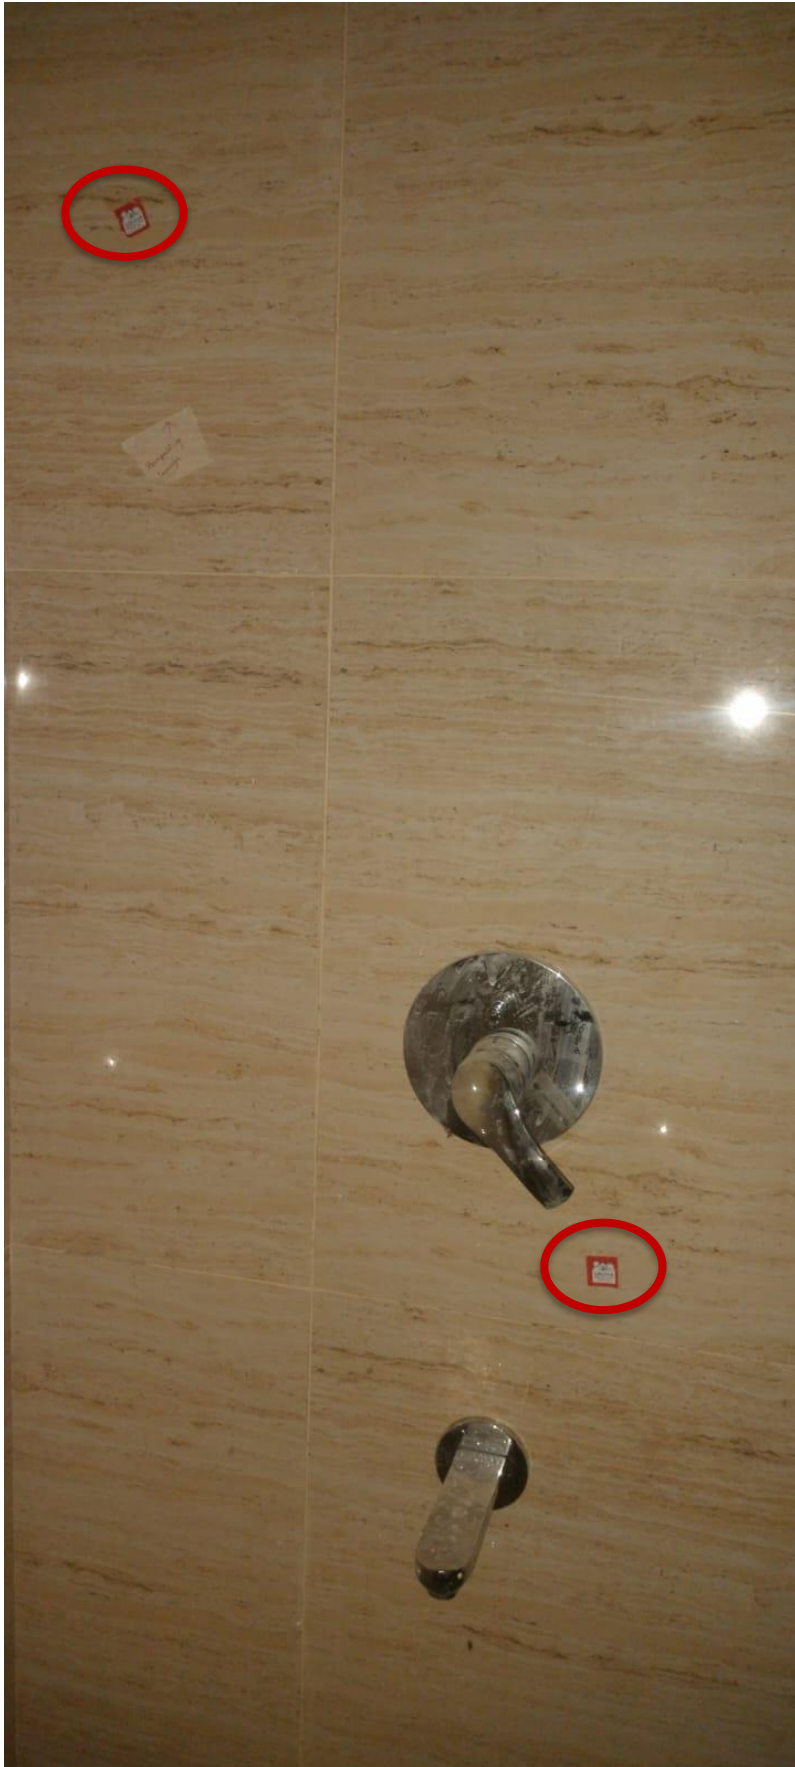
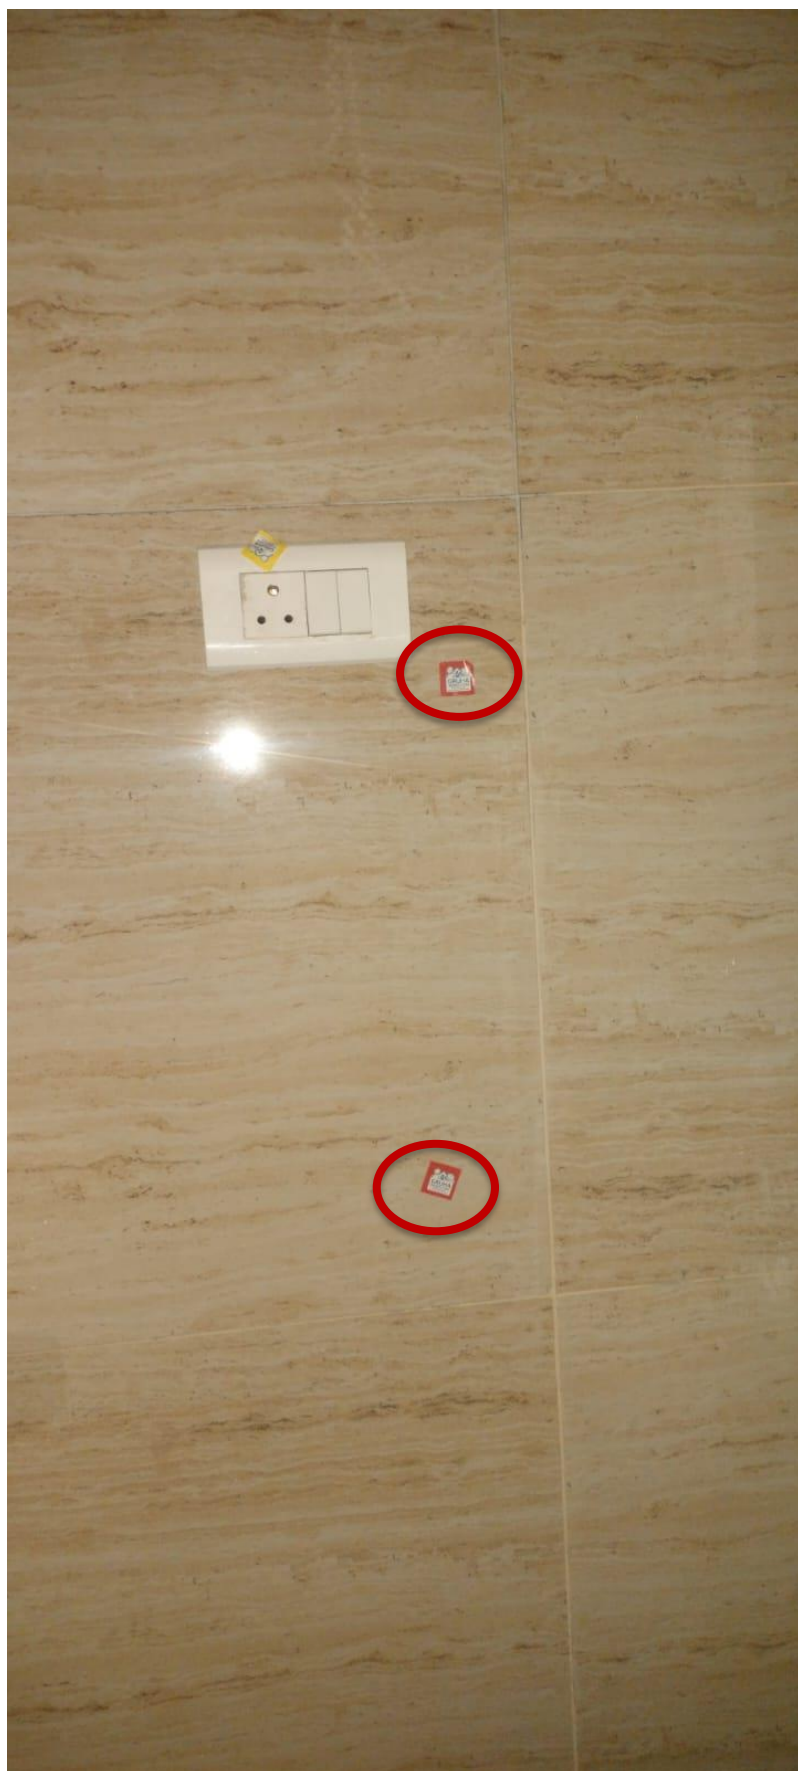
| <b>Observation Description</b> | Hollow sounding response detected in 19 wall dado tiles across multiple walls in the Children's Bedroom Toilet (CBRT) during acoustic tapping tests. Large voids behind wall tiles indicate incomplete adhesive buttering/troweling, improper comb coverage, or poor adhesion to the underlying rendered wall. |

| <b>Recommendation</b> | <p><b>Step 1</b></p> <p><b>Mapping &amp; Grout Removal:</b> Mark the perimeter of all 7 hollow tiles clearly. Carefully rake out and clear the tile grout around these tiles to isolate them and prevent damage to surrounding intact tiles.</p> <p><b>Step 2</b></p> <p><b>Non-Destructive Epoxy Injection (For Partial Voids):</b> Drill small pilot holes along the tile grout lines at the hollow zones and pressure-inject high-flow, low-viscosity epoxy grouting resin until all voids beneath are completely filled.</p> <p><b>Step 3</b></p> <p><b>Tile Removal &amp; Re-laying (For Extensively Hollow Tiles):</b> If de-bonding is extensive, carefully lift the affected tiles, remove the loose bed mortar down to the solid base slab, apply a fresh uniform bed of high-polymer tile adhesive, and re-lay the tiles level with adjacent flooring.</p> <p><b>Step 4</b></p> <p><b>Curing &amp; Re-Grouting:</b> Allow the injected resin or tile adhesive to cure for 24 hours, then re-grout all surrounding tile joints using waterproof tile grout.</p> |

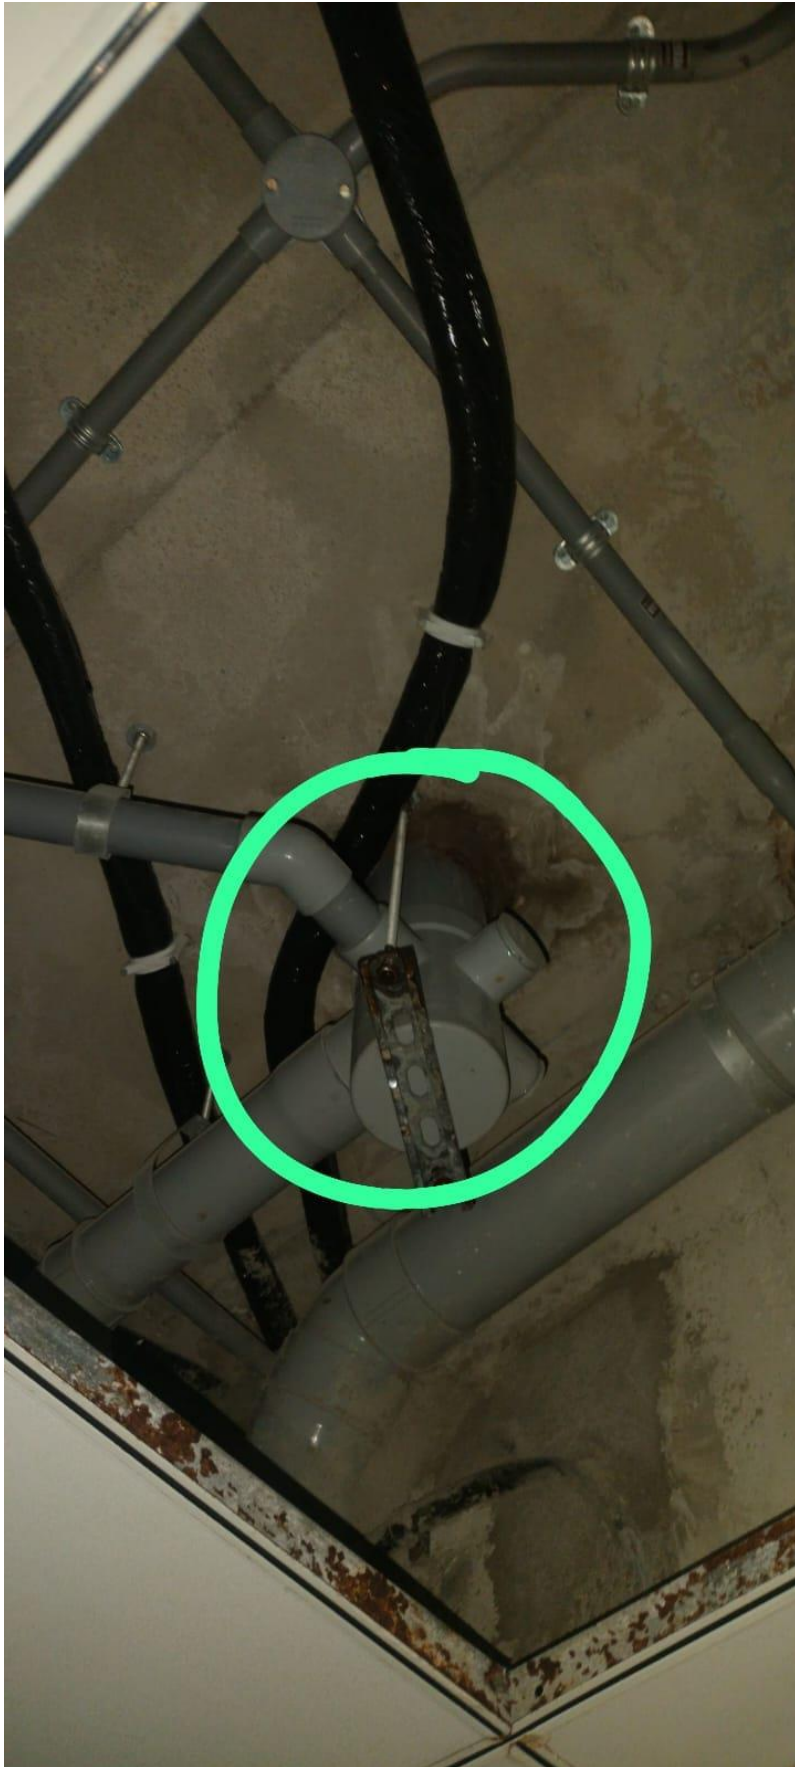
| <b>Observation Description</b> | Active dampness and water seepage stains observed around the dry and wet area drain floor trap bore packing penetration in the RCC ceiling slab of the Children's Bedroom Toilet (CBRT). |

| <b>Recommendation</b> | <p><b>Step 1</b></p> <p><b>Surface Chipping &amp; Core Opening Preparation:</b> Remove the false ceiling tiles to gain full access. Chip away loose, weak concrete, or deteriorated packing material around the weep hole/core cut perimeter using a light chisel. Clean the surface thoroughly using a wire brush and high-pressure air/water to remove dust.</p> <p><b>Step 2</b></p> <p><b>Surface Priming:</b> Apply a coat of SBR latex or polymer-modified cement slurry as a bonding agent on the cleaned RCC core opening surface and pipe interface to ensure a strong chemical and mechanical bond.</p> <p><b>Step 3</b></p> <p><b>Re-Bore packing with Non-Shrink Micro-Concrete / GP2 Grout:</b> Formwork shuttering around the pipe penetration from below. Pour/pack high-strength, non-shrink free-flow grout (e.g., GP2 packing compound) or polymer-modified micro-concrete into the core-cut cavity around the pipe, ensuring complete compaction without air voids.</p> <p><b>Step 4</b></p> <p><b>Waterproofing Elastomeric Coating:</b> Once the grout is fully cured, apply a 2-coat elastic, fiber-reinforced acrylic polymer waterproofing membrane (e.g., Brush bond RFX) over the repaired annular core surface, extending at least 100 mm onto the pipe collar and adjacent RCC slab soffit.</p> |
