# ULTRA PREMIUM HOME INSPECTION REPORT

**GRUHA  
INSPECTION  
SERVICES**

| Project / Apartment | Rajapushpa Imperia |
| Location | Tellapur |

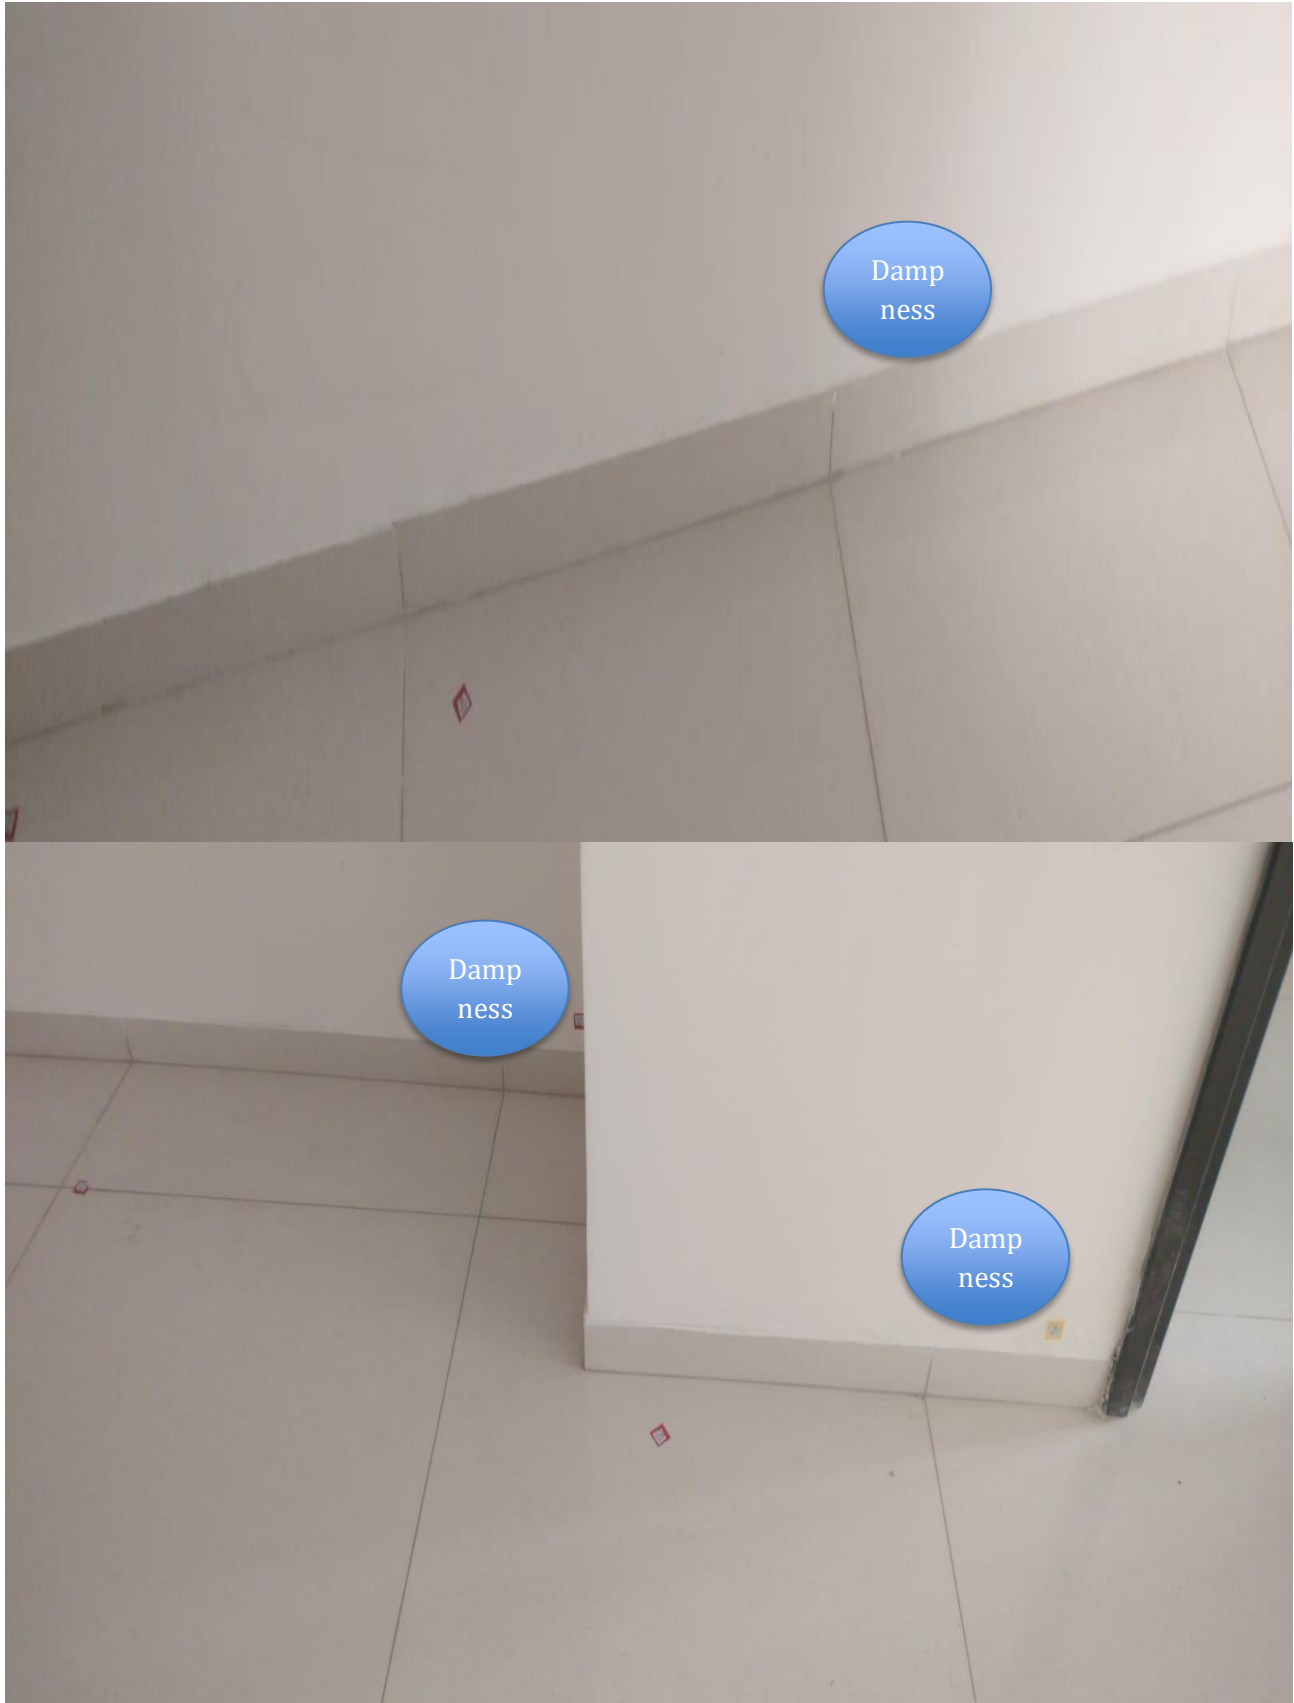
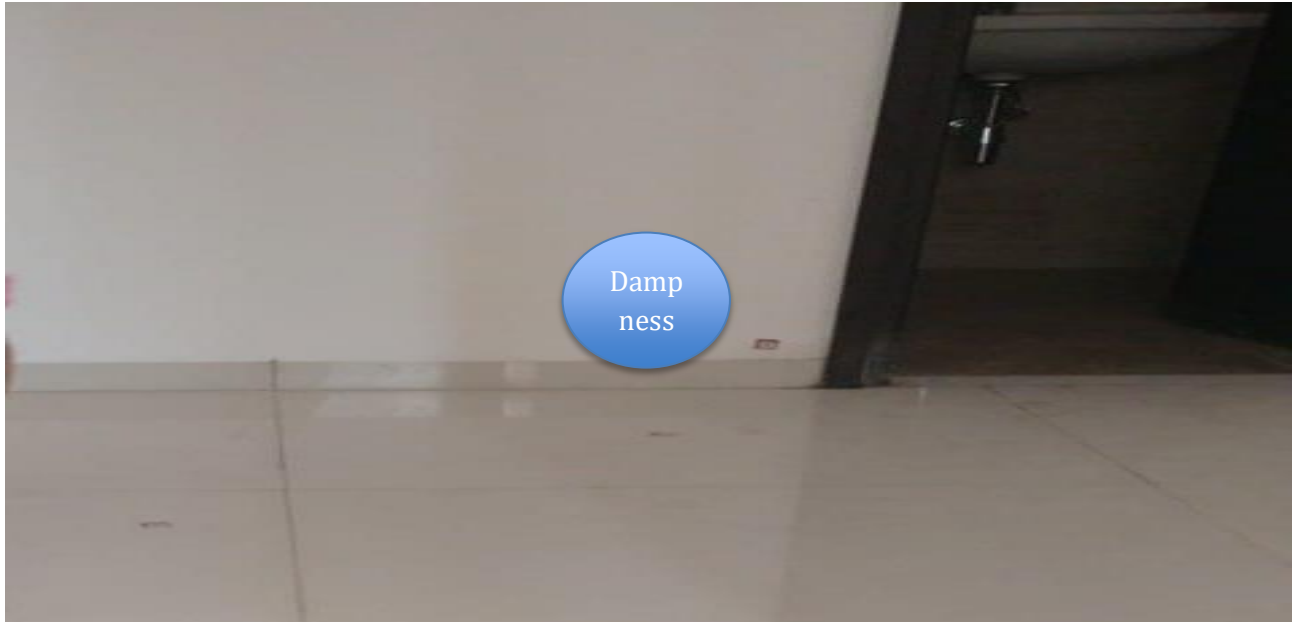
- **Active Moisture Infiltration:** Active dampness levels ranging between **13% to 55%** were recorded in walls adjoining wet areas (utility and washrooms) due to open/voided corner joints and inadequate perimeter grouting.
- **Core-Cut & Borepacking Leakage:** Active seepage was detected around the ceiling weep hole / core-cut in the Master Bedroom Toilet (MBRT) ceiling and around drain borepacking in the Children's Bedroom Toilet (CBRT) ceiling.
- **Elevated Water TDS:** Water quality testing indicated a **TDS of 820 ppm**, exceeding the desirable standard (500 ppm max under IS 10500:2012). This poses scaling risks to concealed piping, solar systems, geysers, and chrome fixtures.

| <b>Observation Description</b> | High active moisture levels ranging from 13% to 55% detected along walls adjoining wet zones (Utility, Toilets, and Washrooms) during non-destructive moisture meter testing. Gaps, missing grout, or cracked cementitious grouting at wall-to-floor junctions and tile corner joints allow splash water and cleaning runoff to bypass the tile surface. Moisture migrates laterally into the sub-screed bedding and capillary-rises into adjoining walls. |

| <b>Recommendation</b> | <p><b>Step 1</b></p> <p><b>Joint Preparation &amp; Grout Raking:</b> Rake out all deteriorated, cracked, or cementitious grout along all corner perimeter joints, wall-floor junctions, and tile-to-sanitary fixture interfaces in wet areas down to a minimum depth of 5 mm using a mechanical grout raker or manual hook tool.</p> <p><b>Step 2</b></p> <p><b>Deep Cleaning &amp; Drying:</b> Clean all raked joints thoroughly using compressed air or a vacuum cleaner to eliminate dust and loose debris. Allow the sub-surface moisture in the wall masonry to dry down below acceptable limits (&lt;12%) before sealing.</p> <p><b>Step 3</b></p> <p><b>Perimeter Joint Sealing:</b> Apply a high-grade, waterproof, stain-resistant epoxy grout</p> <p><b>Step 4</b></p> <p><b>Wall Surface Treatment &amp; Repainting:</b> Scrape off all blistered or flaking paint and efflorescence on affected outer wall plaster surfaces. Apply a coat of damp-block primer, allow it to cure, patch with acrylic wall putty, and refinish with two coats of premium interior emulsion paint.</p> |

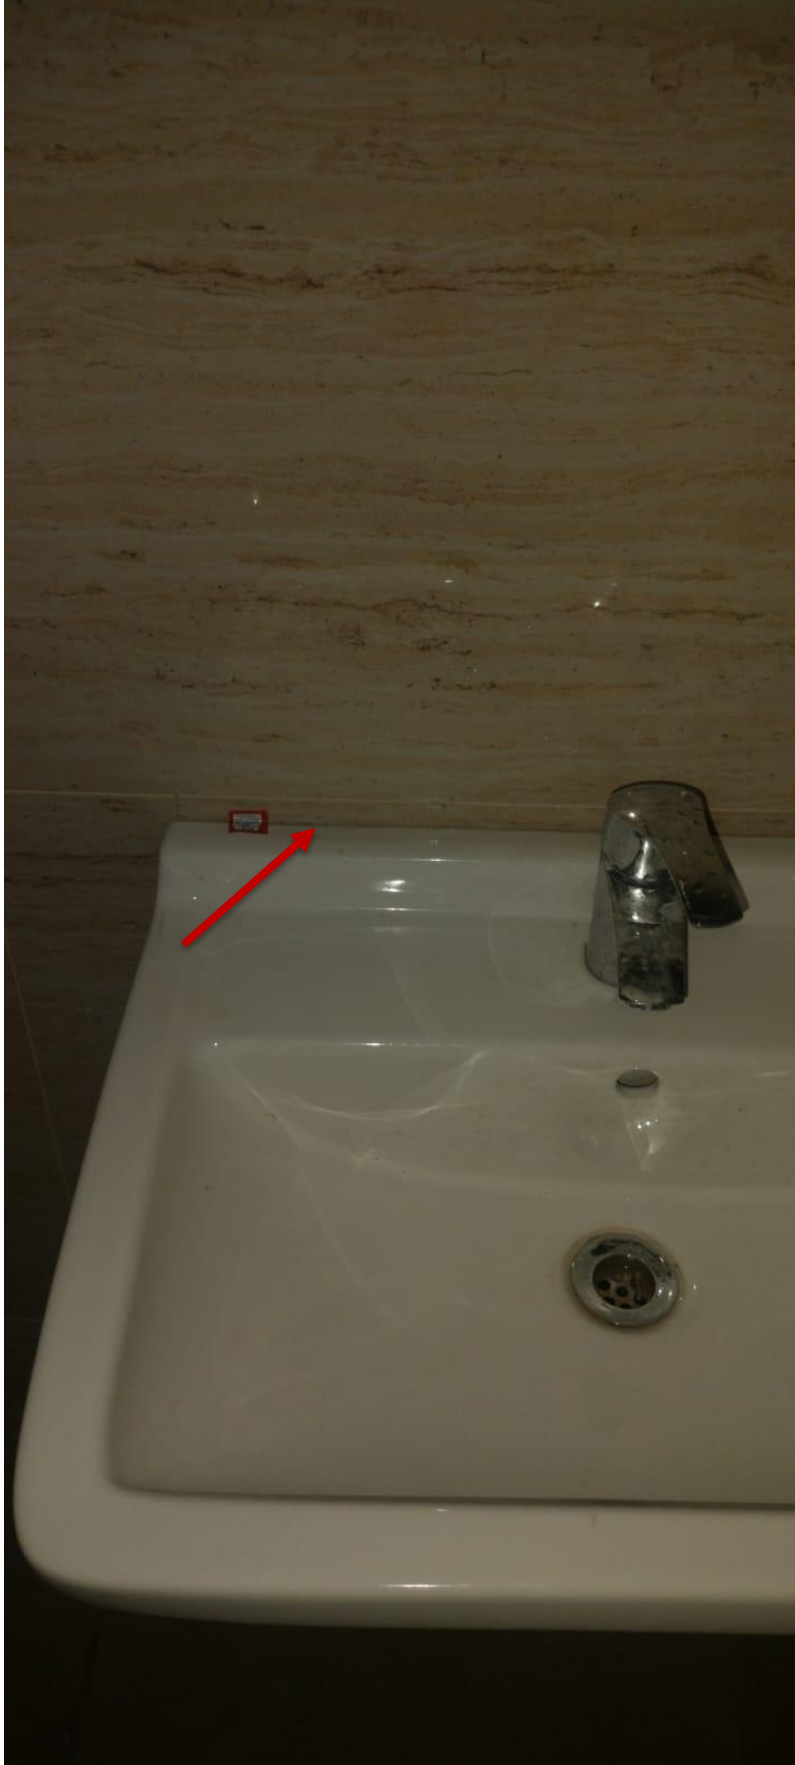
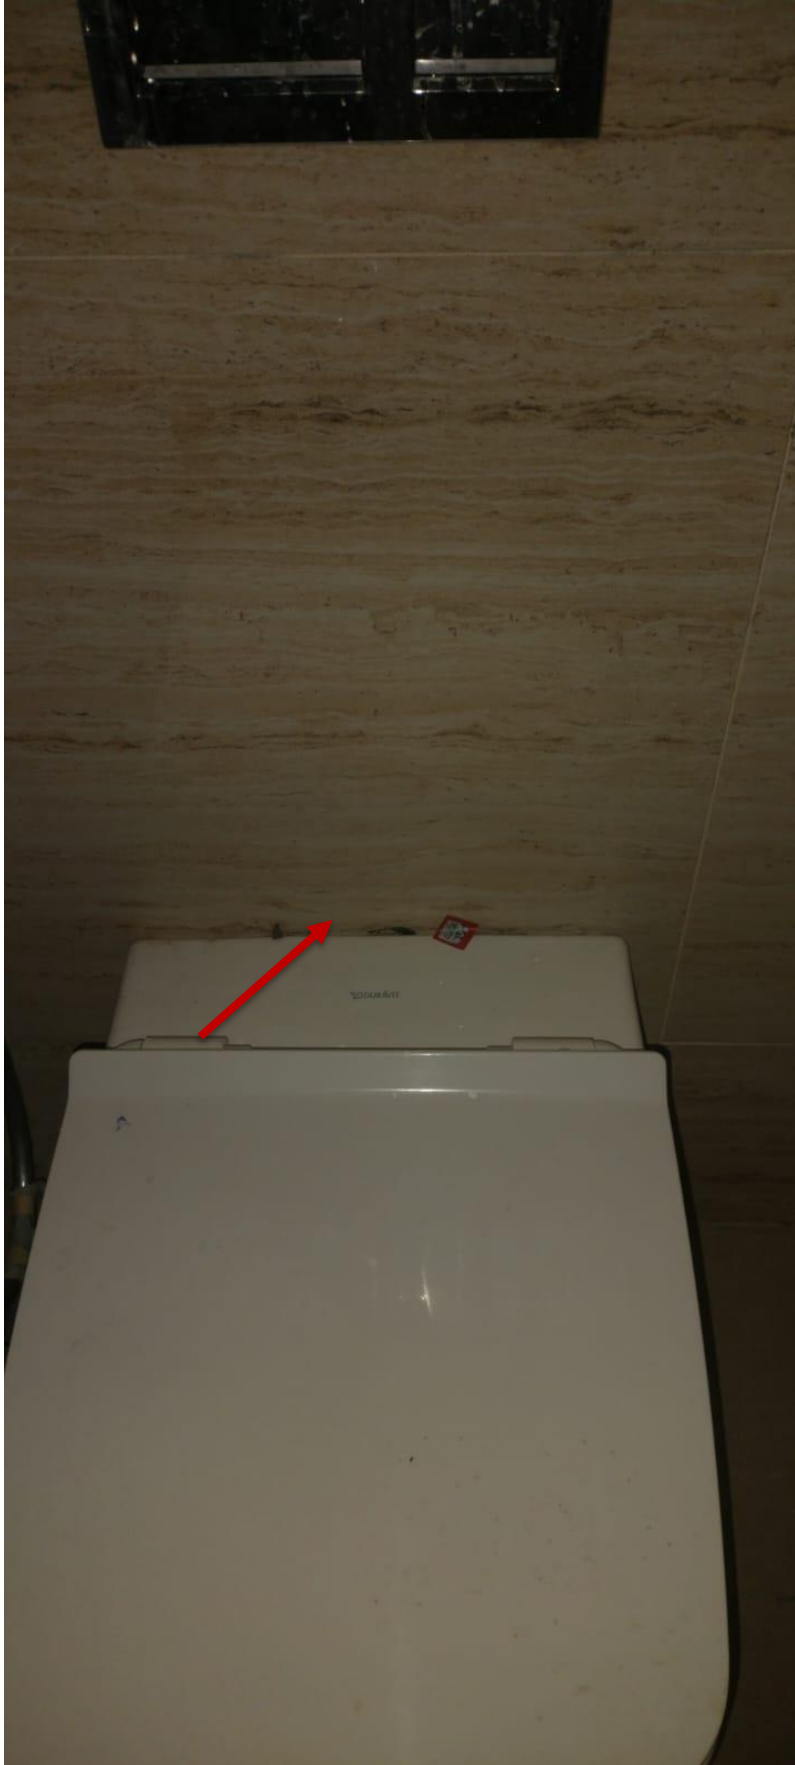
| <b>Observation Description</b> | Unsealed gaps observed at the junctions between ceramic fixtures (washbasin, wall-mounted water closet) and the tiled wall, as well as around Chrome Plated (CP) plumbing fittings (faucets, spouts). |

| <b>Recommendation</b> | <p><b>Step 1</b></p> <p><b>Surface Preparation:</b> Clean the perimeter gaps around all ceramic fixtures and CP fittings thoroughly using a dry microfiber cloth and mild solvent to remove any dust, moisture, or construction residue.</p> <p><b>Step 2</b></p> <p><b>Sanitary Sealant Application:</b> Apply a continuous, neat bead of high-quality, anti-fungal, sanitary-grade silicone sealant along the junction where the ceramic fixtures (washbasin, WC) meet the wall tiles. Ensure a smooth, angled finish to promote water run-off.</p> <p><b>Step 3</b></p> <p><b>CP Fitting Isolation:</b> For CP fittings, ensure the decorative plates/flanges are pushed completely flush against the tiles. Apply clear silicone sealant directly behind the flanges to prevent water from tracking back along the concealed pipe threads into the wall cavity.</p> |

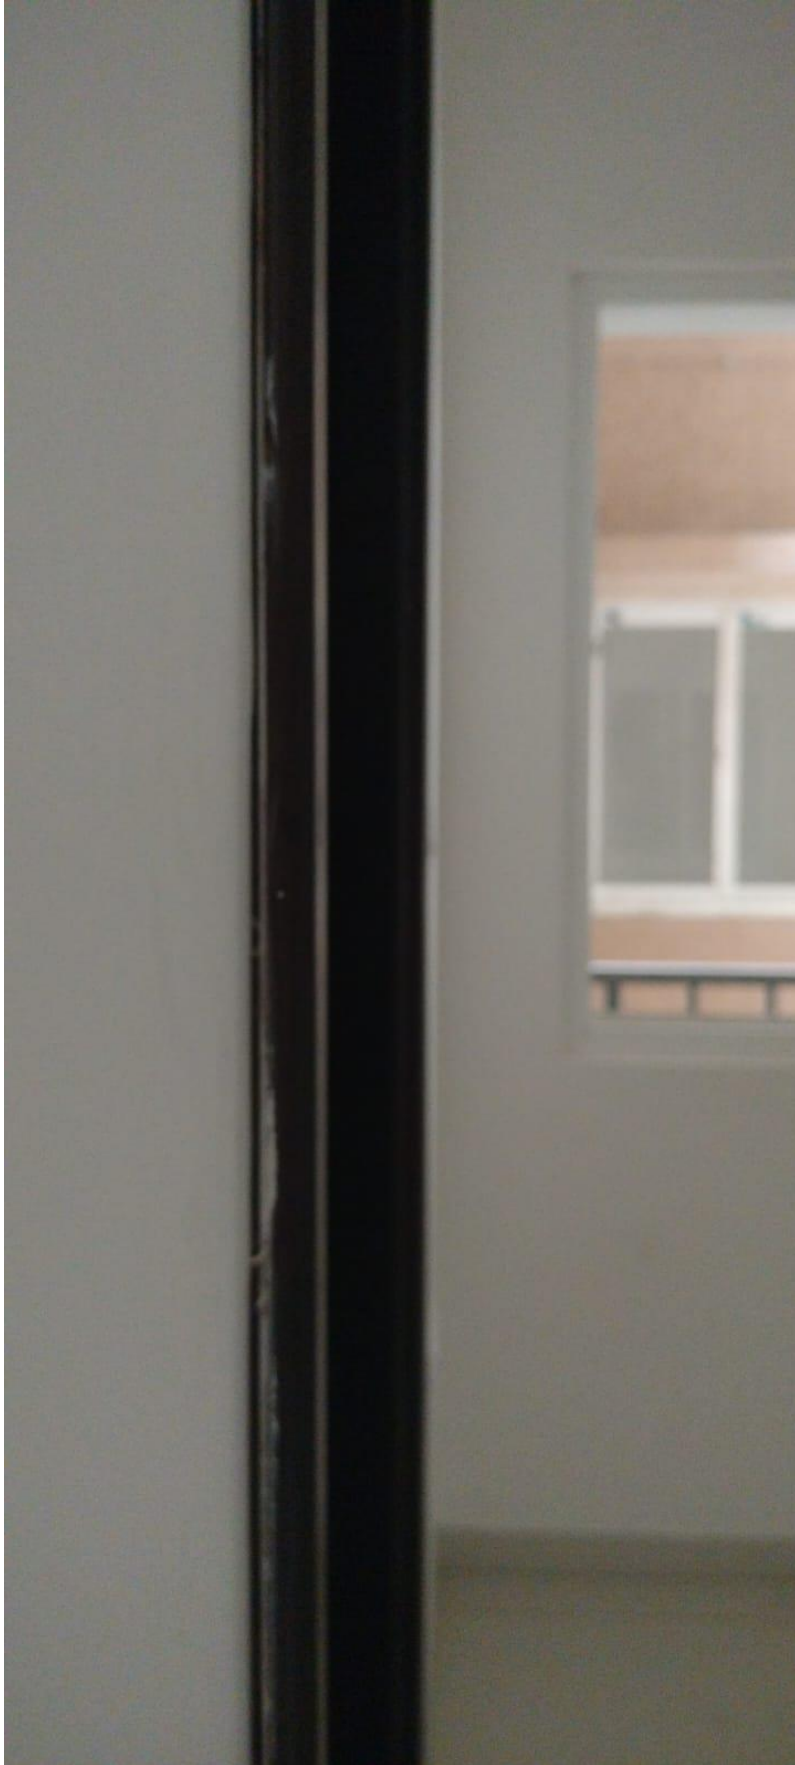
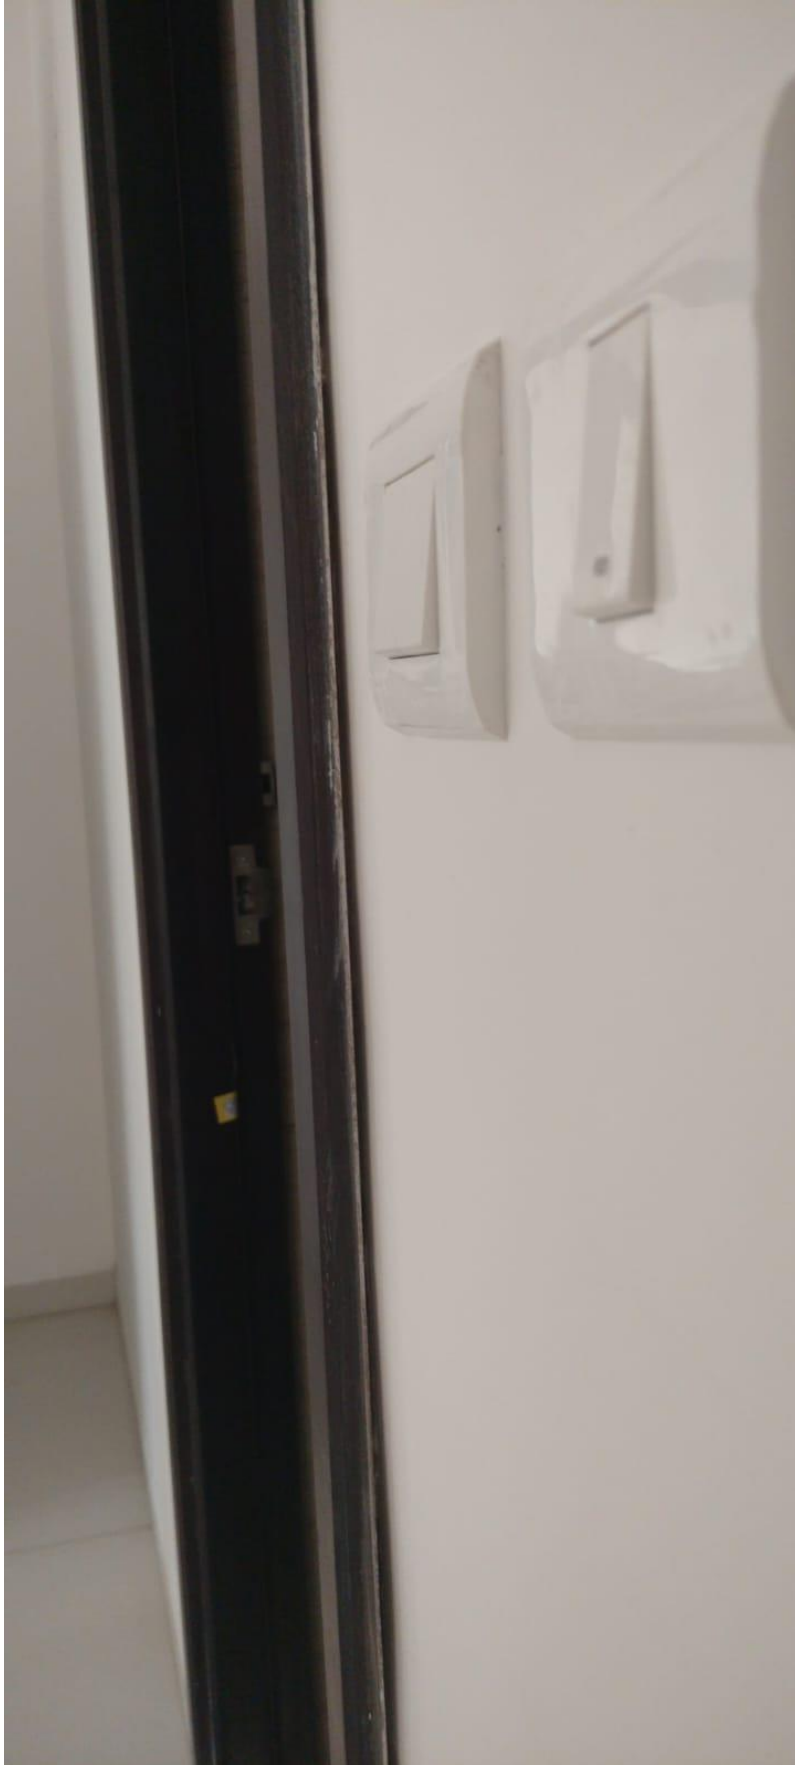
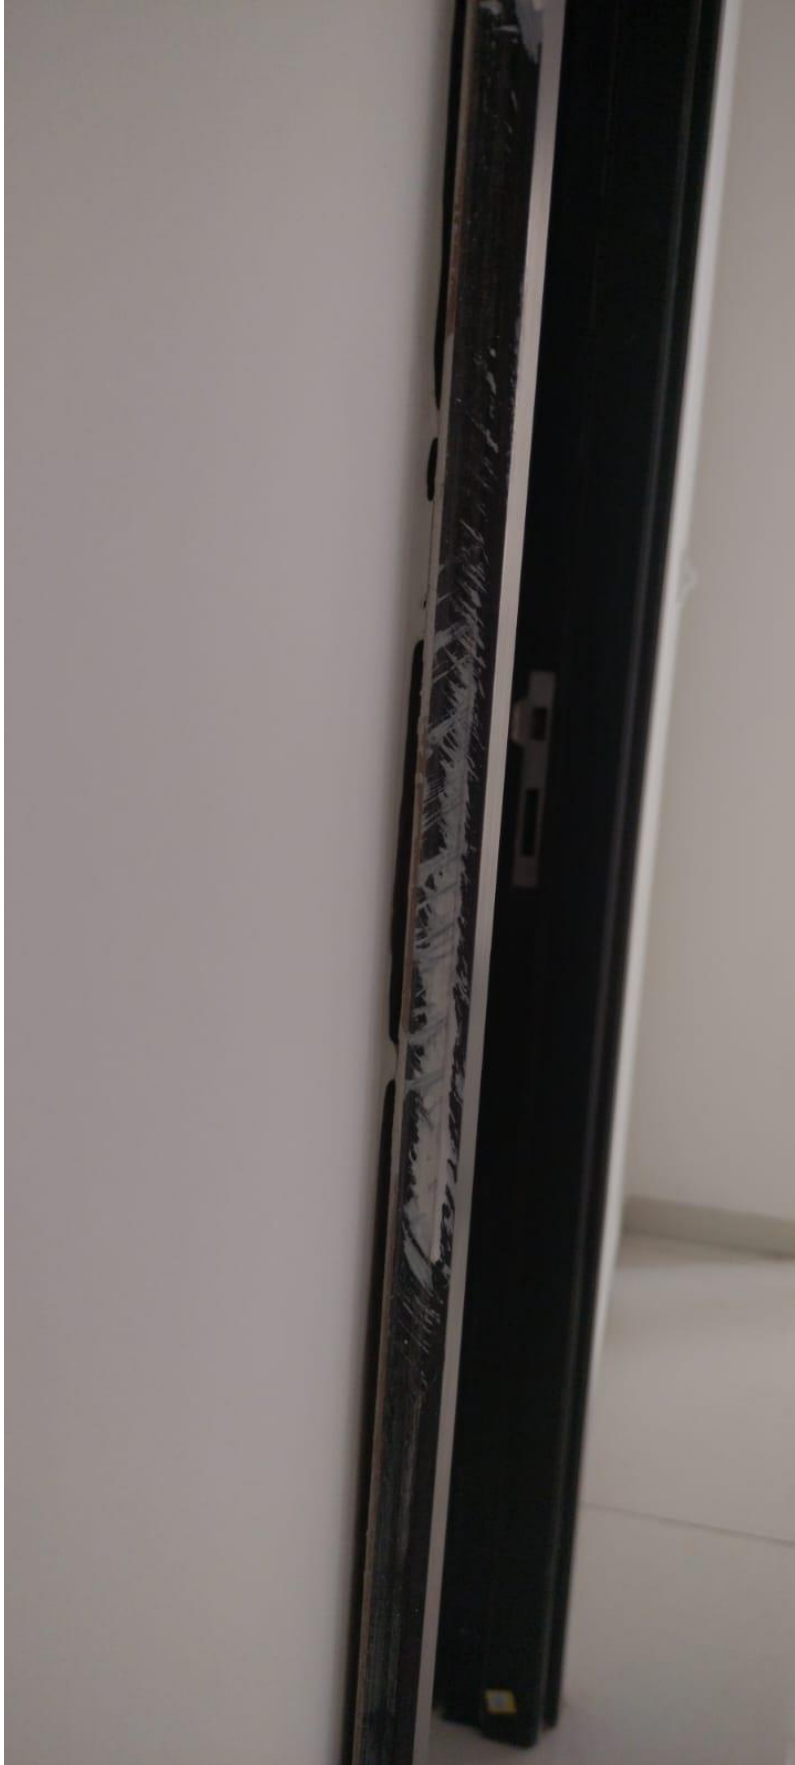
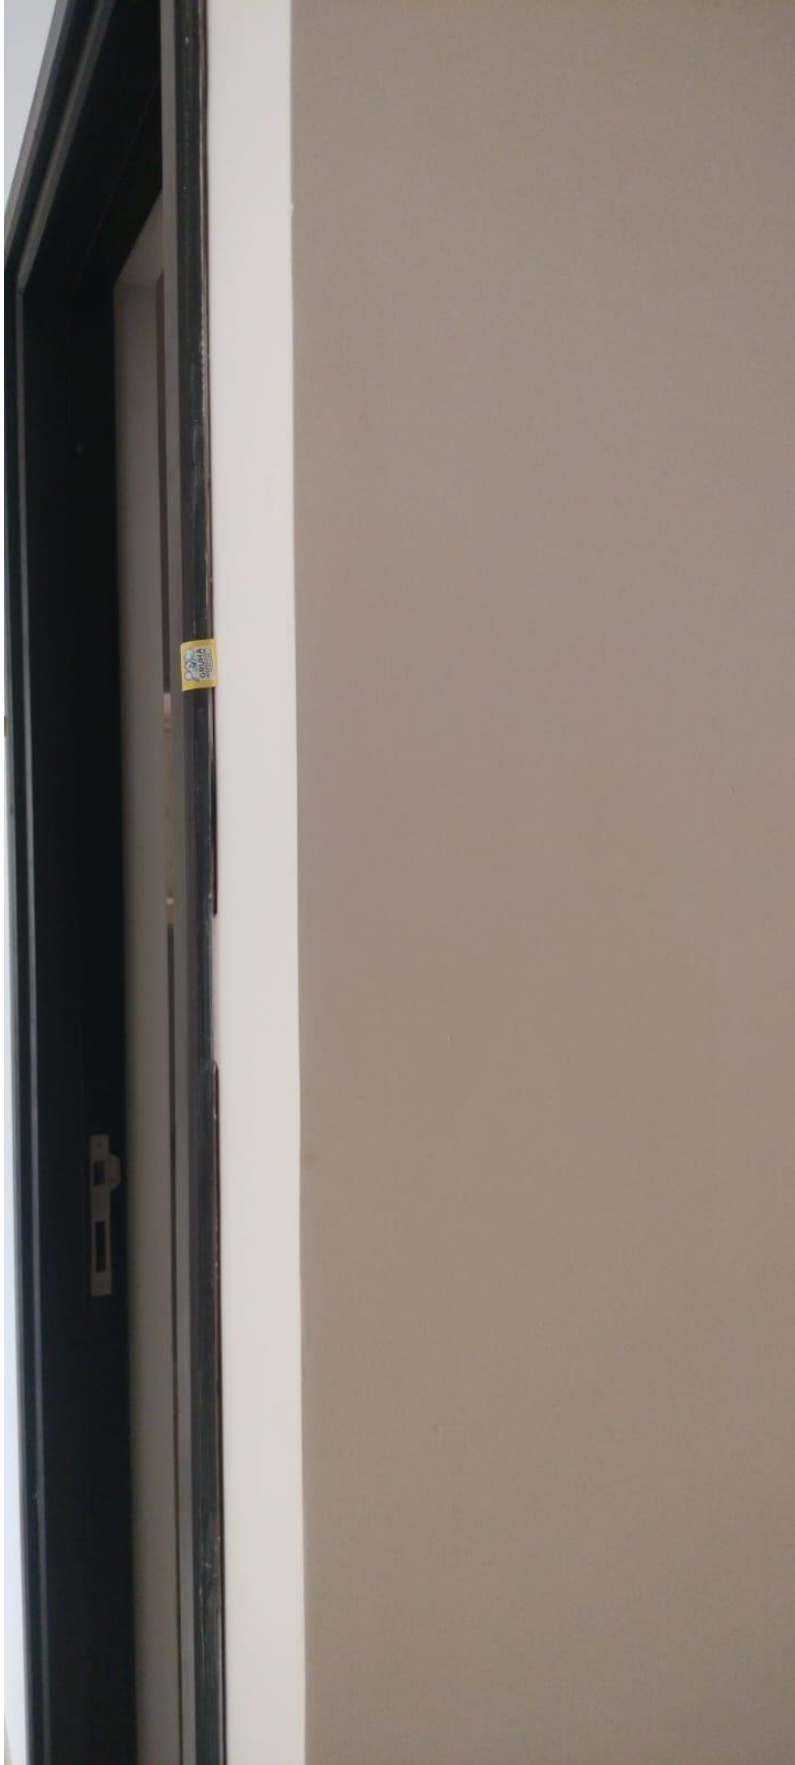
- **Perimeter Gaps at Door Frames:** Unsealed gaps between door frame architraves and wall surfaces were observed across all room doorways. These gaps require flexible, paintable acrylic/polyurethane sealant to avoid moisture exposure, insect harborage, and frame swelling.

| <b>Observation Description</b> | Unsealed gaps and micro-voids observed between the door frame architraves and the adjacent wall surfaces across various doorways. |

| <b>Recommendation</b> | <p><b>Step 1</b></p> <p><b>Joint Preparation &amp; Surface Cleaning:</b> Scrape away any loose plaster, paint flakes, or construction dust from the perimeter gap between the door frame architrave and the wall surface. Clean thoroughly using a dry brush or micro-vacuum.</p> <p><b>Step 2</b></p> <p><b>Masking &amp; Backer Rod Placement (If Gap &gt; 5 mm):</b> Apply painter's masking tape along both the architrave edge and the wall line to achieve neat, sharp sealant borders. For deep gaps (&gt;5 mm), insert a compressible polyethylene backer rod to control sealant depth.</p> <p><b>Step 3</b></p> <p><b>Acrylic / Polyurethane Sealant Application:</b> Apply a continuous, uniform bead of paintable acrylic sealant (for dry interior walls) or flexible polyurethane sealant along the entire architrave-to-wall junction using a caulking gun.</p> <p><b>Step 4</b></p> <p><b>Tooling &amp; Touch-Up Finishing:</b> Smooth and tool the sealant bead flush using a wet spatula or finger for a clean finish. Remove masking tape immediately and allow curing before performing wall paint touch-ups.</p> |

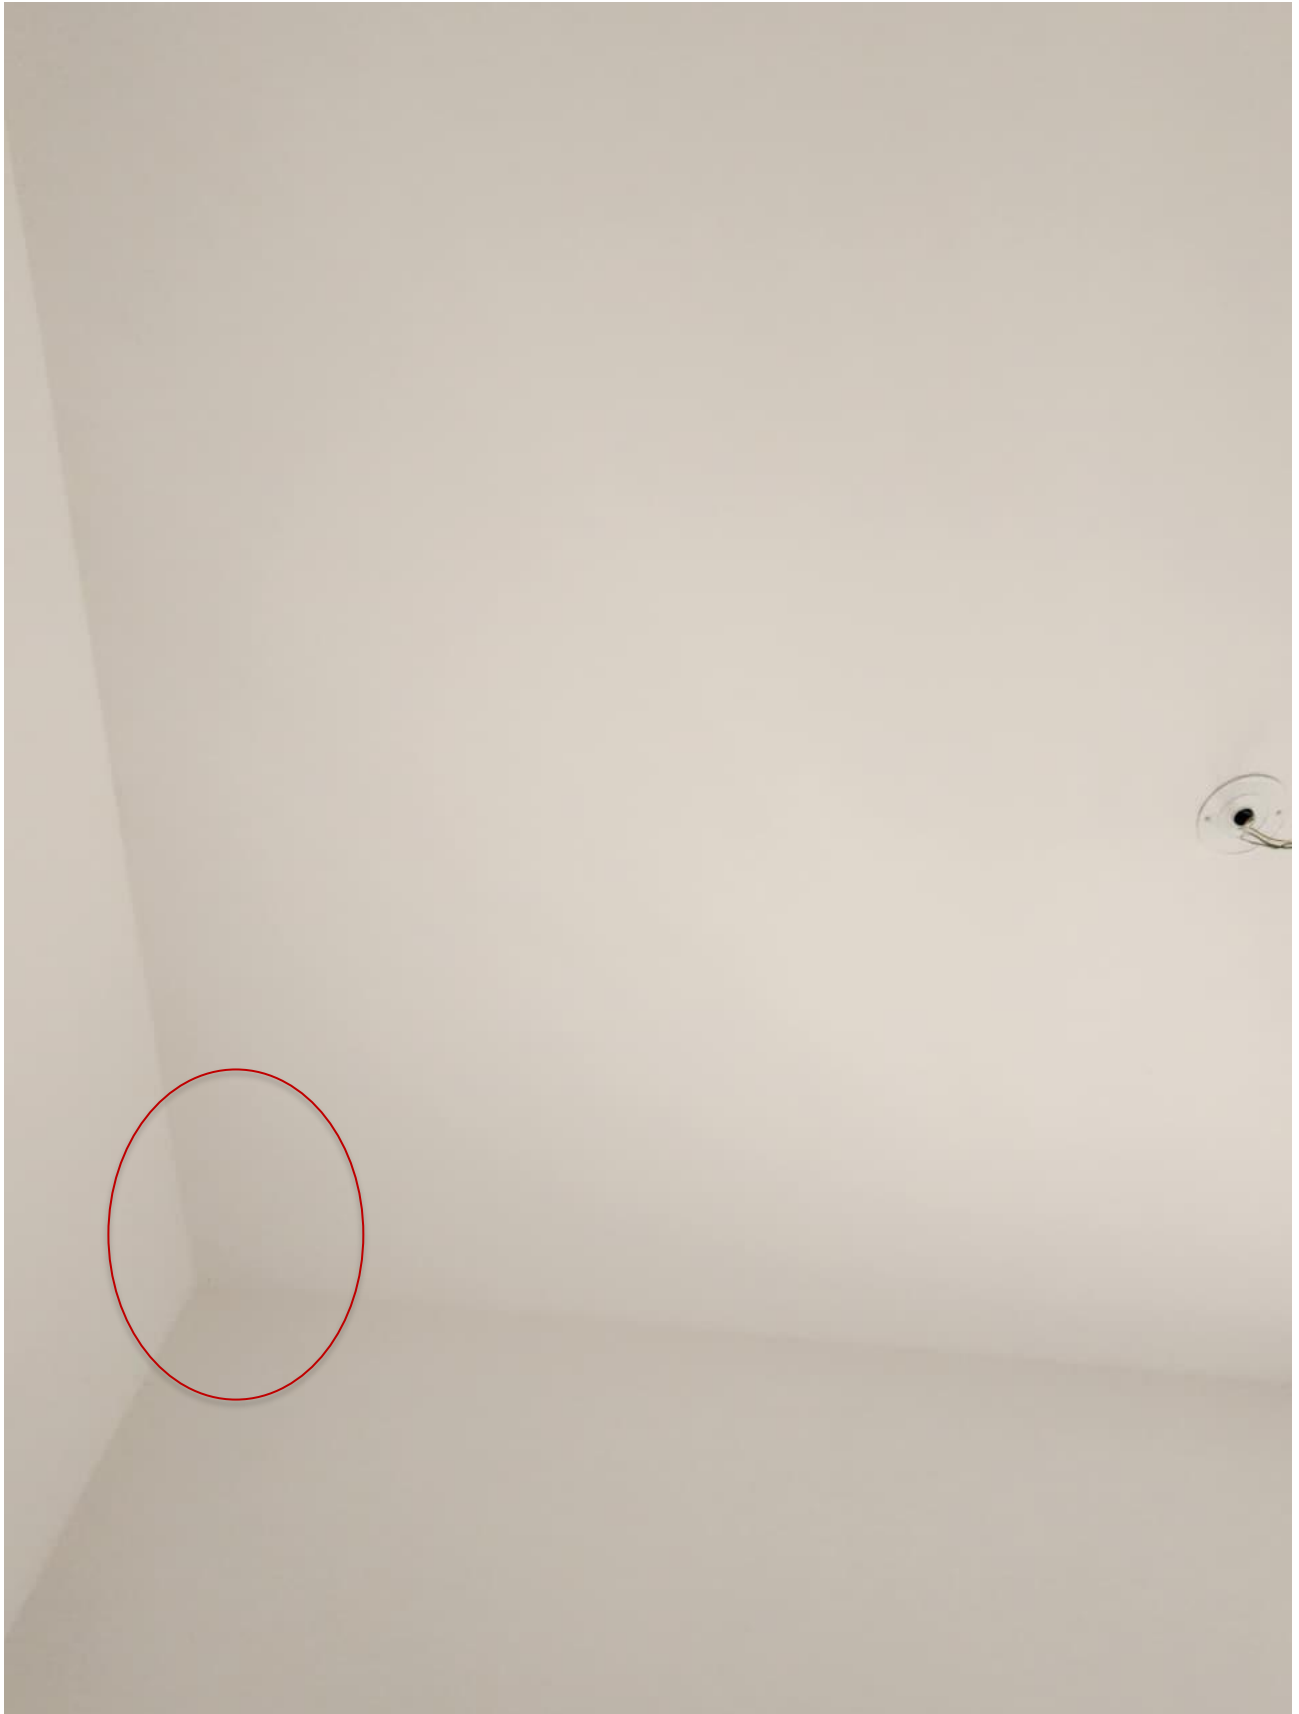
- **Slab-Wall Joint Seepage:** Damp patches and moisture ingress were identified at external wall-to-slab junctions in the **Kitchen, CBR, and MBR corners**. This indicates micro-cracking or improper plaster sealing on the external elevation/facade, allowing rainwater migration.

| <b>Observation Description</b> | Active dampness patches and moisture stains observed along multiple ceiling-to-wall corners where the external peripheral walls join the ceiling slab in the Kitchen, CBR, and MBR. |

| <b>Recommendation</b> | <p><b>Step 1</b></p> <p><b>External Elevation Inspection &amp; Crack Sealing:</b> Inspect the corresponding external outer wall facade using thermal imaging or visual access. V-groove all external hair-line cracks along the slab-beam junctions and seal them using a high-flexibility, UV-resistant polyurethane crack filler.</p> <p><b>Step 2</b></p> <p><b>External Waterproofing Coating:</b> Apply a two-coat elastomeric exterior waterproof coating (e.g., acrylic/silicone-based elastomeric coating) over the external wall surfaces to provide a continuous, weather-resistant waterproof barrier with crack-bridging capability.</p> <p><b>Step 3</b></p> <p><b>Internal Remediation &amp; Touch-up:</b> Allow the internal damp areas to dry completely (verify with a moisture meter until readings drop below threshold). Scrape off peeled paint and efflorescence, treat the internal corner with a damp-block primer, apply polymer putty, sand smooth, and repaint.</p> |
